# CONFIDENTIAL HUMAN FACTORS INCIDENT REPORTS FEEDBACK

## Nº14

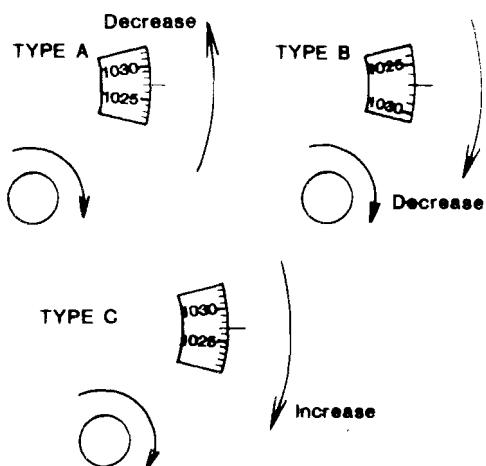
At 2000ft, my co-pilot said, "You've gone below 2000ft!". I replied that I had not, but then saw that my altimeter was set on 1030mb and not the correct QFE of 1020mb.

However, this does not explain why the wrong datum pressure was set, after all, altimeter pressure settings are constantly being changed without error.

Consider the attached diagrams of the altimeters, drawn 2/3 actual size. The

altimeters are viewed from a distance of some 50cm, while the instrument panel is acknowledged to suffer from shake. In the AS332 fleet of many aircraft, the individual helicopters are fitted with altimeters of types "A" & "C" or "B" & "C". As the pilots fly from either seat, according to crewing requirements and convenience, a pilot may find himself using an instrument of type "A", "B", or "C".

These altimeters are superficially similar, but the sub scales and the mode of changing the datum pressure setting are all different. It seems now, that most of my colleagues have difficulty in seeing and setting the correct pressures.

Whatever happened to the altimeters with veeder counters for the pressure setting, that we used to have 20 years ago?
