# Aviation FEEDBACK

Lightning never strikes twice in the same place — or does it?

elcome to Drone FEEDBACK Edition 4. Firstly, I'd like to thank those who have taken time to send in a report. Without you, others would have missed out on learning something, and we would not have any content. We are very grateful to those that have altruistically shared the benefit of their experience.

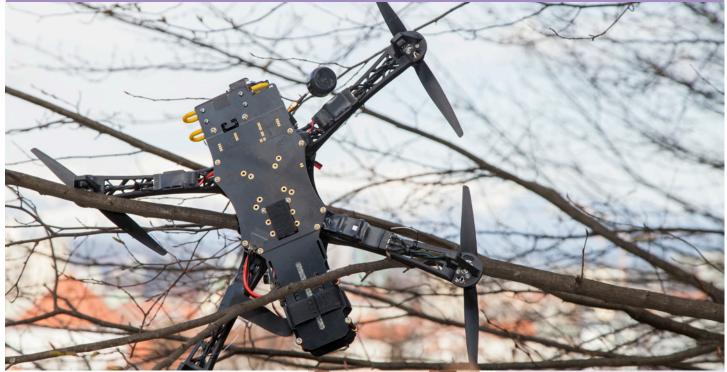
Examination of the UA and review of the log file by the UAS manufacturer identified that the left rear frame-arm folded back during the flight and struck the motor. This resulted in failure of the rotor, triggering the emergency landing mode. The UAS manufacturer considered there was a high likelihood that the locking collar at the junction of the frame arm had not been fully tightened, causing the rotor arm to fold back in flight.

In the photograph top right, we have highlighted in red three of the four collars that need to be tightened before flight. This is achieved by straightening the arm from its folded position, pushing the collar towards the arm root with the airframe and then twisting the collar so that two red markers align.

If it is not tightened enough, it is possible that vibration would result in the collar becoming loose allowing it to rotate freely and perhaps work its way down towards the motor end of the arm. Although the arm would initially be unlikely to break away from where it is attached to the airframe, the arm would be very likely to swing back towards its folded position. See the diagram that is below Report No 2 for how the rotor arms swing for the purpose of storage.

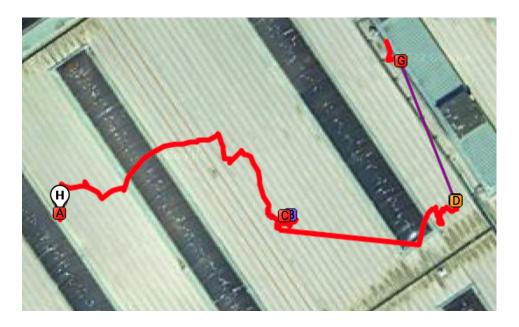
Before commencing the flight, all systems indicated that they were functioning correctly. Once the aircraft was in flight and positioned to video a long transversal beam, it was put into the hover with the vision system preventing it from climbing any higher. After a few seconds in the hover the aircraft suddenly moved sideways by 2 to 3 metres before stabilising again. The pilot reacted by countering the sideways movement with right stick input, but the shift in position had already happened. An immediate switch into ATTI followed, with a return to the home point. Fortunately the aircraft did not come into contact with anything. Subsequent analysis of the log files showed that the aircraft repositioned itself of its own accord at the moment the satellite reception dropped to 5 from 10 before returning to 10.

The GPS satellite reception map of the flight is attached below. The first straight line was the positioning section of the flight. The second in purple was the sudden displacement of the aircraft.

The HF component of this report is simple. Don't be lulled into a sense of certainty that GPS reception is good enough inside a building. Whilst in the last four or five years the quality of GPS reception has improved enormously, it is still not viable to fly with GPS positioning switched on in an

Even with vision sensors switched on, the aircraft will change its position very rapidly to correspond to where it thinks it should be, and stick-control inputs will not change its flight path. If ambient lighting is below 100 lux, the vision sensors become very intermittent, which in CHIRP's experience has also resulted in the aircraft changing its position without any control inputs. So do beware of the potential for sudden and unexpected shifts in the position of the aircraft if you are flying in low light or limited GPS.
