CHIRP MARITIME FEEDBACK

Issue No: 34

01/2014

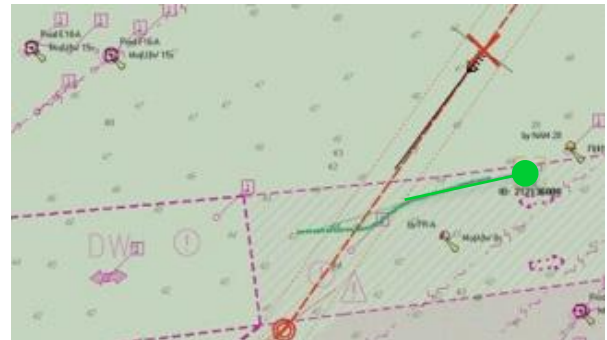
Report text: We are loaded tanker Length 242m breadth 44m, draft 15m bound from Skagen to Rotterdam. Due to dense fog we proceed at 11.2 kts. From the East there is in traffic lane approaching vessel "A" on a collision course. Our heading 220 and their heading is about 260. Collision is imminent and we called them ask to go astern of as per Collision Rules. They refuse and tell that it's too late for them! They tell us that they will go ahead of us, crossing our bow. We can easily see that it is not possible as they have only 8.7 kts speed. Our only possibility is stop engine and let the speed go down. Finally they changed their course more to port as observed from the radar track plotting pictures. If we had not stopped our engine, they never would have passed our bow. We had three radars plotting continuously their manoeuvres and situation was critical all the time and that's why we decided to ask what they are going to do. Our speed was only about 5kts when they finally passed our bow.

CHIRP contacted the ship owner of ship "A". They replied with a report from their ship's officer of the watch (OOW) who confirmed the time and position as per the reporter's statement. The OOW observed the reporter's ship to be making a speed of 9.6 knots with ARPA plot showing an opening bearing to his starboard side with CPA 1.0 miles. The OOW claims his course was 263 and speed 8.7-8.9 knots and saw the ship abeam at 3-4 Miles distance, not in thick fog as claimed by the reporter. The OOW also did not hear any fog signals. He called the reporter's ship and told him of his intentions to alter course to port to increase the CPA to 1.5 miles. The reporter asked that he pass astern but the OOW replied it was too late to undertake that manoeuvre. The reporter's claim to have stopped his ship was not observed. The OOW on ship "A" concludes he believes in such situations, altering course and good cooperation is more effective to avoid risk of collision, especially in good visibility and not dense fog. Also there was sufficient sea room with no closer vessel at that time.

The MAB reviewed the statements from both ships and they noted a number of inconsistencies between the reports from each ship, most notably one ship claims to be in dense fog and the other having clear visibility. However the statement from the OOW on the Ship 'A' reveals he saw red lights on his starboard side and therefore he was the crossing vessel and should have taken early avoiding action.

- The Officer of the watch (OOW) should have complied with the Collision Regulations and taken early and decisive action;
- OOW should have called the Master when the close quarter's situation appeared to be imminent;
- The company should undertake OOW training in order to improve the level of understanding of the Collision Regulations, and
- The company should consider the adequacy of their auditing of Bridge operations.
