CHIRP MARITIME FEEDBACK

Issue No: 38

01/2015

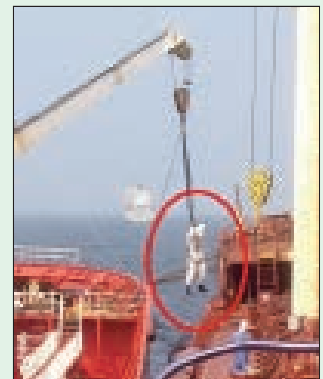
The supercargo ignored all advice and despite every warning, he jumped across to the mother vessel using a safety harness on the ship's crane hook (like Tarzan)!

The Supercargo and the daughter vessel's crew were advised that this type of transfer is very dangerous.

CHIRP Comment: The report highlights a very dangerous practice. The pressure to visit the mother ship appears to have been solely due to the supercargo and perhaps in the belief he was creating a good impression on his first assignment. The result was a senior person flaunting safety standards on both ships. The safety culture on the ship operating the crane was not strong; the crew did not feel empowered to stop lifting the inspector when he insisted on the lift. The inspection company needs to review the procedures and requirements when personnel are transferring between the ships.

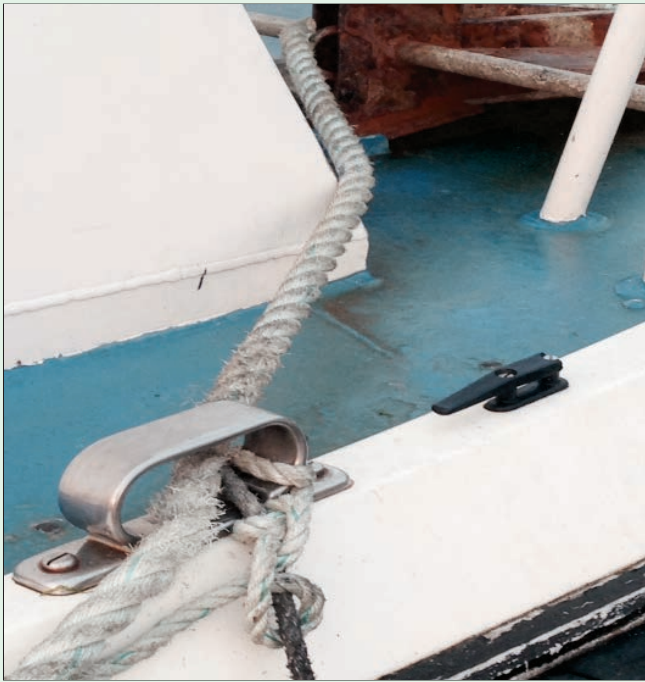
Prior to boarding one day, it was noted that the relief ferry was being secured to the slipway on the island using only a frayed bow line as a spring, the vessel being left powering against the spring while passengers disembarked and embarked.

The reporter's concern is that the rope might break, or the vessel might pull a ring out of the pier as considerable power is used to hold the vessel against the slipway, especially if the tide is ebbing hard, or a strong offshore breeze is present. The reporter's concerns are compounded by the fact that the skipper does not stay at the helm during loading and unloading. Of lesser concern is that no safety announcements are taking place, which is common on this route.

Lessons Learned: The crew could usefully be sent on a safety awareness course and then adequately supervised to ensure compliance with safety regulations.
