Editorial

REPORTS ...

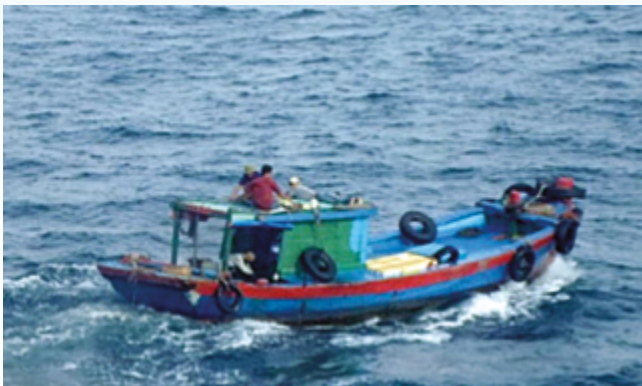
Fisherman or pirate? One of the vessels involved in the incident

The Officer of the Watch believed that the two fishing boats astern were a distraction and the fishing boats forward might be suspicious. The Bosun was requested to check the forward end of the vessel carefully. Five pirates armed with

knives boarded the vessel from the fishing boats on the bow, and tried to gain access to the forecabin by breaking the padlock. From a safe distance, the Bosun spotted the armed robbers and informed the bridge.

The Maritime Advisory Board commented that this report reinforces the need for ships' crews to ensure they have a security plan in place, and they each know their role as listed in the plan. The plan should not be generic but be tailored to suit the circumstances for the area of the world they are in. This could involve ISPS compliance, Best Management Practices, and intelligence-based reports of any security related activity that warrants defensive measures in a particular area. The incident as reported is similar to many attempted robberies in the Far East, but we have also seen similar reports coming from South America, the Caribbean, and East Africa.

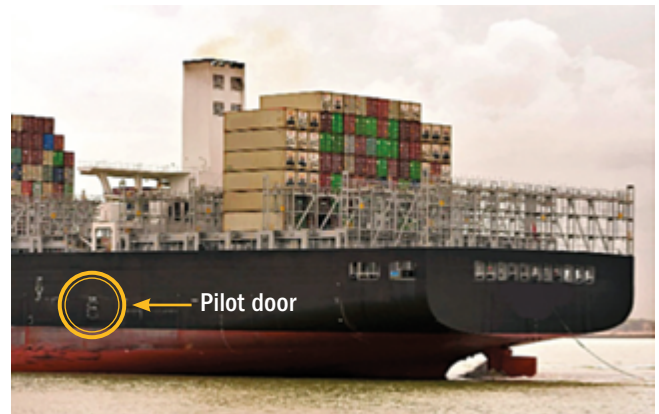
The attached picture is of a new build container ship 333m x 48m, constructed at a shipyard in the Far East. She arrived in Port "A" fully loaded, but when she sailed in light condition the pilot could not disembark because of the cut-away at the quarter. In light condition, the last meter of the ladder was not flush with the side of the hull and the pilot boat would have been forced to operate under the counter. The vessel was requested to ballast the ship down to enable the pilot to disembark safely.

The pilot door not lying within the parallel mid-body in light condition

This is the first of a group of 5 new built vessels under our management. The fifth and final vessel will be delivered to us within the next few weeks. The current pilot boarding arrangement is definitely a design failure that was not

recognized before and during the building phase. We only became aware that at certain loading conditions the lower part of the pilot ladder would be left aft of the parallel body, imposing obvious hazards, after we took delivery of the vessel.

To resolve the issue we discussed possible alternatives with the shipbuilder and agreed to modify the vessels by adding a secondary means for pilot boarding. This involves installation of an additional pilot ladder to be used in conjunction with the existing accommodation ladder. The main features of the modification are;

- The secondary means of pilot transfer shall be used in case of draughts lighter than 11.609 metres. For drafts deeper than 11.609 metres, the existing primary pilot ladder with pilot door will be used, which is approved by the International Marine Pilots Association, (IMPA), and the Panama Canal Authorities;

- The additional pilot ladder will be fitted in way of Frame 81+600, by means of suitable eye plates (not a reel). This is within the parallel mid-body of the ship and within the midship half-length of the ship;

- The additional pilot ladder will be secured to the ship's hull by means of Class-approved securing fittings, (magnetic and detachable type), and all steps shall rest firmly against the ship's side;

- The additional pilot ladder shall be transported from its stowage position and shall be launched by means of suitable davits and messenger ropes; and

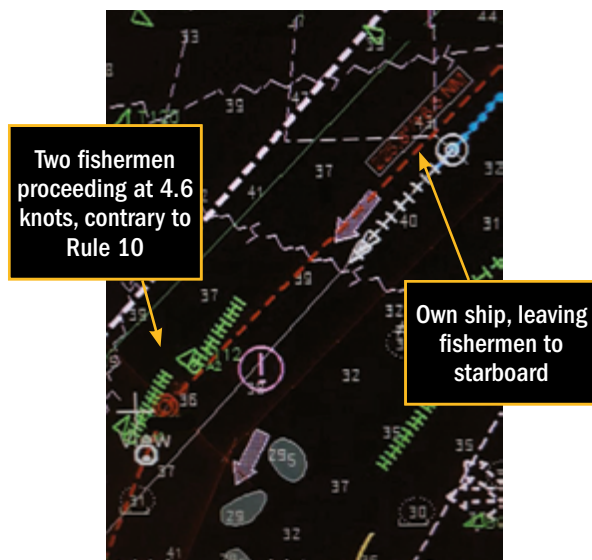
At least five fishing vessels were noted to be contravening Rule 10 in the English Channel. The vessels were in radar range of Dover Coast Guard/CROSS Gris Nez Traffic, but none of the fishing vessels were called by either station. I have observed this numerous times, and have seen many vessels get into difficult situations with fishing boats behaving in this way. At no point were any fishing vessels spoken to by either observing station during the course of my four hour watch.

ECDIS Display of fishermen contravening Rule 10 in the vicinity of F3 buoy.

Further dialogue with the reporter determined that tidal streams were against own ship for the transit and that the fishermen were showing a speed over the ground of 4.6 knots. CHIRP agreed to discuss the matter further with Dover Channel Navigation Information Service, and national fisheries organisations.

Should you find yourself in a position where fishermen are contravening Rule 10 in the Dover Straits, then **CHIRP** advice is to report this to Dover Coast Guard / CROSS Gris Nez as appropriate in order for them to create a hazardous incident report and launch an investigation.

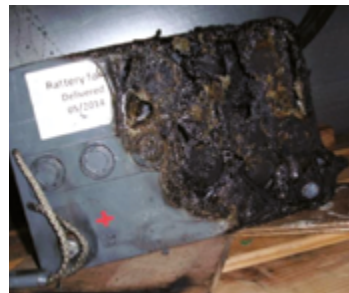
During a period of heavy weather, the battery tipped onto its side and slid against the steel lining of the bulkhead. As the battery terminals were not covered, this caused the battery to short and led to it overheating.

Damaged battery after the fire.

- All batteries, including spares, must be secured in place to prevent movement
- All spare batteries should have the terminals covered with insulating material to prevent accidental shorting
