## Editorial

Welcome to the 50th edition of Maritime FEEDBACK which is being prepared at Lunar New Year – so *Kung Hei Fat Choi* to all our readers, reporters and sponsors, and we wish you a safe and happy Year of the Dog.

### Rescue boat lifting strops

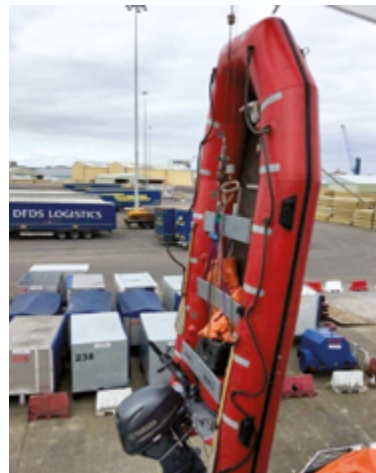
The lifting strops for the vessel's two inflatable rescue boats, (IRB's), had recently been renewed. At the time of the incident the vessel was alongside, and the opportunity was taken for some familiarisation training. This included swinging out the port rescue boat. Unfortunately, the deck crew who had fitted the new strops attached the aft strops to strongpoints on the hull, and not to the correct lifting points on the transom. This resulted in an unstable lift as the weight of the outboard motor caused the boat to rotate about the aft strops and assume a vertical position, bow up, as shown in the photograph.

Rescue boat – hanging vertically because strops have not been fitted correctly

Once the port boat had been swung out over the ship's side it was lowered a few metres, at which point the boat tilted to a vertical (bow up) position. The boat was subsequently recovered by attaching a heaving line to the bow which in turn was secured to the mooring deck, thus bringing the boat to the horizontal position for stowage.

Investigation revealed that the aft strops on both boats had been attached to the wrong strongpoints on the hull and not to those on the transom. Having positively confirmed that this was the root cause, the strops were repositioned to the correct strongpoints, and both boats were successfully test launched.

The investigation determined that the crew members concerned were unsure of which strongpoints to use when refitting the strops and, unfortunately, chose not to seek clarification. In order to prevent a recurrence of this incident, the correct strongpoints were then permanently marked.

Whilst the changing of one piece of equipment with an identical certificated replacement may appear to be straightforward (and in this case, was not difficult), it is important that there is appropriate supervision and that such items are then cross-checked / tested before use.

When equipment is removed or replaced full notes/ photographs should be taken and kept on board to ensure replacements are fitted correctly. On this occasion, it seems that further clarification was not sought when questions were raised amongst the crew who were refitting the strops.

- It is good practice for vessel operating procedures to include photographs and accompanying notes in a clear logical order – these should be unambiguous. In this case, the procedures would include both the launching and recovery procedures, and the procedure for changing out the lifting strops. A picture is worth a thousand words and can be extremely helpful.
- The above, coupled with a briefing and risk assessment prior to undertaking the task, would negate the Human Element comments in the report related to appropriate supervision and crew not clarifying the location of the strongpoints when refitting the strops.

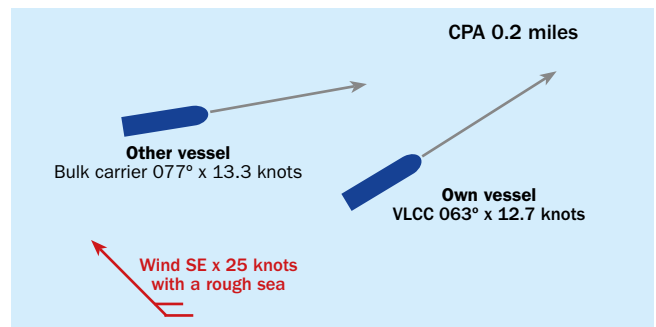
Vessel “xxx”, (a bulk carrier), was on our port quarter with a heading 077° and a speed of 13.3 knots. Own vessel, (laden VLCC), was proceeding on heading 063° and a speed of 12.7kts. See diagram below.

Schematic diagram showing relative positions of the two vessels

It was a slightly doubtful as to whether this was a Rule 13 situation in which “xxx” was overtaking us, or a crossing situation as per Rules 15 and 16 in which she was the give-way vessel and we were the ‘stand-on’ vessel as per Rule 17. Given the relative aspects of the vessel, we perceived it as an overtaking situation and in line with Rule 13(c), good seamanship would dictate that it was an overtaking situation. Either way, we were the stand-on vessel and “xxx” was supposed to take avoiding action.

No avoiding action was observed from “xxx” and with a CPA of 0.2 miles and TCPA of 30 minutes, we decided to contact her on VHF to ask for her intentions. She replied that she intended to maintain course and speed.

We therefore decided to take our own actions and altered course 30° to starboard in order to maintain a safe distance of at least 1.5 miles. By altering to starboard, we let her overtake us at a safe distance. Due to the relatively small difference in speed between the two vessels, we were ‘pushed’ off our intended track by about 3 nautical miles. As we were in the open ocean, we considered this the safest action given the complete ignorance of the other vessel in judging the situation.

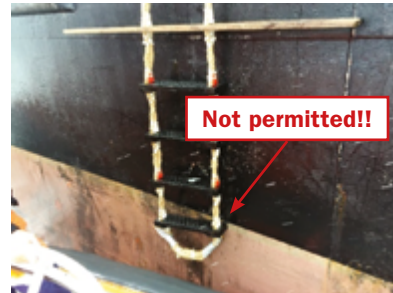
- Incorrect pilot ladder rigging (see picture 1).
- Pilot ladder bottom rubber steps – chock missing. Steps at uneven gaps and angled. The manropes have been fitted with monkey’s fists at the ends, and the side-ropes are not continuous as the regulations require - they do not pass under the steps but terminate lashed together (see picture 2).
- Rope ladder secured to ship’s side by only one magnet which was loose and located more than 2 metres from the bottom of the gangway platform.
- Whilst disembarking a vessel using a port side ladder, the

1 – Dangerous loop at bottom of ladder

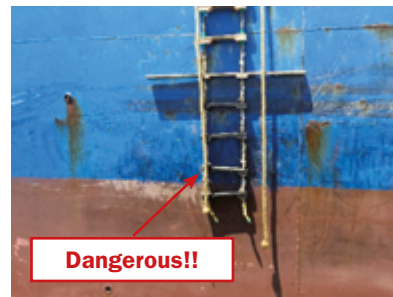
2 – Uneven ladder step

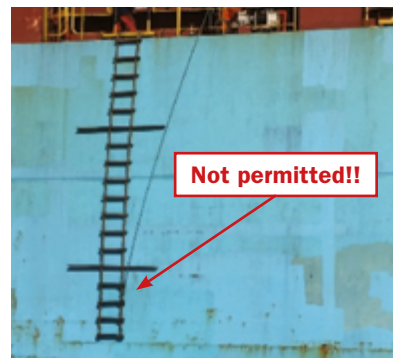
- Pilot noticed a nylon chock loose and hanging out, approx. 3.5 metres from the bottom of the ladder on the aft side.
- A tripping line was fitted below the bottom spreader, and the ladder steps were not horizontal (see picture 3)
  - A heavy metal socket was fitted at the end of a heaving line. The line was lowered during a transfer on the outward pilotage.
  - Rung bent on rubber ladder steps. Tripping line fitted below spreader. Side ropes not continuous as also mentioned in the comment for picture two (see picture 4).

3 – Tripping line below spreader

The **CHIRP** Maritime Advisory Board commented that the SOLAS requirement for a tripping line states: “When a retrieval line is considered necessary to ensure the safe rigging of a pilot ladder, the line should be fastened at or above the last spreader step and should lead forward. The retrieval line should not hinder the pilot nor obstruct the safe approach of the pilot boat.

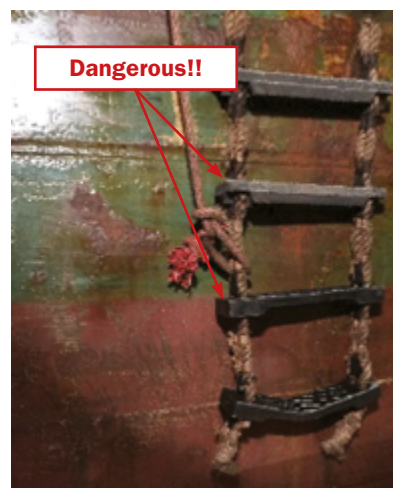
4 – Bent step and tripping line below spreader

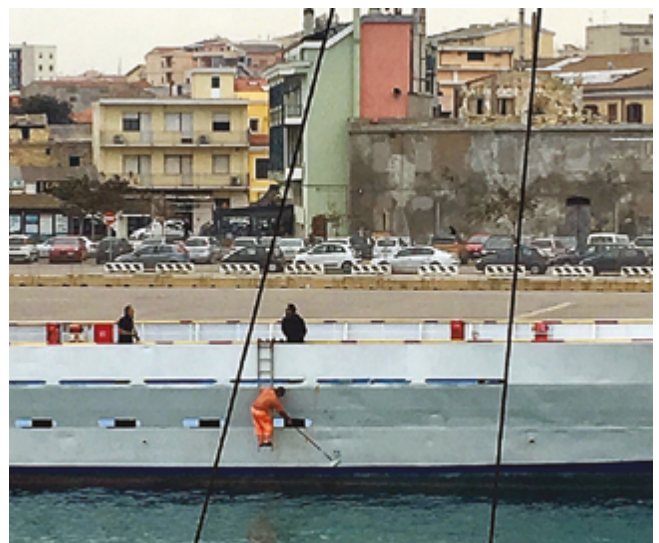
The following is a brief description of a scene that I witnessed whilst alongside in a small Mediterranean port. There was a small coastal ferry moored directly astern of us which is used to connect the port with a nearby island. On her starboard (outboard) side, I could clearly see a crew member working over the side in an unsafe manner. He was dangerously leaning over a metal embarkation ladder and was not wearing any kind of personal protective equipment apart from safety shoes. This picture was taken at the time. There was also what looked like an officer supervising the job from the deck... demonstrating a complete lack of safety culture!

Painting over the side – lack of safety precautions

**CHIRP** sees many things wrong in the picture. As a “smoke oh” exercise, or perhaps at a Safety Committee Meeting, or even just for fun, why not examine the picture to see how many hazards you can spot. You may well be inclined to check that all of your own onboard procedures are robust in terms of planning, risk assessment, toolbox talks and execution of the job itself.
