MARITIME FEEDBACK

Issue 58
March 2020

An independent and confidential reporting system for the maritime industry

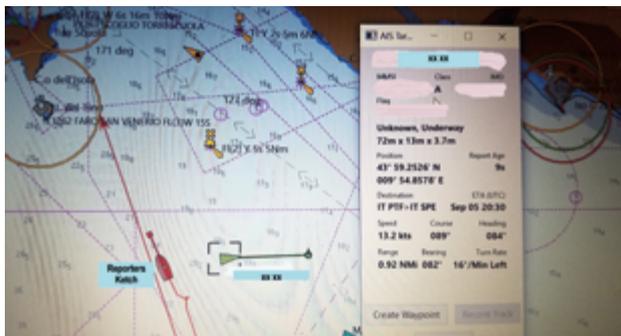
It was a clear night with good visibility, and we were approaching the outer reaches of our destination port, when we noticed a power-driven vessel approaching from our port side. We observed it visually and on our AIS unit (Note: the ketch's AIS was a receive only unit, not a transponder). We were making 5.8 knots under power and the approaching vessel was making 13 knots. The AIS showed a CPA of around 100m so we closely monitored the approaching vessel expecting it to alter course to starboard and pass astern of us. Our navigation lights were on and bright but the approaching vessel closed without altering course, so we turned on our deck lights to further illuminate our ketch and reduced speed to 2 knots. As the approaching vessel remained on what appeared to be a collision course, I altered course hard to starboard and eventually completed a full 360° round turn. Once the other vessel had passed, I

resumed my original course. I tried calling the other vessel on VHF Channel 16 to alert her to the near miss, but there was no reply. I then took a screen shot of the AIS.

Screen shot of AIS display after the round turn to starboard

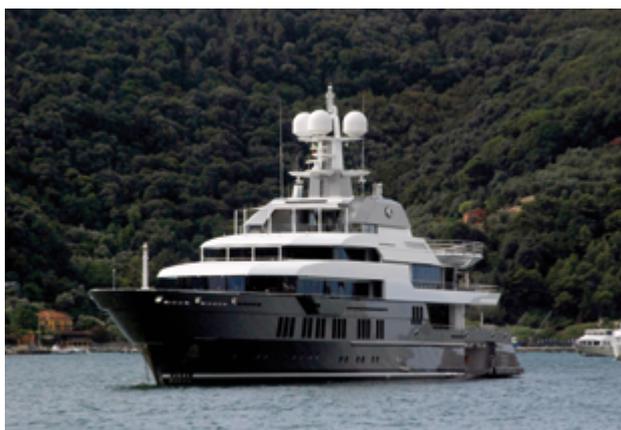
The 72m motor yacht safely at anchor the following day

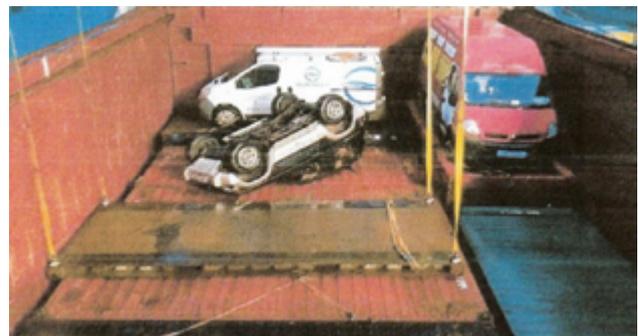
The 4x4 after the incident

The flat involved in the incident was to be placed athwartship, parallel and close to the white van. Whilst lowering down into the hold, the forward right-hand side of the flat struck the track of the moveable bulkhead. The contact was enough for the 'top lock' lifting equipment to become detached. This corner then dropped, causing the second 'top lock' on the same side to become detached, which caused the flat to tip over. The lashings attaching the vehicle to the flat then failed, and the vehicle dropped into the hold on its roof.

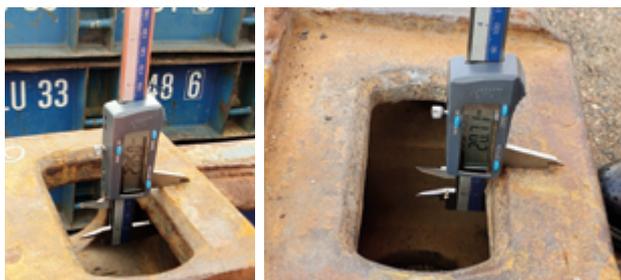
Inspection of the flat involved showed that the top plate thickness of the lifting socket of this type of unit is (at approximately 20mm) some 8mm thinner than the standard fittings on other more modern flats and the industry standard (approx. 28mm). Given that the top of the plate is chamfered, only a parallel plate thickness of 8-10mm is available for the tab to connect with. This increases the risk of the tab on the lug moving enough to enable the lug to twist and disconnect especially if there was a twist in the strop. The light rain at the time may also have lubricated the surfaces.

At ≈20mm the top plate thickness was 8mm thinner than more modern "flats" and the current industry standard, ≈28mm

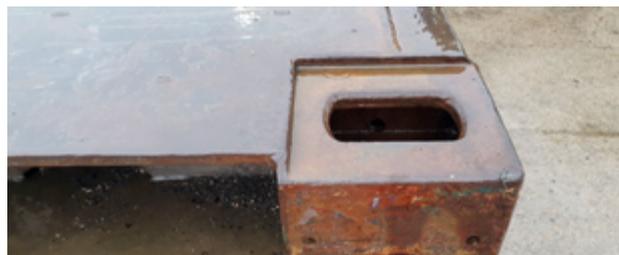
Chamfer on the lifting socket can be clearly seen.

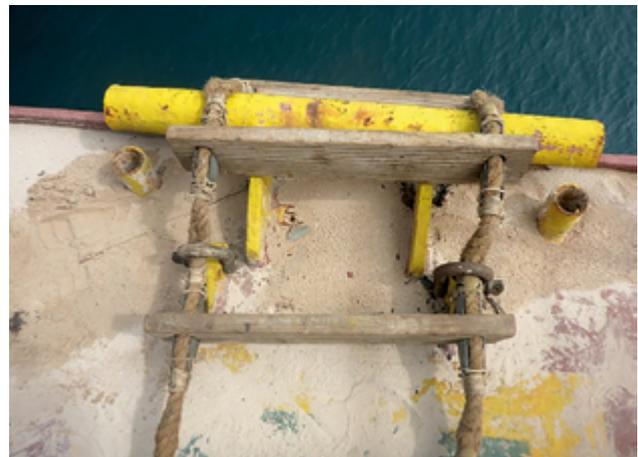
Pilot ladder incorrectly secured to the deck using D-shackles to choke the side ropes.

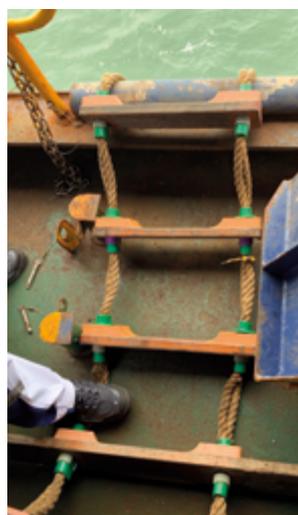
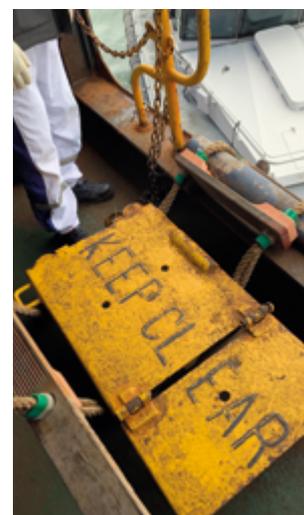
I boarded the vessel and noticed that the ladder had been put under a steel platform. I asked the crew to lift the platform because I wanted to know how this ladder was secured to the deck. After they lifted the platform, I found out that **the ladder hadn't been secured at all**. It ran under the platform, and this platform alone held it down. The ladder came from an electrically powered winch reel, which also wasn't mechanically secured.

They say a picture paints a thousand words – this clearly demonstrates the appalling lengths that some mariners will go to with respect to endangering life.
