MARITIME FEEDBACK

Issue 62
March 2021

An independent and confidential reporting system for the maritime industry

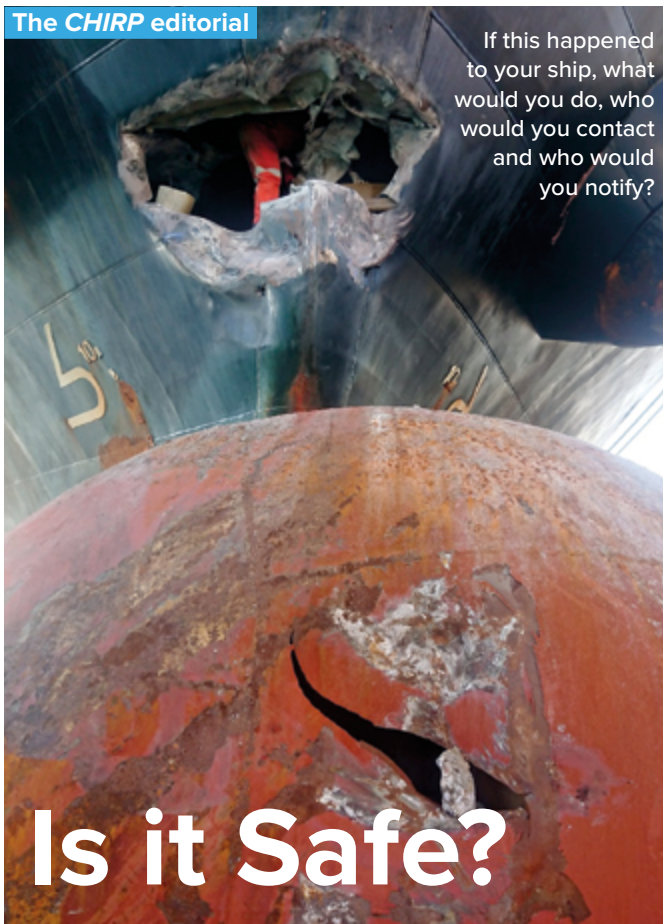
Our cover photograph is a dramatic shot of damage to the stem and bulbous bow of an ocean-going ship. Our correspondent asked how the ship can determine whether it is safe to continue

the voyage, or whether the crew should attempt to make temporary repairs. Our reply was that in cases of this nature, the damage should be inspected by a classification society surveyor. Classification societies set the rules for safe ship construction and are the appropriate people to consult whenever there is structural

damage. Their surveyors can call upon a great deal of knowledge and experience and have tremendous resources to back them up if necessary. In this case, we also suggested the insurers should be informed. Mariners who find themselves in difficulty are never alone, there are many sources of advice and support available. There is no shame in admitting you are not sure how to handle an unusual situation, so do not be afraid to ask for help.

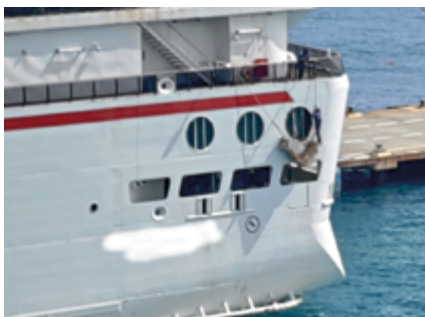
A cruise ship was moored on the pier opposite my ship. I noticed a stage which was rigged on the port shoulder being relocated laterally whilst a crew member was standing on it. Although the person on the stage was wearing some PPE, (safety harness, safety shoes, gloves, and an inflatable lifejacket), I consider it quite an unsafe act. The crew member working on the stage should have vacated it to a safe position on deck before attempting to reposition the stage. (See photos below).

Figure 1 of 3 – Unsafe repositioning of a stage

Although there are many assumptions being made, there is also a disconcerting sequence of photographs which illustrate poor safety awareness by the crew engaged in the task with an apparent lack of supervision, instruction, and training. Good practice would be to have a Jacob's ladder rigged for access to the stage from the deck above and a lifebuoy and line ready for immediate deployment close by. Furthermore, good practice would never allow a stage to be relocated laterally with a person remaining on the stage as this entails untying the gantline securing one end of the stage and supporting the weight by hand grip alone whilst the gantline is moved and resecured. Finally, there appears to be a tarpaulin rigged beneath the stage (to catch any drips?) which would imply an awareness of environmental protection, which makes the obvious lack of safety awareness even more baffling.

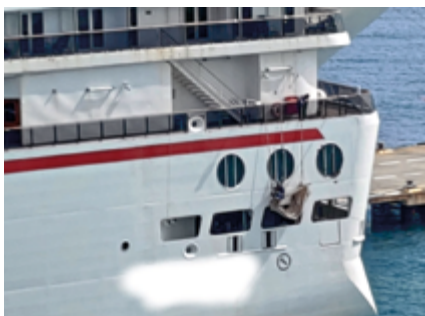
Figure 2 of 3 – Unsafe repositioning of a stage

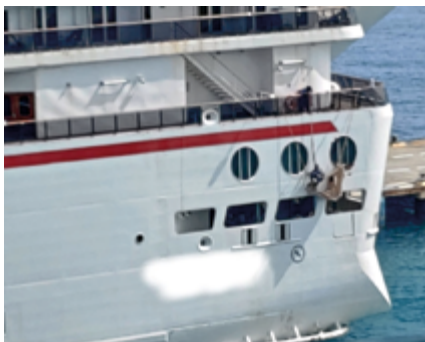
Figure 3 of 3 – Unsafe repositioning of a stage.

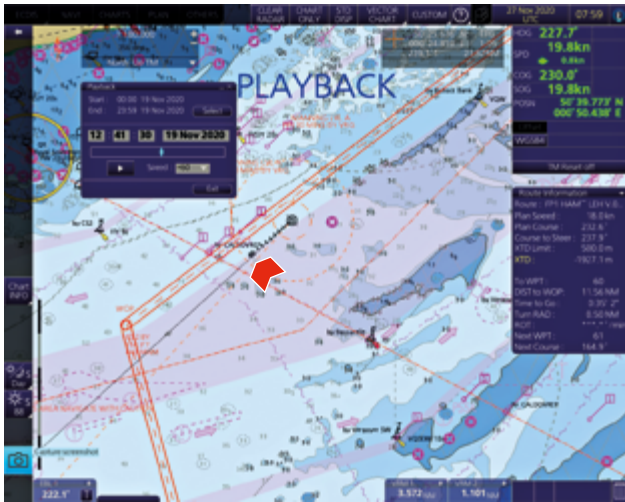
the DPA. Subsequently, after contacting the captain of their vessel, the DPA reverted to *CHIRP* with a response including a series of screen shots from the bridge of the container ship and a commentary from the captain with regards to the incident. The screen shots show that the container vessel was south of the planned route and outside the charted safety corridor in a position close to the boundary between the SW lane and the central separation zone.

Figure 4 – Screen shot from the container vessel.

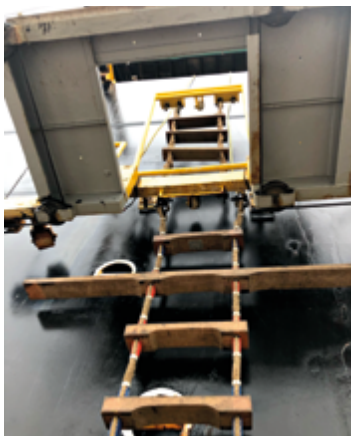
Figure 5.
PBA as presented:
 Pilot ladder presented in two sections. Both sections are secured solely to the accommodation ladder platform instead of to the ship. Yellow horizontal frame sections are impeding access during ascent or descent.

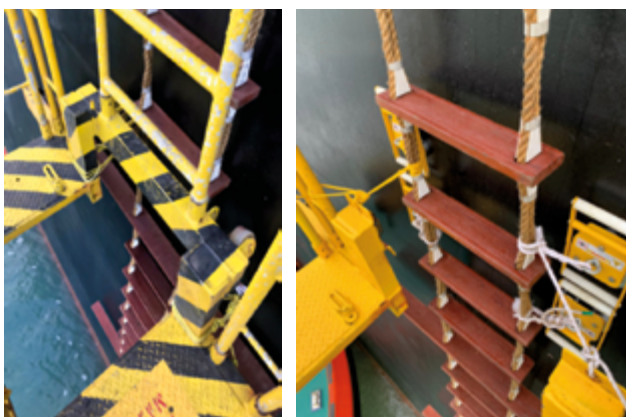
The vessel arrived at pilot station at night, pilot refused to board on arrival as ladder appeared to be non-compliant. (Figure 6).

Figure 6 (left) original arrangement as presented.
 Figure 7 (right) after modifications

A second pilot did board in daylight and the vessel came in, it was reported to local Port State control who, after viewing pictures, deemed it compliant but not safe. Port Authority issued the vessel with notice that the arrangement was to be rectified before next visit otherwise vessel would not have a pilot. Dialogue took place over several weeks and on return the vessel presented a modified configuration (figure 7) as the boarding arrangement. Vessel was served on arrival and the pilot confirmed arrangement was safe.

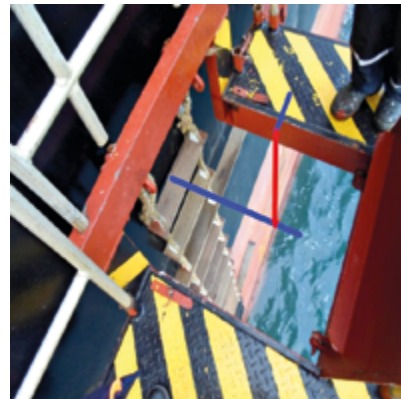
A trap door arrangement with the pilot ladder secured to the underside of the platform, so the ladder did not pass up through the hatch. Dialogue took place but no adjustments had been made, on arrival at port limits the vessel was refused pilotage until boarding arrangements were compliant and safe. After 3 days at anchor the arrangements had been adapted to a combination arrangement with the pilot ladder secured to strong points on the main deck.

Figure 8 (left) What was presented originally (rejected)

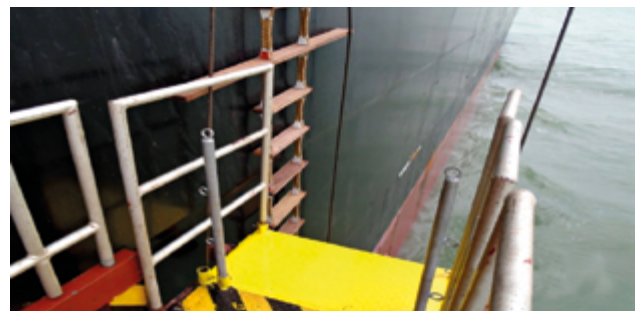
Figure 9 (below) This was the final arrangement (minus the securing magnets which were in place when used by a pilot).

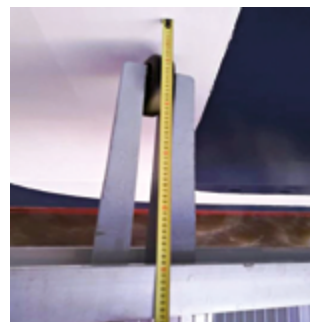
Combination ladder, the gap between the pilot ladder and the lower platform was greater than 20cm (when measured it was 50cm). Dialogue took place with the vessel who originally stated this could not be modified. Sorry captain, but there will be no pilot boarding your vessel. They found a solution on board and reduced the gap to 20cm. A pilot boarded.

Figure 10 Before modification Figure 11. After modification

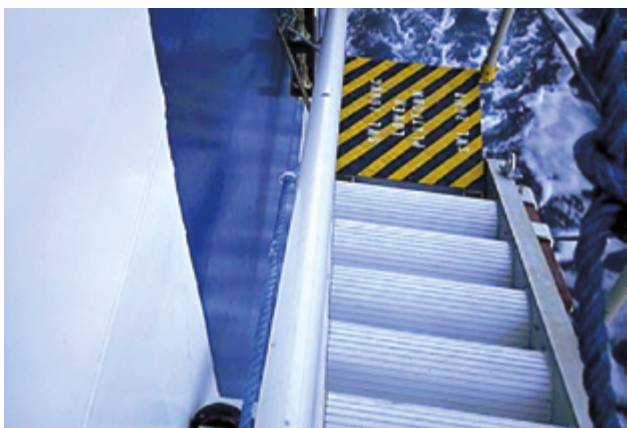
Figure 12. Compliant combination pilot boarding arrangement ready for use.
