MARITIME FEEDBACK

Issue 64
August 2021

An independent and confidential reporting system for the maritime industry

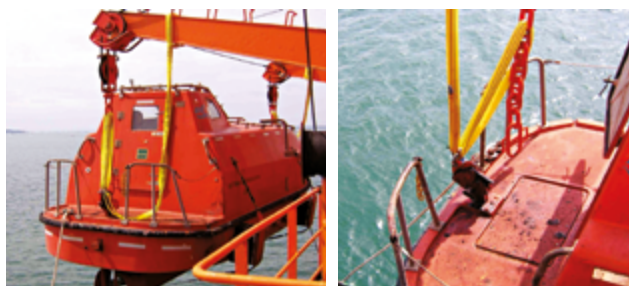
Undertaking maintenance on the lifeboat hooks - the hanging-off stop is rigged along with the fall prevention device (FPD). Once the weight of the boat is taken by the hanging-off stops the hooks can be released. The FPD can remain attached to their shackles.

FPDs were regarded by regulators as an interim measure whilst hook designs were improved. However, they provide a separate and alternative load-path and are easy to rig and unrig. They can be cut in an emergency and provide much needed security for crews who over the years may have understandably lost confidence in the on-load off-load lifeboat release equipment.

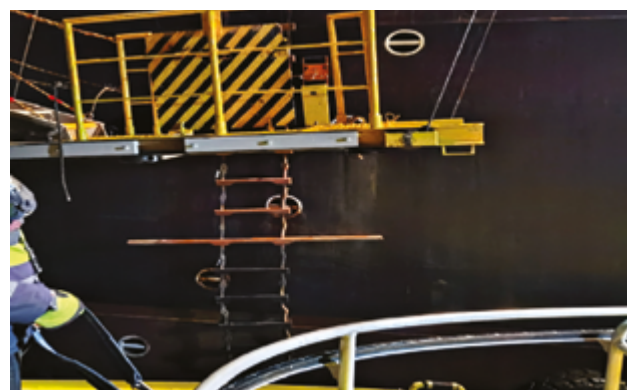
Trapdoor type combination, accommodation ladder platform less than five metres above the sea.

The Pilot told the Master that in moderate sea and swell conditions access would not have been possible due to the risk of the pilot being caught under the platform by the waves.

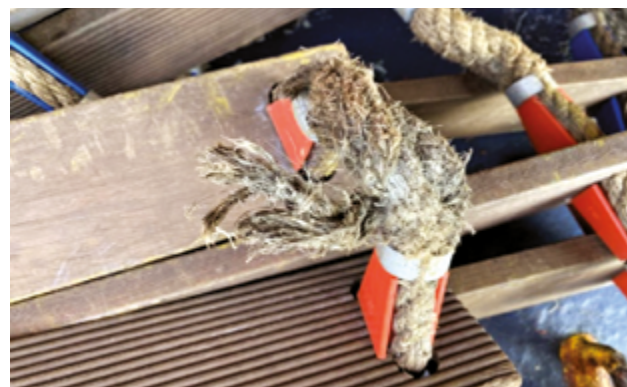
Pilot ladder did not meet SOLAS standards.

The pilot ladder had a broken strand. This was not visible before the pilot started to climb the ladder, as it was located at the top. However, it was clearly visible to the ship's staff. The Master was advised that the ladder must never be used again and must be taken out of service and destroyed.

Damage to pilot ladder side ropes is often caused by the ladder not being stowed away off the deck in a safe, well-ventilated storage locker. By being left in the open, the ladder is liable to damage by crushing or abrasion or can be damaged by chemicals, or cargo dust residues which can also chemically and physically attack the rope fibres.

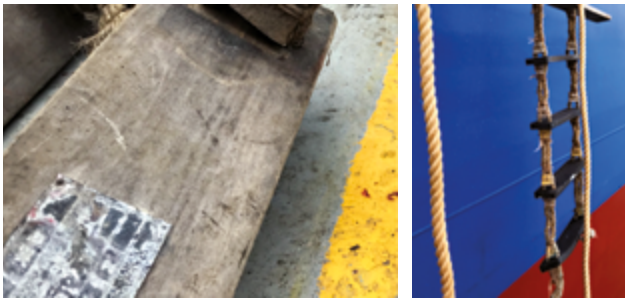
Comments from reporter: When disembarking from this vessel I found that the ladder appeared well-used, and the chocks and steps were loose. I advised the attending officer that the ladder should be replaced or repaired. The vessel was less than three years old, so I assume it was in use from her maiden voyage. The corrosion on the manufacturer's plate made it impossible to check details. (See photo)

The chocks supporting the pilot ladder steps are not secured against the steps, allowing the steps to rotate. When the pilot places his foot on the steps there is a risk of slipping from the ladder. This is very dangerous. The ladder must be taken out of service and repaired ashore or replaced.
