MARITIME FEEDBACK

Issue 67
June 2022

An independent and confidential reporting system for the maritime industry

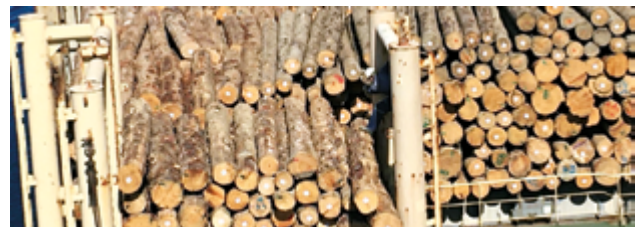
A pilot embarked on a loaded log-carrying vessel which was about to depart. There was no safe walkway over or around the logs. The only way the crew could access the forecabin was either by balancing on the railings around the ship's side or by climbing over the logs. None of the crew wore the right PPE to climb safely over the logs, and those balancing on the ship's side were at risk of falling overboard.

The IMO's Code of Safe Practice for Ships Carrying Timber Deck Cargoes (the 2011 TDC Code) applies to timber-carrying vessels over 24m. Although it is not mandatory, it provides safety guidance that says:

(2.8.2) "Special measures may be needed to ensure safe access to the top of and across the cargo" and

(2.8.5) "A safe walking surface not less than 600mm wide should be fitted over the cargo" alongside a wire lifeline.
