## Communication: the key to better safety

# CHIRP

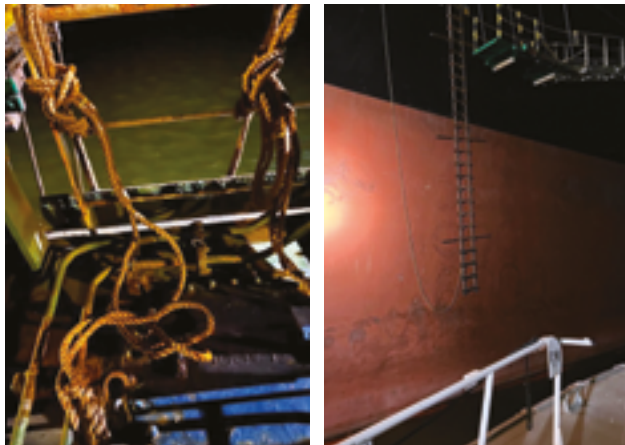
M2051

A pilot boarded a tanker at anchor. When they arrived at the top of the ladder, they discovered that it was tied to a rotten railing, there were no suitable hand-holds nearby, and there were many trip hazards on the deck near the embarkation point.

When the pilot raised this with the master, he was told that the ladder was not usually rigged in that position but had instead been moved to accommodate the pilot station's direction to rig a 7m ladder. This was higher than the 5m maximum height at the normal embarkation point, so the ladder had been moved.

The master should have challenged the pilot station's request to move the ladder from its designated position on safety grounds. In many cultures, authority figures are not challenged, which might have been the case in this situation. However, the master and crew know their vessel best! If the request was made because of a high sea state or significant swell, CHIRP would question whether safe embarkation would have been possible in such conditions.

**Communication** – Vessels should challenge any direction that means a departure from authorised procedures, particularly where safety could be compromised.

**Situational awareness** – Before any activity, particularly one which deviates from normal procedures, a dynamic risk assessment is vital to ensure that the area is safe. Had this been undertaken effectively, the crew should have noticed that the ladder's fixing point was unsuitable.

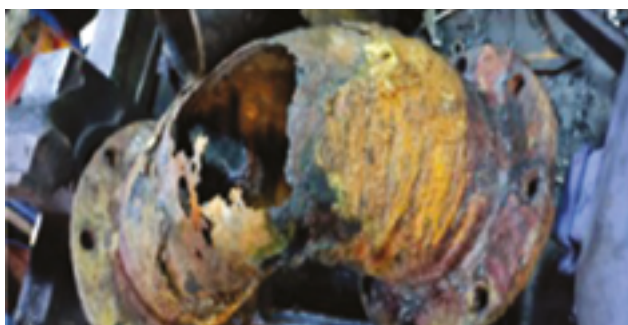
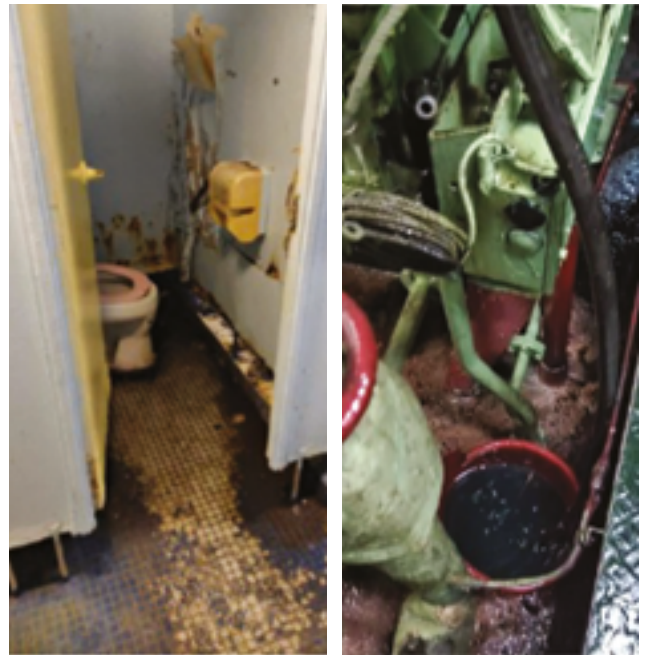
*M2028 (submitted by ISWAN)*

A seafarer complained about awful working conditions on board their ship. The accommodation was unhygienic, food was insufficient, and the equipment was in disrepair: the main engine and gearbox leaked oil, and the seafarer claimed that oil and garbage were frequently discharged overboard. The air conditioning was also broken.

The photographs suggest that the vessel has not been compliant with minimum regulations for a considerable time, yet this was not detected by any external audit. This is not an isolated case, and CHIRP regularly receives similar reports. The number of vessels with unseaworthy or poor conditions remains stubbornly high, despite numerous international and national regulations regarding minimum safety, environmental and welfare standards. Flag states are obliged to enforce standards, but international law has few consequences if a flag state fails to do so adequately.

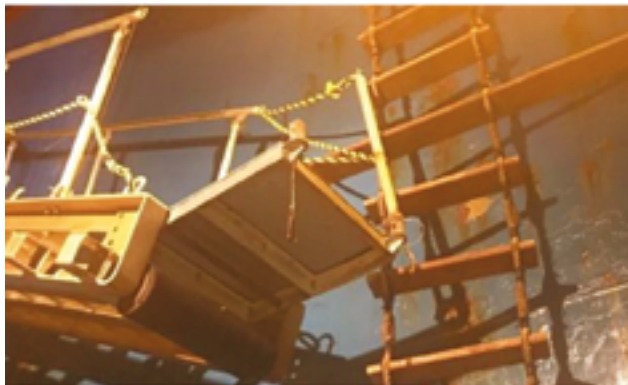
M2065

Combination ladders: Trapdoor Type Combination  
The pilot who reported this incident had reported the same non-compliant transfer arrangements on this vessel two months earlier. At that time, the master was advised and given drawings of the required modifications. The port state was also informed. On arrival at the port two months later, nothing had been done to rectify the situation.

The new master on board knew nothing of the previous non-compliance report. As part of the trapdoor combination, the pilot ladder could not rest against the ship's side. It was hanging free of the ship's side by 200mm. This time a formal notification was given to the Port State Control authorities to attend the vessel.

visit this port because it is on a liner service) would have the same non-compliance matter raised against the vessel. From a pilot's safety perspective, this deficiency is very dangerous, and the ship's staff seem to have given scant regard to the deficiency.

Pilotage and port state authorities are generally considerate when genuine first mistakes are made, and advice is given to rectify the problem. They are not so receptive when the advice is completely ignored. Port states or individual port authorities are strongly encouraged to empower their pilots with "stop work" authority - to refuse to board vessels with non-compliant or unsafe pilot ladders. They could make this clear to visiting vessels in their pre-arrival documentation.
