Drones are about people, too...

Welcome to Drone FEEDBACK Edition 6. So, what sort of reports have we seen and are there any trends emerging since the issue of FEEDBACK Edition 5?

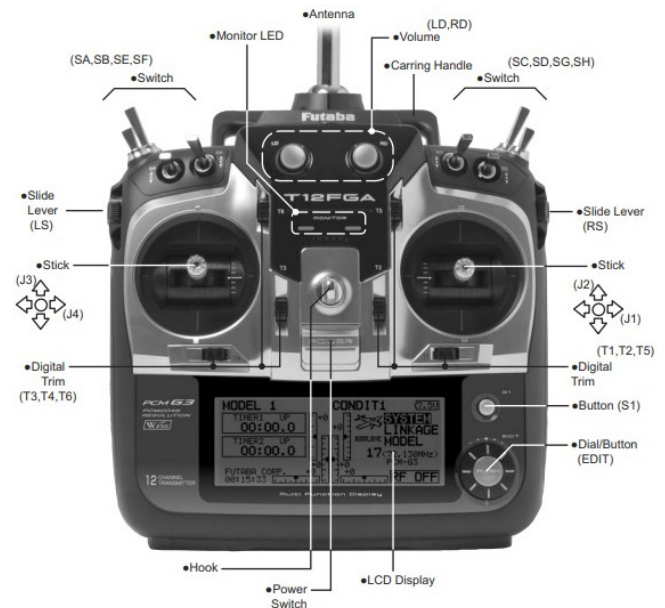
Futaba T12 FGA controller

My transmitter is a Futaba T12 FGA and for 14 years the choke switch has been set on a switch SA which is a 3-position switch and a short lever. However, one flight last year the engine was not at its best, so I landed OK and found that the choke switch was in the middle position, meaning it was partially choked. So, to prevent that happening again I changed it to a 2-position switch SF which is on the top left-hand side and has a long lever. Need I say more!

CHIRP Comment: Human factor analysis at 2.30am is impressive, by anyone's standards! It did seem to do the trick though, because the reporter discovered the root cause of the occurrence: a switch knocked into the wrong position. Very easy to do, but with significant consequences. The photograph above shows the switches that the reporter refers to in the text.

As for manned aircraft, immediate action drills can be useful for time-critical incidents so, if experiencing a sudden loss of power, a check of power source (be it battery or fuel) selectors is a worthwhile action just in case something has been inadvertently moved.

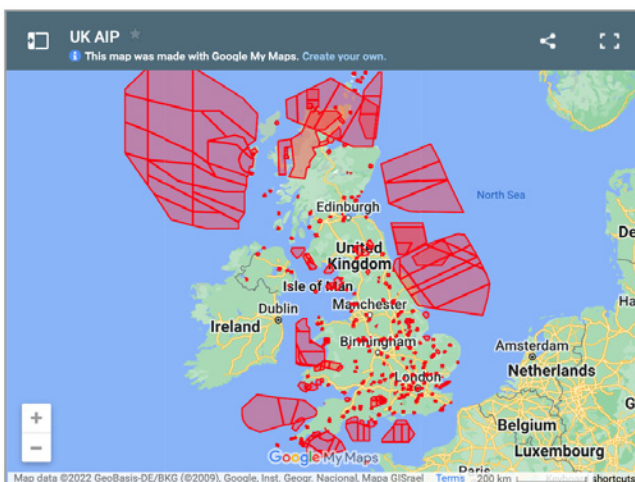
UAS Restrictions Map

The final point that is worth making, is that if you are going to use Google for flight planning, then the start point is to access the NATS Aeronautical Information Service: <https://www.nats.aero> click 'Airspace' on the top menu and then select 'Drones & new airspace users' where you will find a tile that says 'UAS Airspace Restriction Maps' within which all current FRZs are overlain onto a Google map (see diagram) that can be downloaded if required.

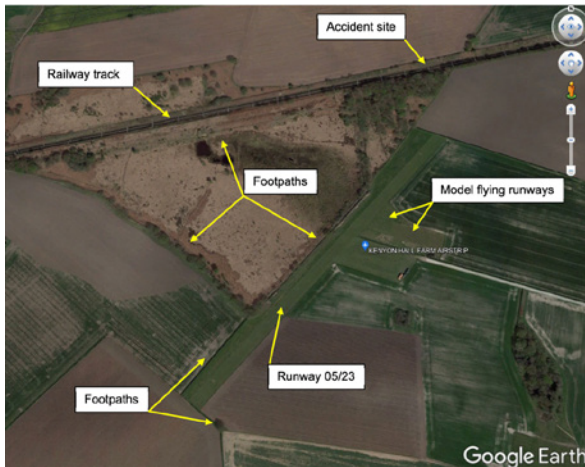
Airfield information: the model flying club is based at Kenyon Hall Farm Airstrip (Figure 1), which is an unlicensed airfield with a grass Runway 05/23 for full size aircraft. There are two runways for model flying, a 75 m strip adjacent and parallel to 05/23 and a 110 m strip, which runs in an east-west direction. A railway track passes to the north of the site. There are several public footpaths which run along the north-west boundary of the airfield, and in the area between the airfield and railway track (see the diagram on the next page).

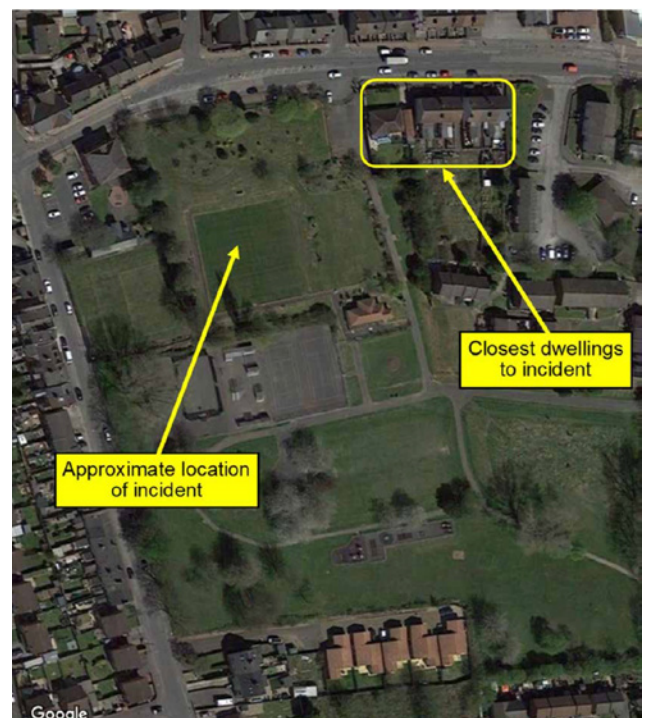
Welfare Park is a public recreation space within a residential area of Huthwaite, Sutton-in-Ashfield. At the time of the incident, the UA was being flown over open ground toward the northern end of the park (see diagram). The closest dwellings were approximately 75 m from the incident site.
