Challenging the Cultural Status Quo

Welcome to the second edition of Superyacht FEEDBACK. Judging by your comments and reaction to the first edition, you share our passion for addressing safety issues and promoting a proactive learning culture amongst your crewmates.

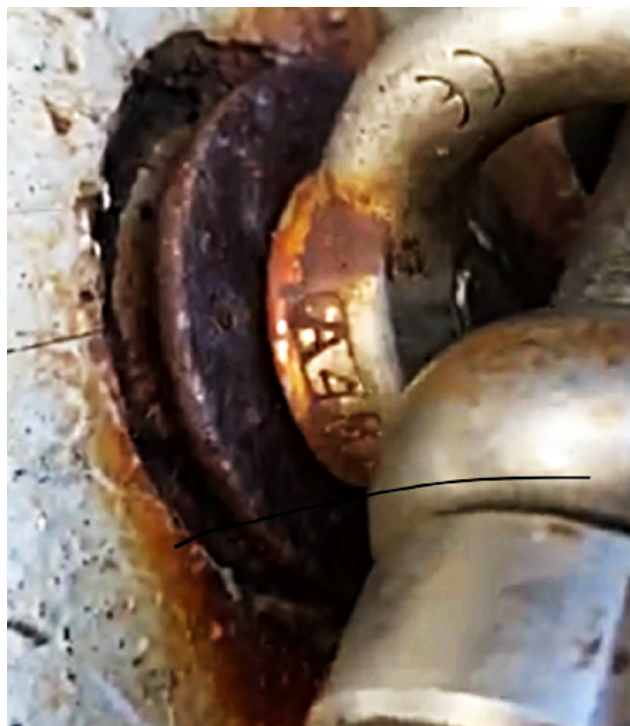
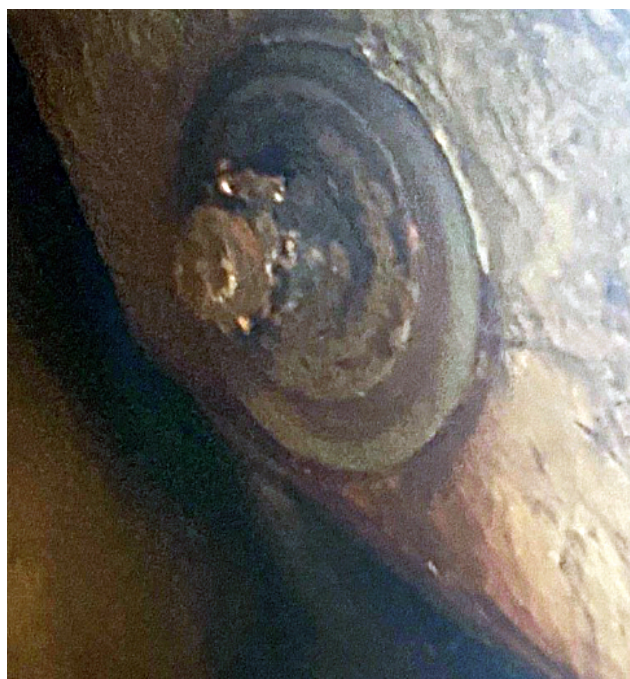
While lifting a 9m tender into the garage, the forward lifting point gave way. Luckily, at this point, the tender was over the chocks and dropped about 30cm into position, causing only minor damage. A crew member was inside the tender but was not injured.

Lifting points were tested annually and visually inspected regularly, but due to the design, the underside of the lifting point was inaccessible, and any corrosion was not visible.

The report is positive: many safety improvements were made, and the vessel is to be commended for its positive safety culture. The equipment's design hampered the inspection of the underside of the lifting equipment. Often, we dissuade ourselves from raising safety reports on poorly designed or installed equipment in the belief that they are 'too big to change' or 'it must be right – it was built that way'. But even naval architects sometimes get it wrong, and if it had been reported, it could have been rectified when next in refit. Do not be afraid to report and record concerns about design deficiencies. Organisational safety management systems operate on a cycle of continuous improvements, and ship designers will be only too glad to receive feedback so that improvements can be made.

The lifting point was rebuilt and strengthened, and an inspection hatch was made. The vessel's SOPs were amended, so that crew members attach the crane hooks to the lifting points, exit the tender before it is lifted, and only enter the tender once in the water.

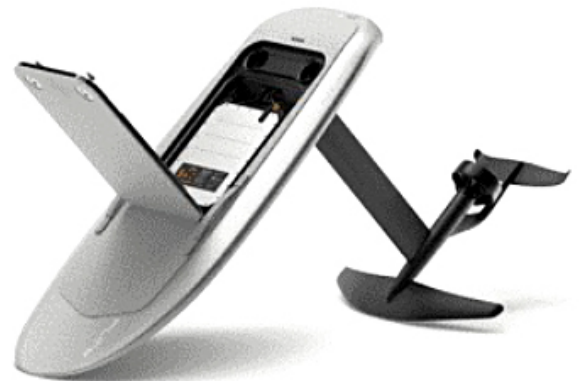
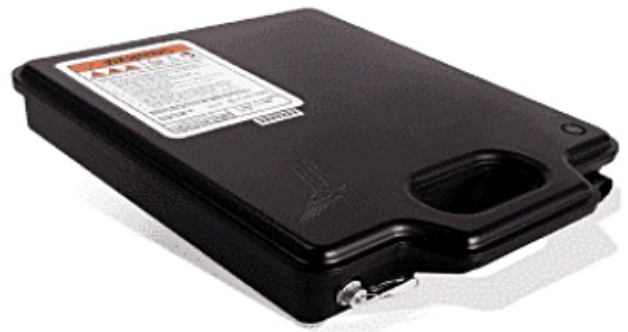
The run-down battery was taken out and placed on the deck in the beach club and replaced with a fully charged one. 30 secs later, the used battery which had not been plugged in to commence charging, started smoking, and 3 secs later erupted into flames. The fire was extinguished in minutes using the installed hi-fog system and a fixed fire hose. The hi-fog automatically went off when two fire detector heads went into alarm.

The thermal runaway occurs when the battery expels toxic gases, which ignite, rapidly increasing the temperature to a very high level.

It is thought that this can be brought about by the mechanical stress of the battery, heat stress or electrical stress, which can occur when overcharging the battery.
