Challenging the Cultural Status Quo

Welcome to the second edition of Superyacht FEEDBACK. Judging by your comments and reaction to the first edition, you share our passion for addressing safety issues and promoting a proactive learning culture amongst your crewmates.

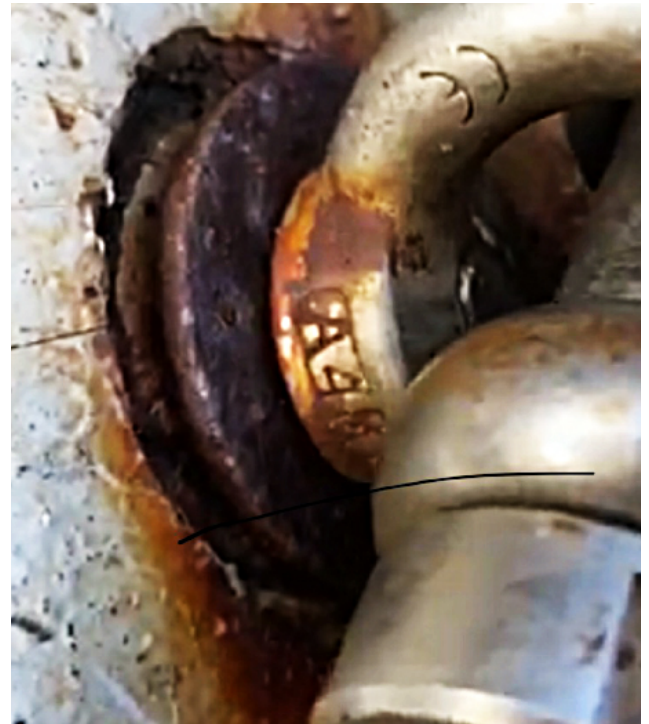
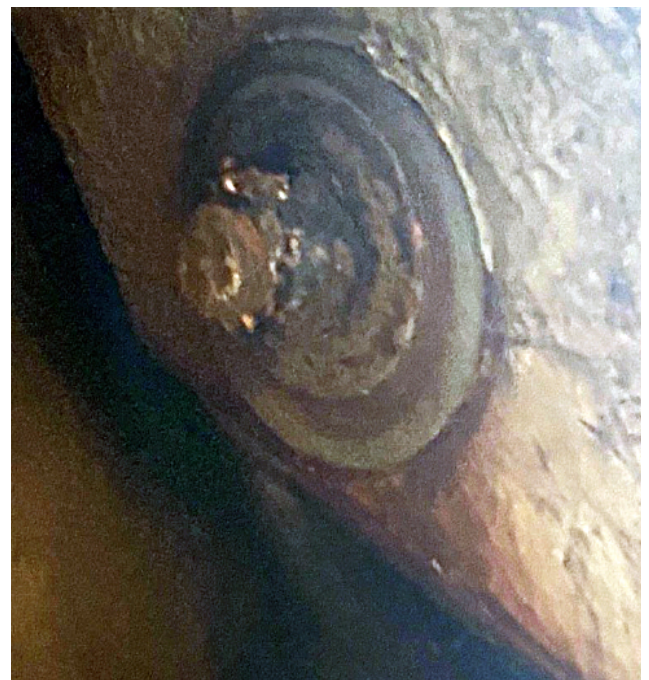
While lifting a 9m tender into the garage, the forward lifting point gave way. Luckily, at this point, the tender was over the chocks and dropped about 30cm into position, causing only minor damage. A crew member was inside the tender but was not injured.

Lifting points were tested annually and visually inspected regularly, but due to the design, the underside of the lifting point was inaccessible, and any corrosion was not visible.

The lifting point was rebuilt and strengthened, and an inspection hatch was made. The vessel's SOPs were amended, so that crew members attach the crane hooks to the lifting points, exit the tender before it is lifted, and only enter the tender once in the water.

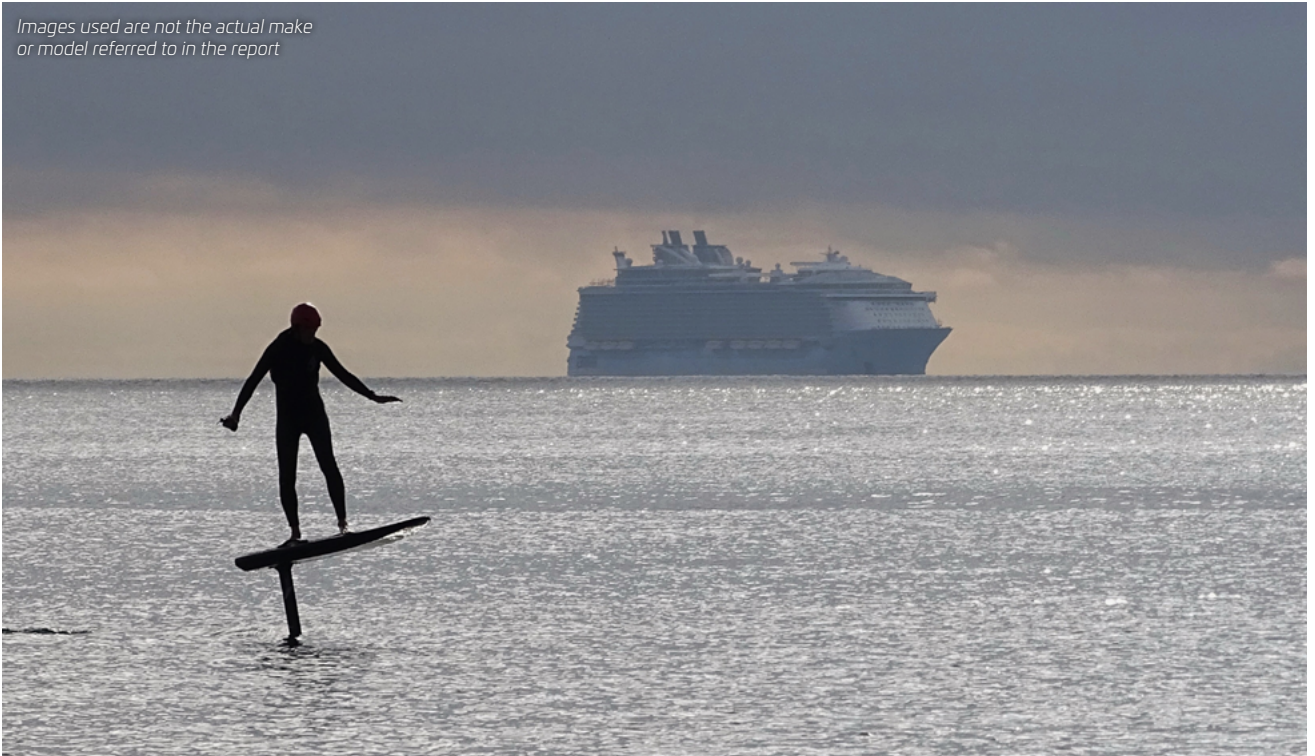
The run-down battery was taken out and placed on the deck in the beach club and replaced with a fully charged one. 30 secs later, the used battery which had not been plugged in to commence charging, started smoking, and 3 secs later erupted into flames. The fire was extinguished in minutes using the installed hi-fog system and a fixed fire hose. The hi-fog automatically went off when two fire detector heads went into alarm.

Their unpredictable nature is a real cause for concern. CHIRP would like to understand in more detail why these batteries can be prone to spontaneous ignition and a thermal runaway reaction.

The thermal runaway occurs when the battery expels toxic gases, which ignite, rapidly increasing the temperature to a very high level.

It is thought that this can be brought about by the mechanical stress of the battery, heat stress or electrical

stress, which can occur when overcharging the battery.

CHIRP feels that it is safe to say that good quality batteries which are properly looked after and taken out of service at the end of their life, should ensure that self-ignition is minimised or eliminated. CHIRP would welcome more reports on incidents involving lithium-ion battery fires.
