Single Points of Failure

Welcome to the Spring edition of FEEDBACK, our free safety newsletter for the global maritime community. We're delighted to report that we're now publishing in Arabic as well as the other seven existing languages, all of which can be found on our website or via our mobile app, which you can download using the QR codes printed on the back page of this newsletter.

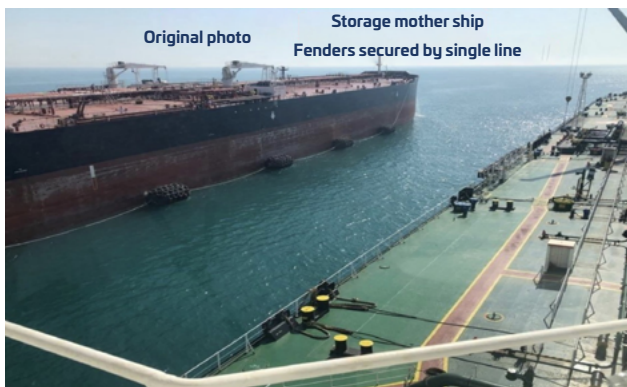
Our reporter sent a photo of a storage ship with incorrectly rigged fenders, noting that a failure of any of the fender's securing lines will lead to a failure of the complete fender protection system.

The rope is a single point of failure – if it breaks, the entire fender arrangement is compromised. Good seamanship demands that each fender is individually secured in position since the relative motion of vessels can cause the securing lines to part.

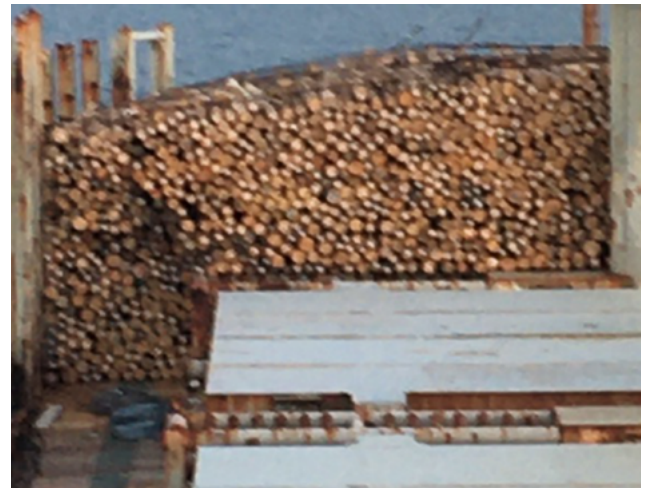
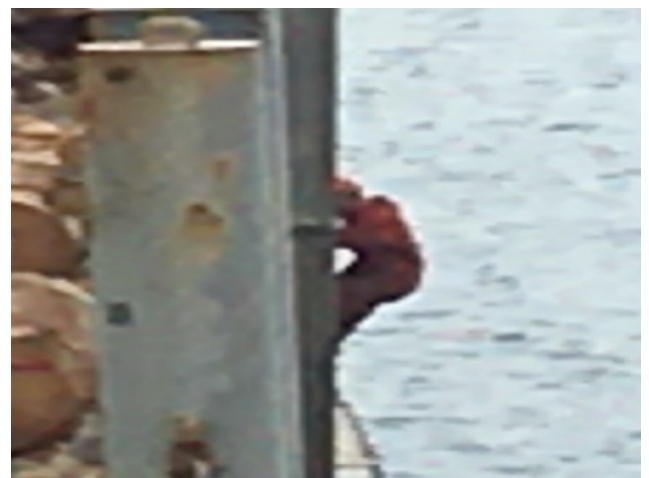
Our reporter sent photos of a vessel loading timber cargo over alternate deck hatches. The timber extended right across the width of the deck, and the crew had to either walk on the narrow tops of the bulwarks or swing outboard of the log stanchions and hang over the side of the vessel. Both methods are unsafe. The pictures show the height of the "log face."

This is a lethal accident waiting to happen.

We have previously reported on deaths that occurred on vessels loading or unloading timber cargos on deck, as well as our thoughts on the shortcomings of the Timber Deck Cargo Code because it does not mandate safe access to be retained at or below deck level. This has safety implications

for routine and emergency access (e.g., fire-fighting and med-evacuating a crew from the top of the logs). And although the vessel's design does not technically breach the Code (which presumably is why its Flag and Classification Society signed it off), the crew safety implications were not sufficiently thought through.

Whether climbing outboard in this manner is an unofficial 'local practice' caused by the lack of operational leadership on board or is implied by the company's Safety Management System, it is exceptionally dangerous and must cease. CHIRP is keen to see the Canadian regulations (which mandate that proper safe accessways for the crew and stevedores) be adopted more widely.

CHIRP is keen to see the Canadian regulations (which mandate that proper safe accessways for the crew and stevedores) be adopted more widely

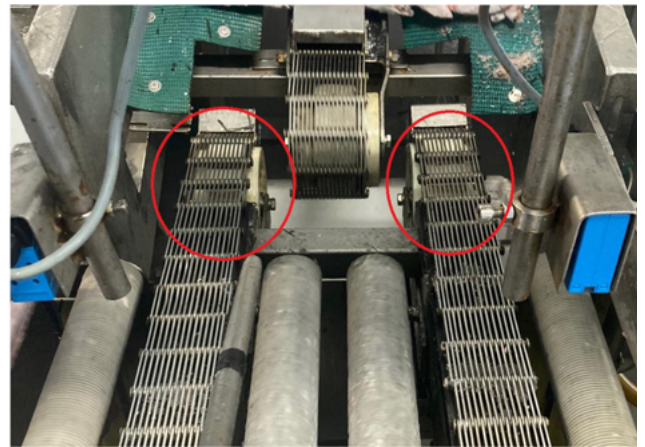
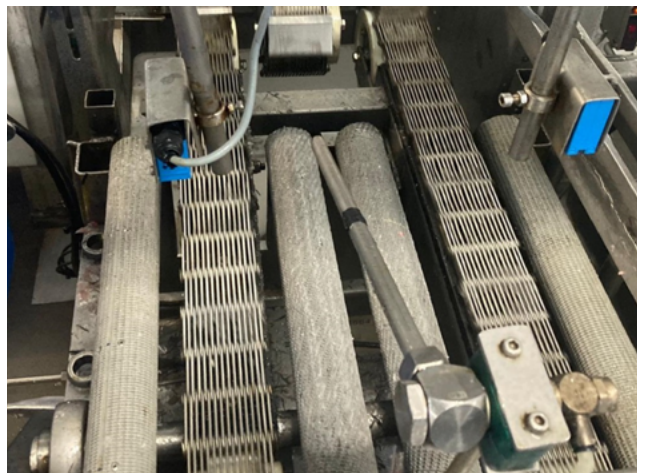
The engineer failed to isolate the system completely and thought activating the emergency stop would prevent the system from operating. CHIRP contacted the company and received very positive feedback on how they would ensure that this type of incident would be prevented from happening again.

CHIRP was informed that the risk had been identified in the risk assessment for this work; it did not include Lock Out, Tag on, Tag off (LOTOTO) procedures which were only available for work on electrical systems and not on equipment with moving parts. The company have made changes to include this safety procedure for all equipment with moving parts.

Everyone must be briefed on planned maintenance work at the daily work planning meeting to ensure that conflicting work activities can be rescheduled and that adequate time and resource is allocated to the task. Because no one else was aware of the engineer's intentions, the incident outcomes could potentially be even more severe.

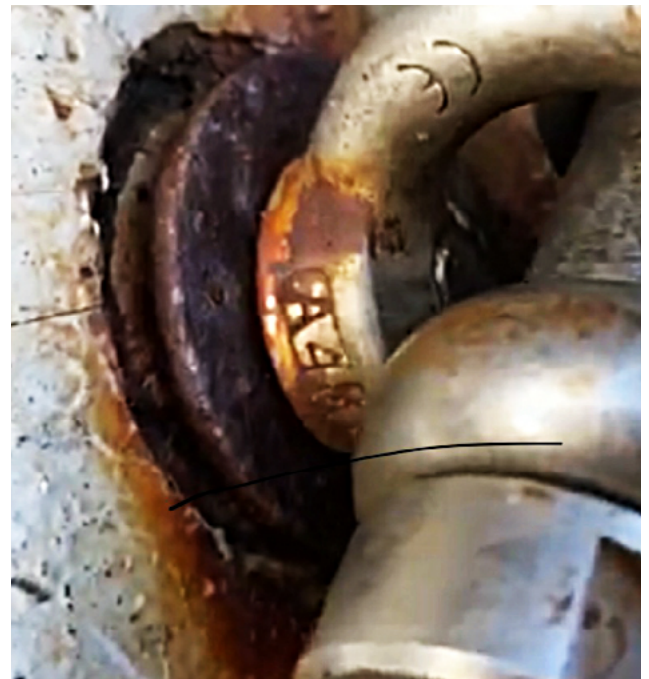
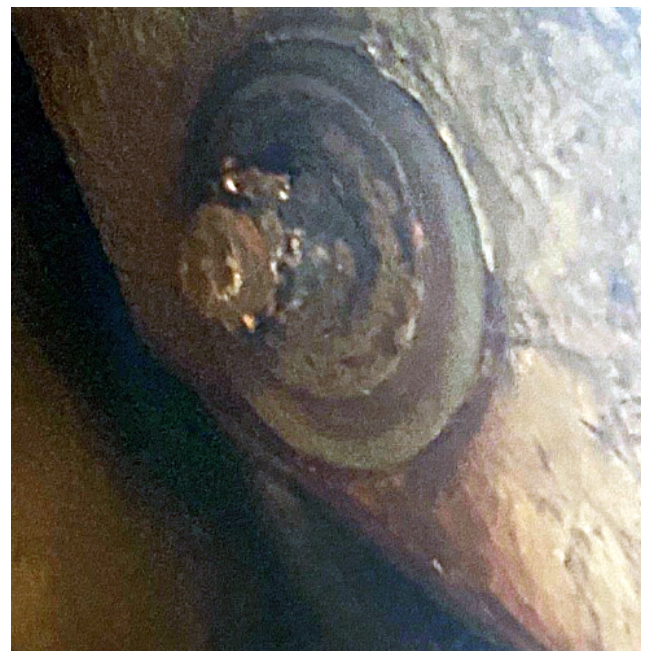
While lifting a 9m tender into the garage, the forward lifting point gave way. Luckily, at this point, the tender was over the chocks and dropped about 30cm into position, causing only minor damage. A crew member was inside the tender but was not injured.

Lifting points were tested annually and visually inspected regularly, but due to the design, the underside of the lifting point was inaccessible, and any corrosion was not visible.

The report is positive: many safety improvements were made, and the vessel is to be commended for its positive safety culture. The equipment's design hampered the inspection of the underside of the lifting equipment. Often, we dissuade ourselves from raising safety reports on poorly designed or installed equipment in the belief that they are 'too big to change' or 'it must be right – it was built that way'. But even naval architects sometimes get it wrong, and if it had been reported, it could have been rectified when next in refit. Do not be afraid to report and record concerns about design deficiencies. Organisational safety management systems operate on a cycle of continuous improvements, and ship designers will be only too glad to receive feedback so that improvements can be made.

Useful references that detail the examination and inspection regimes for lifting equipment include the UK MCA's MGN 332(M+F) Amendment 1 and the Cayman Island's Shipping Notice 04/2021. Additionally, UK MGN 560(M) sets out the SOLAS III/36 requirements for launching appliances; these must be adhered to if the tender is also classified as a lifeboat or rescue boat. Accompanying an inspector during a thorough examination is a good learning opportunity: watch what they check for and ask questions.
