ANNUAL DIGEST

CHIRP

Annual Digest of Reports and Insight Articles 2022

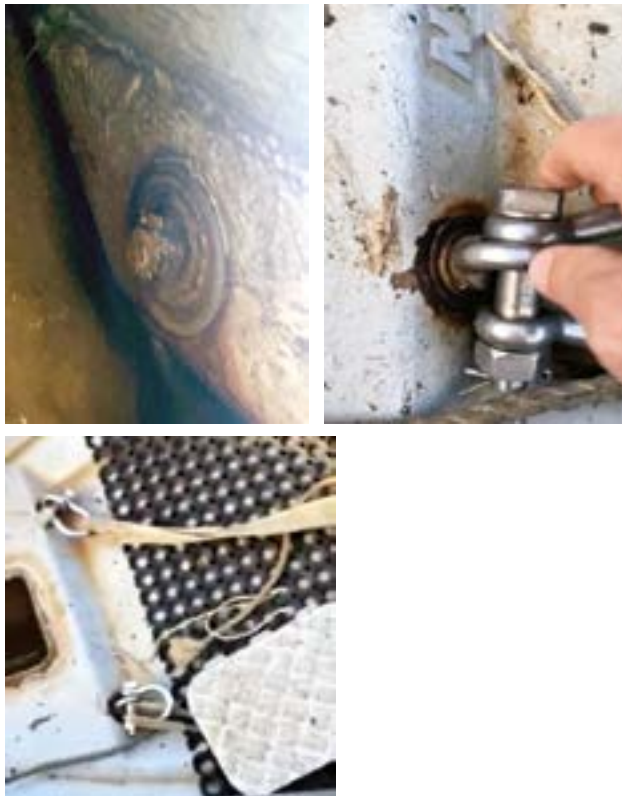
M1979

A new crew member inspected the ship's lifesaving equipment to familiarise themselves with the equipment on board. They discovered that the lifting eyes in the ship's workboat were damaged and loose, which meant it was not the eyes carrying the load but a length of threaded bar which appeared poorly maintained. If the lifting eyes had failed while the boat was being lifted it could have resulted in serious injury to the two crew members who are ordinarily inside when it is lowered into the water.

The condition of the items in the photographs suggest that neither inspection nor maintenance routines were effective, and that the boat's crew were either unaware that the lifting eyes were in a dangerous condition or did not feel empowered to report their concerns.

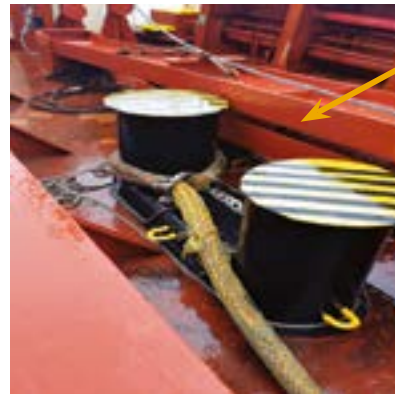
Log stanchion in lowered position

A lumber carrier embarked a pilot as it approached a loading berth where a tug waited to assist. The pilot requested that the vessel secure the tug's line to the mooring bits on the forward deck. After this was achieved, and as the tug came under the line to push up, the tug master realised that his line had been improperly secured: it had been wrapped around the bits and secured with a shackle, rather than the eye being dropped over the top of the bits.

When questioned the master explained that, when lowered, the log stanchions were so close to the bits that they obstructed the bits. The master was informed that they should not use a shackle in future, and that the bits should not be used when the log stanchions were lowered.

The vessel is relatively new, and the deck layout has not been modified since she was built. This suggests that the improper placement of the log stanchion and mooring bits is the product of poor design. This is known as a latent error, and CHIRP believes that there is a high probability that incidents will continue to occur on the vessel because the mooring bits cannot correctly and safely be used as intended. The likelihood of an incident is further increased because of the proximity of the bulwark brackets which create a trip hazard.

The trip hazard and inability to correctly work the mooring bits are evident, and CHIRP is concerned that these had seemingly not been detected either during commissioning trials, during flag and class inspections, or by the crew themselves. CHIRP is also concerned that other vessels of the same design might also contain the same latent design hazards.

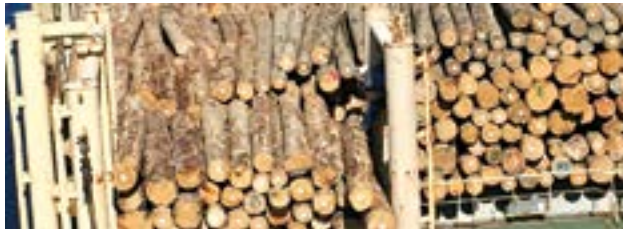
The pilot raised the matter with the master and alerted the authorities to these significant safety breaches.

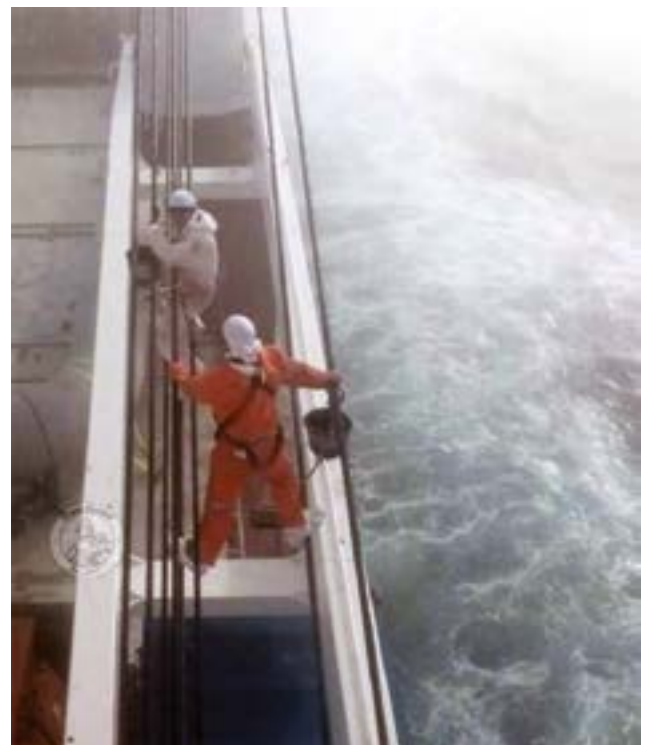
They are not wearing safety helmets or lifejackets despite being close to the edge of the vessel. This activity took place in full view of the bridge team, but they were neither challenged nor stopped.

If you are sent aloft wearing a harness, make sure there is a rescue plan in place. A rescue plan is a pre-planned procedure to safely retrieve someone suspended at height in a harness. It should also be regularly practised to ensure it can be done safely and quickly

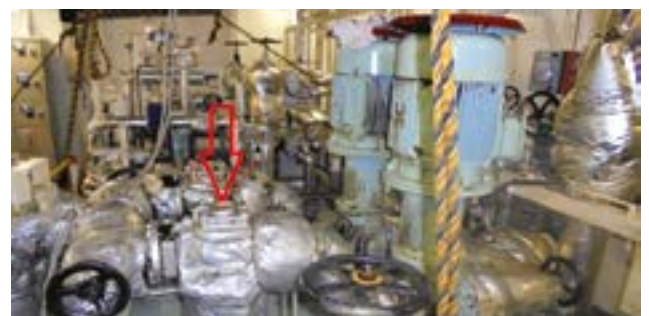
The reporter told us that the chief engineer held the daily meeting at 8 am to discuss the work plan for the day with the senior engineer and the rest of the engine officers and crew. Among others, the inspection and maintenance of the auxiliary boiler’s No1 fuel oil pump filter was discussed. A Toolbox meeting was held regarding the precautions and hazards associated with the maintenance work.

The work commenced after lunch at around 13:40. The senior engineer was about to dismantle and remove the pump’s filter cover when hot fuel and gases suddenly escaped.

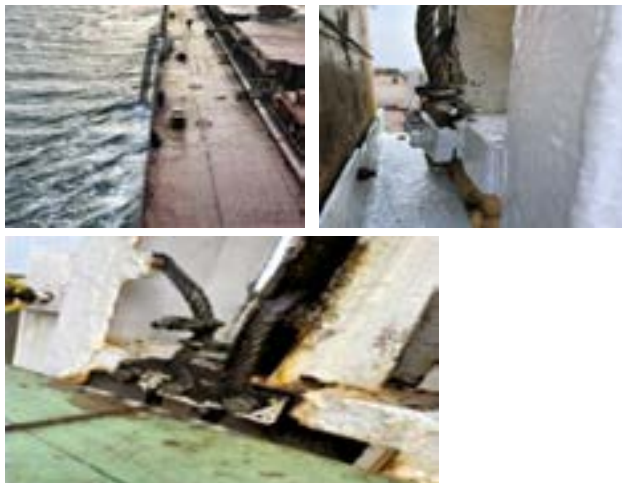
The Master undertook remedial action with respect to the accommodation ladder and the fall securing.

Pilot boarding arrangements are regularly featured in our Maritime FEEDBACK newsletters. However, the accommodation ladder is often perceived by ships' crews to be less of a risk because it is a robust structure and viewed as a part of the hull's structure. Because of these factors, accommodation ladders can be overlooked when undertaking ladder maintenance, especially items such as the hull fixtures to which the wires are affixed. Like the pilot ladder, it is often difficult for a pilot to fully appraise the safety standards of the accommodation ladder's fittings prior to boarding. This incident shows it is also an area of vulnerability and CHIRP wants to highlight this.

Reducing the periodicity for changing the falls to between 18 and 30 months for vessels that have accommodation ladders in these exposed areas should be considered, as should changes to the design for securing the falls. However, thorough maintenance must always be provided to the wires, sheaves and fixtures no matter how difficult the access to the wires may be.

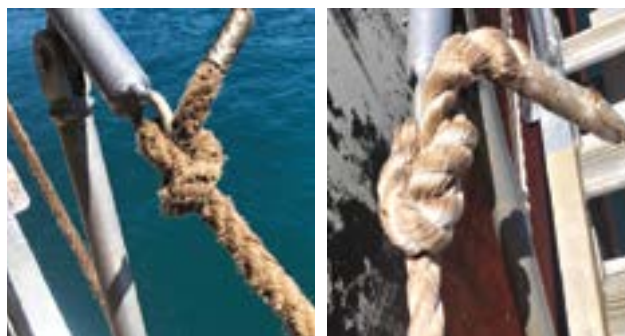
The repeated use of overhand knots in this case indicates that either the officer did not correctly supervise and inspect, or that the crew have become desensitized to a deviance from standard procedures: the local practice on the ship or within the company for securing the pilot ladder rope with an overhand knot had become the accepted norm.

Despite being incorrect there appears to be no culture of challenge by the crew or officers to secure the ropework with the correct knot.

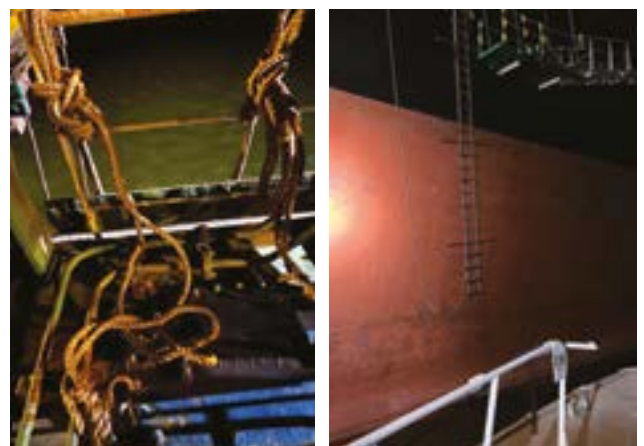
A pilot boarded a tanker at anchor. When they arrived at the top of the ladder, they discovered that it was tied to a rotten railing, there were no suitable hand-holds nearby, and there were many trip hazards on the deck near the embarkation point.

When the pilot raised this with the master, he was told that the ladder was not usually rigged in that position but had instead been moved to accommodate the pilot station's direction to rig a 7m ladder. This was higher than the 5m maximum height at the normal embarkation point, so the ladder had been moved.

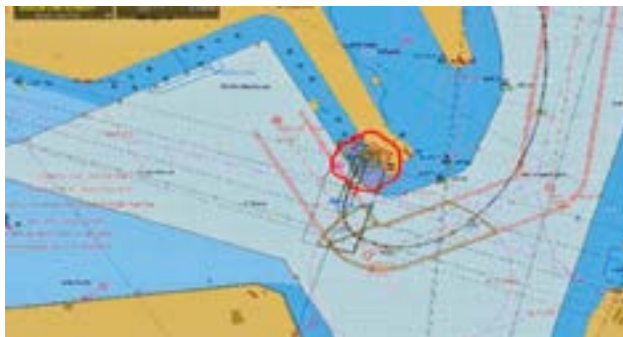
As it passed the mooring dolphin, the vessel turned short round to port, assisted by the tugs. About 5 minutes later the officer at the stern alerted the bridge that the vessel was drifting towards the end of the breakwater. The current was running in an easterly direction during the turn to port, which caused the drift, although the pilot believed that it was running in a westerly direction. The pilot gave several engine orders from dead slow to full ahead to increase the distance from the breakwater, but a noise was heard on the port quarter. Following checks within the engine room to ensure the hull was not breached, the vessel berthed port side alongside at the oil terminal.

An investigation revealed that there were no fatigue issues nor any substance abuse. All equipment was in-class and properly maintained. The passage plan berth to berth was very comprehensive and under-keel clearance (UKC) calculations were prepared and shown to the pilot at the master-pilot exchange. All navigational equipment relevant to this passage plan was being used and accurate. The bridge team members were adequately trained for making proper use of all navigational aids, and for being aware at all times of the vessel's position. The master-pilot exchanged information and pilot card was properly completed and the pilot was fully aware of vessel's particulars and manoeuvring characteristics.
