Welcome to Drone FEEDBACK Edition 7. This is our first newsletter of 2023 and there are some very instructive Human Factors and Just Culture occurrences in this Edition. Amongst others, they include an Emergency Services Drone colliding with a Cessna 172 aircraft on final approach to an aerodrome, a 28kg Drone filming at the Henley Regatta that ran out of fuel (battery), dropped vertically and narrowly missed passengers sitting on a boat. The common link? Human Factors.

CONTENTS

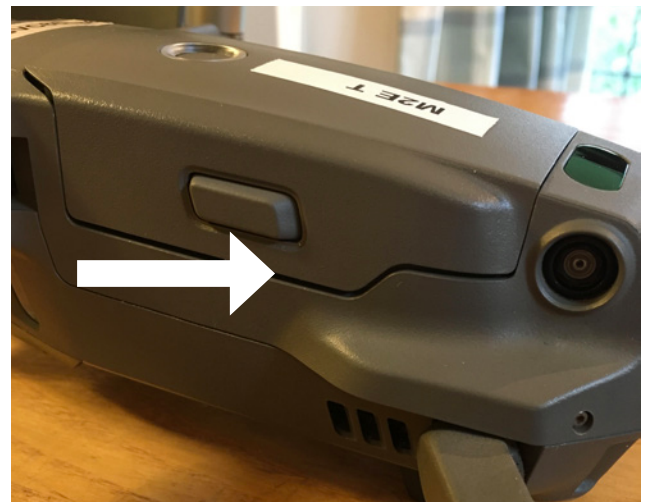
Report Text: The flight crew were wearing gloves to install batteries into a Mavic 2 Enterprise Advanced. The battery powered-on the UA but when it came to take off, an error was displayed stating that the battery was not inserted correctly. The flight was cancelled. Upon visual inspection, the battery looked as if it was installed correctly, but when it was firmly depressed, 2 audible clicks were heard, and the battery was then secure. It was about 1°C and the flight crew were wearing gloves that would have meant loss of dexterity.

Figure 1 - Battery not clicked into place (note gap)

Procedural changes: The following improvements are to be made to the pre-flight checklists every time a battery is installed onto a Mavic:

Install battery onto the UA. Ensure a click is heard as the battery clips into place. Note that more than a single click may be heard.

Try to remove the battery without pressing the battery release tags.

Repeat the above procedure or cross check with another remote pilot if you are unsure.

Check for warnings on the controller before launch. If a warning is seen, cancel the flight and rectify.

CHIRP Comment: This was a well caught and handled incident, that may well have had consequences if it had been any different. If a battery is not properly fitted into the aircraft and contact between the battery and airframe is lost, even momentarily, the motors will stop and the aircraft will descend vertically to the ground. We would recommend:

- For this model of RPAS, hearing the double click and feeling for the potential gap (with gloves removed), is essential!
- If you are operating in low temperatures, always be aware of the operating temperature range. In the case of a Mavic 2 it is -10° to + 40° C
- The Manufacturer or Operator might consider applying witness lines, which would make it easier to visually identify an incorrectly seated battery.
- It is worth noting that just because the Mavic 2 is thought of as being easy to deploy, it does not mean the pilot can ignore pre-flight checks. Easy to do in haste, but this may lead to repenting at leisure.

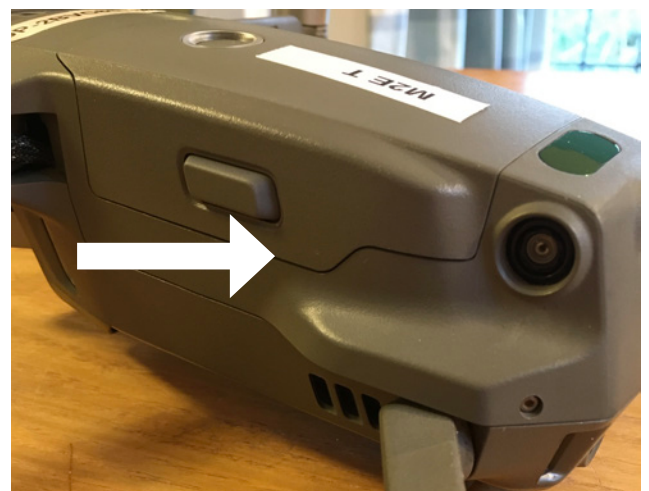
Figure 2 - Battery securely clicked into place (gap reduced)

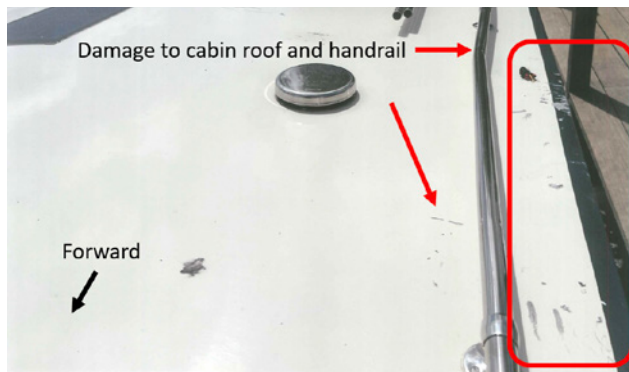
Shortly after the low voltage warning had occurred in flight, the battery reached a critical voltage level at which point controlled flight was lost and the aircraft then descended in near free fall. The aircraft's kinetic energy when it collided with the boat was estimated to have been about 13,700 Joules. The CASA research paper indicates that fatal injuries would have occurred if the 28 kg aircraft falling at 30 m/s had struck a person on the boat.

Whilst returning to land following a trigger of the low battery voltage warning, the aircraft's battery voltage depleted to the extent that controlled flight was no longer possible. The aircraft descended, in near free-fall, and impacted an occupied private boat on the river. If the aircraft had struck a person on the boat, it is likely that fatal injuries would have occurred.

The pilot did not replace the aircraft batteries when he had intended to, and a pre-flight check of their voltage before the accident flight was most likely not performed. In addition, the low voltage battery warning had been set to a level below that recommended by the manufacturer. Had the battery warning been set to the manufacturer's recommended setting, the aircraft may have been landed safely under the pilot's control.

Damage to the Cabin roof and left side Handrail

- It's never wise to change voltage limits below manufacturers recommended minimum level. They are normally set at a level that has been tested and other limits may have been set accordingly. It therefore follows that other parameters may be impacted, and the pilot may not know which ones have changed and how they have changed. One example of this would be wind gust limits which are set in part by maximum power output calculations.

- On an aircraft system like the Alta, it might be sensible to fix a sticker to the controller with the voltage limit at which return home is necessary, so it is easier to remember, particularly if there is no audible warning mechanism.

- The lack of a briefing for the Observer and Camera Operator. If they had been briefed it might have resulted in one of them calling into question the lack of a voltage check, as part of the pre-flight checks before the accident flight. It sounds like there was time pressure and too much focus on getting the filming done.

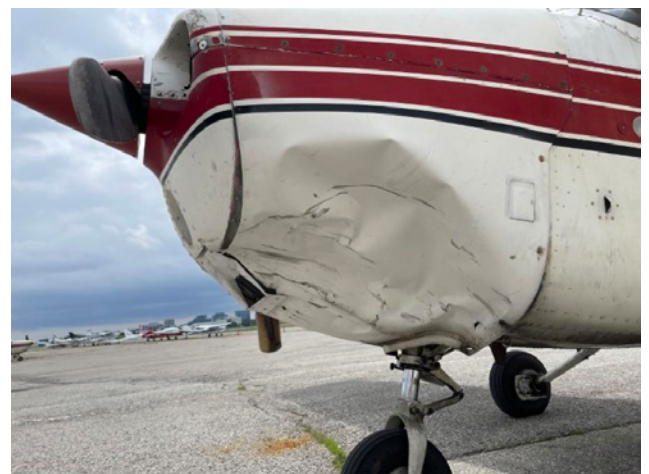
At approximately 1301 Eastern Daylight Time, the student pilot and flight instructor heard and felt a solid impact at the front of the aircraft. Suspecting a bird strike, they continued the approach and made an uneventful landing, exiting the runway and proceeding to park on the ramp. After parking the aircraft, they observed damage on the front left cowl under the propeller; however, there were no signs that a bird had struck the aircraft.

1. The flight crew of the Cessna 172N was unaware of the presence of airborne remotely piloted aircraft traffic in the vicinity and, due to several factors, the active scanning that is part of the see-and-avoid principle was unsuccessful in identifying the conflict.

2. York Regional Police policy does not require that visual observers be trained crew members, and the remotely piloted aircraft pilot did not brief the visual observer on his role and responsibilities before the operation. As a result, the visual observer was not aware of the requirement to maintain visual line-of-sight with the remotely piloted aircraft, nor was he trained in visual scanning techniques or aircraft identification.

3. The remotely piloted aircraft pilot was tasked with operating the camera system, monitoring the status of the remotely piloted aircraft, and communicating on multiple channels. As a result, he likely became task saturated, restricting his ability to visually monitor the remotely piloted aircraft and hear radio calls on the control zone's mandatory frequency and the sound of incoming aircraft, both of which preceded the collision.

4. In the moments leading up to the collision, the pilot of the remotely piloted aircraft likely was task saturated, the visual observer was unaware of the requirement to maintain visual line-of-sight, and the Cessna pilots' active scan was unsuccessful; consequently, the conflict went unrecognized, and the 2 aircraft collided.

Damage to the Cessna 172 after collision with the DJI M210

Safety action taken: The York Regional Police has amended its Command Directive LE-388 to include the addition of a pre-flight risk assessment tool and an updated Remotely Piloted Aircraft Pilot Checklist. There is also additional guidance for the role of visual observer, including a quick reference card outlining their roles and responsibilities, as well as a requirement to have a visual observer present for all operational remotely piloted aircraft flights.
