## CHIRP Maritime – There For Everyone

**W**elcome to the Summer edition of Superyacht FEEDBACK, a safety newsletter that explores topical safety issues based on your submitted reports.

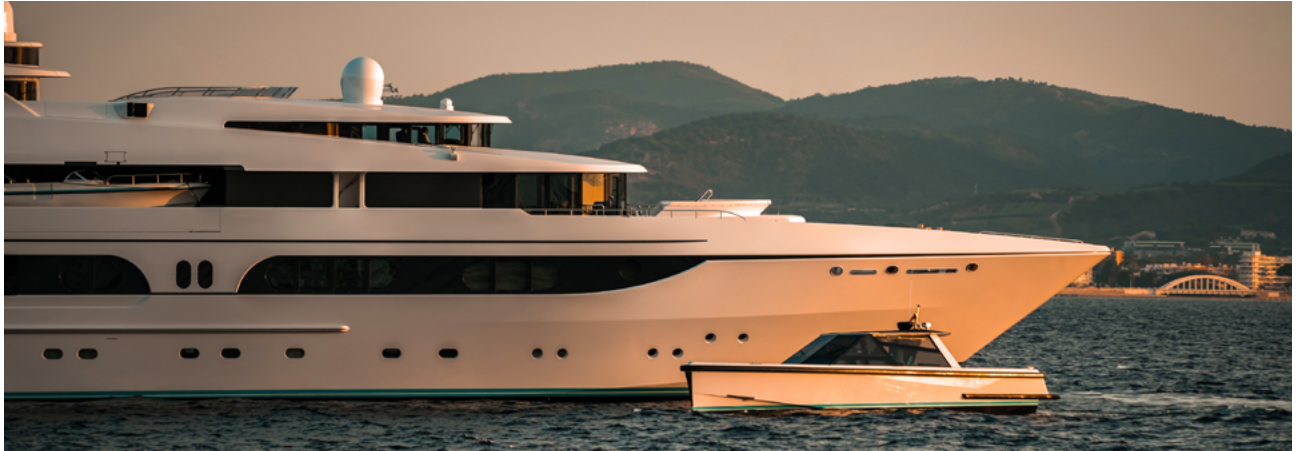
Our reporter was part of a team launching the tender from the shell door opening in calm weather conditions. After checking the hoist arrangement and securing the forward and aft lifting arms, the tender was lifted off the chocks. Another crew member went around to lower the outboard side of the tender chocks. Once they were back inboard, the crane arms were extended, but when the tender was halfway out, the bow suddenly dropped to the deck and slid into the water. Meanwhile, the aft end of the tender hit the deckhead, sending ceiling panels flying.

The cause was a sheared eye bolt thread. No additional loading was introduced while lifting the tender until the point of failure. The eyebolt conditions appeared to be in good condition, although there was some uncertainty about when they were replaced last.

Such incidents are not uncommon, and failure under load is often caused by inappropriate eyebolt design or weight-

carrying capacity. When lifting, we naturally focus on the type and rating of the lifting strops used, but often the fixed lifting points are overlooked. Lifting eyebolts should have their capacity and test-date stamped on them or on a metal test certificate affixed immediately adjacent to them. Be sure to check your lifting arrangement for the tenders and work boats on your vessel!

When eyebolts are replaced, it is important to replace them with the same specification as the original, and properly fixed back in position. Another contributing factor can be the angle that the eyebolts make with the lifting shackles. If the lifting eyebolt and lifting strops are not in alignment, a shear force is produced which can cause failure of the eyebolt/s.

**Overconfidence** – Often there is an expectancy that the eyebolts will 'just work'. Be aware of such single points of failure in a lifting rig and pay particular attention to these areas, such as deformation, pitting or wear and tear.

**Capability** – During our investigation we heard anecdotes from yacht crews that eyebolts were sometimes changed locally, with a different design e.g. to be less obtrusive. Given the criticality of the eyebolts for safe lifting, maintainers must ensure that the eyebolt specification is safe and meets the original design requirement, which will have an additional safety margin for shock-loading lifting forces. If you're not certain that the eyebolts on your vessel are 'as originally designed' then seek expert advice!

**Local Practices** – As the eyebolts were replaced, it is essential that the original equipment parts were replaced with the same specification eyebolts. Thoroughness in the procurement process is critical to ensure that the tender can be lifted each time safely. How thoroughly do you procure original spare parts? Does your management have a procurement policy?

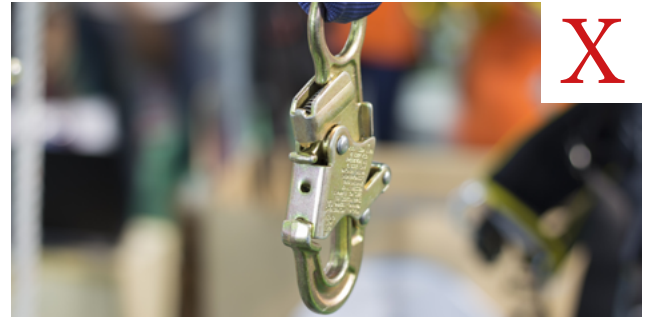
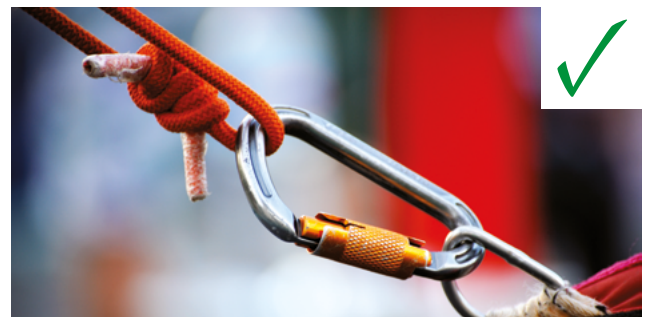
He realised he was missing one carabiner and grabbed a quick-release shackle, which was used as the primary point for connecting to the vessel. A little while later, a deckhand found the chief officer swimming behind the boat. The chief officer reported that during the inspection, he had accidentally knocked the quick-release shackle, which released the safety line causing him to fall into the water.

The chief officer was following the permit-to-work requirements and used a crew member (buddy) to ensure that the gear was being worn correctly in accordance with the PtW, which is commendable. However, picking up a quick-release shackle instead of a carabiner and using it as the main securing point created a single point of failure which inevitably led to the fall from height.

CHIRP stresses that working at height PPE should be kept separate from other lifting or securing gear. This gear should be stored in clean, secure compartments and regularly scrutinised for damaged.

The PtW requirements were not followed properly because anyone working at height must be fully supervised during the work. No other work activity should be undertaken which takes away that essential duty. It's important to ensure that the crew are trained on the full requirements of the PtW system so that the full process is followed. In previous FEEDBACK editions, CHIRP has emphasised that when crew are working aloft a rescue plan must always be prepared as part of the risk assessment. Crew members who fall and are suspended by their safety harness must be rescued within 15 minutes to avoid serious injury or even death due to blood circulation being constricted.

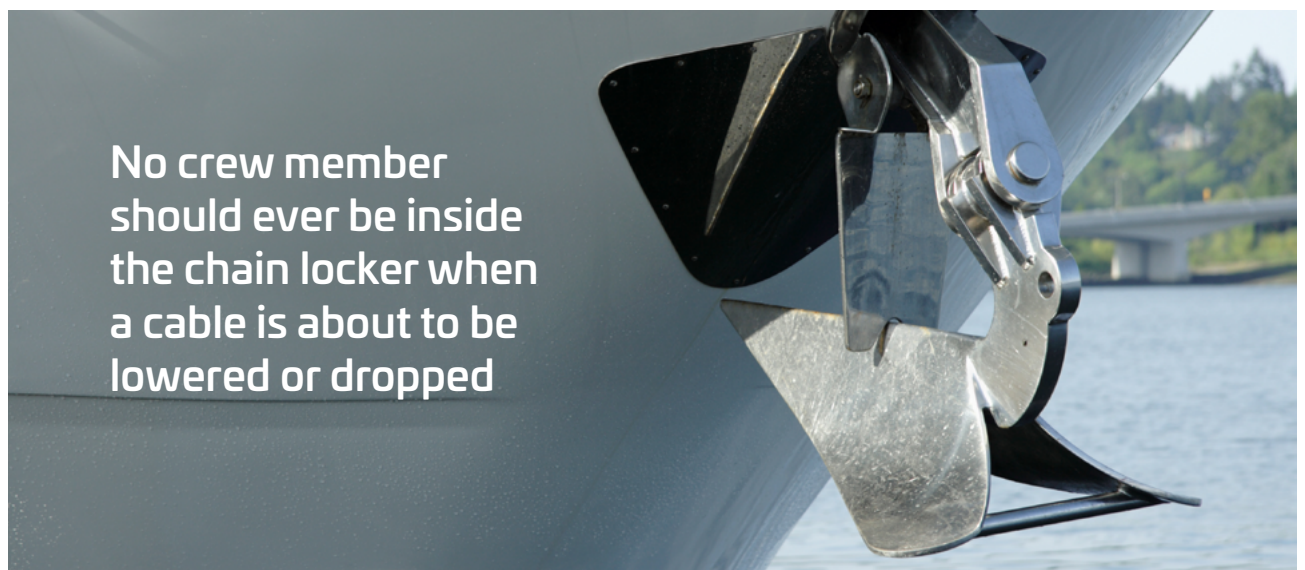
There appears to be a design issue with the chain locker: either the locker is too small to accommodate the cable pile when the anchor is stowed, or the spurling pipes are not adequately designed to allow the cable to self-stow. Design modifications should be considered to eliminate this unnecessary risk before the next docking.

No crew member should ever be inside the chain locker when a cable is about to be lowered or dropped

**Design** – The poor design of the anchor system created an unnecessary risk which required a crew member to manually flake the cable to prevent it from piling up. Redesigning the spurling pipe in the chain locker to allow the cable to self-stow and not pile up is highly recommended.
