Ensuring Safety in Fishing Operations

Welcome to the first edition of our safety newsletter for the commercial fishing industry. For over 2 decades, CHIRP Maritime has empowered seafarers worldwide by raising awareness of safety lessons learned from real-life scenarios. Because we recognise the unique circumstances and challenges faced by the commercial fishing sector, we are proud to introduce a new publication specifically for fishers, based on reports submitted by fishers. We hope to create a safe and non-judgemental learning environment where fishers can share, and learn from, the experiences of others. This helps to prevent similar incidents in the future and contributes to a safer maritime environment overall.

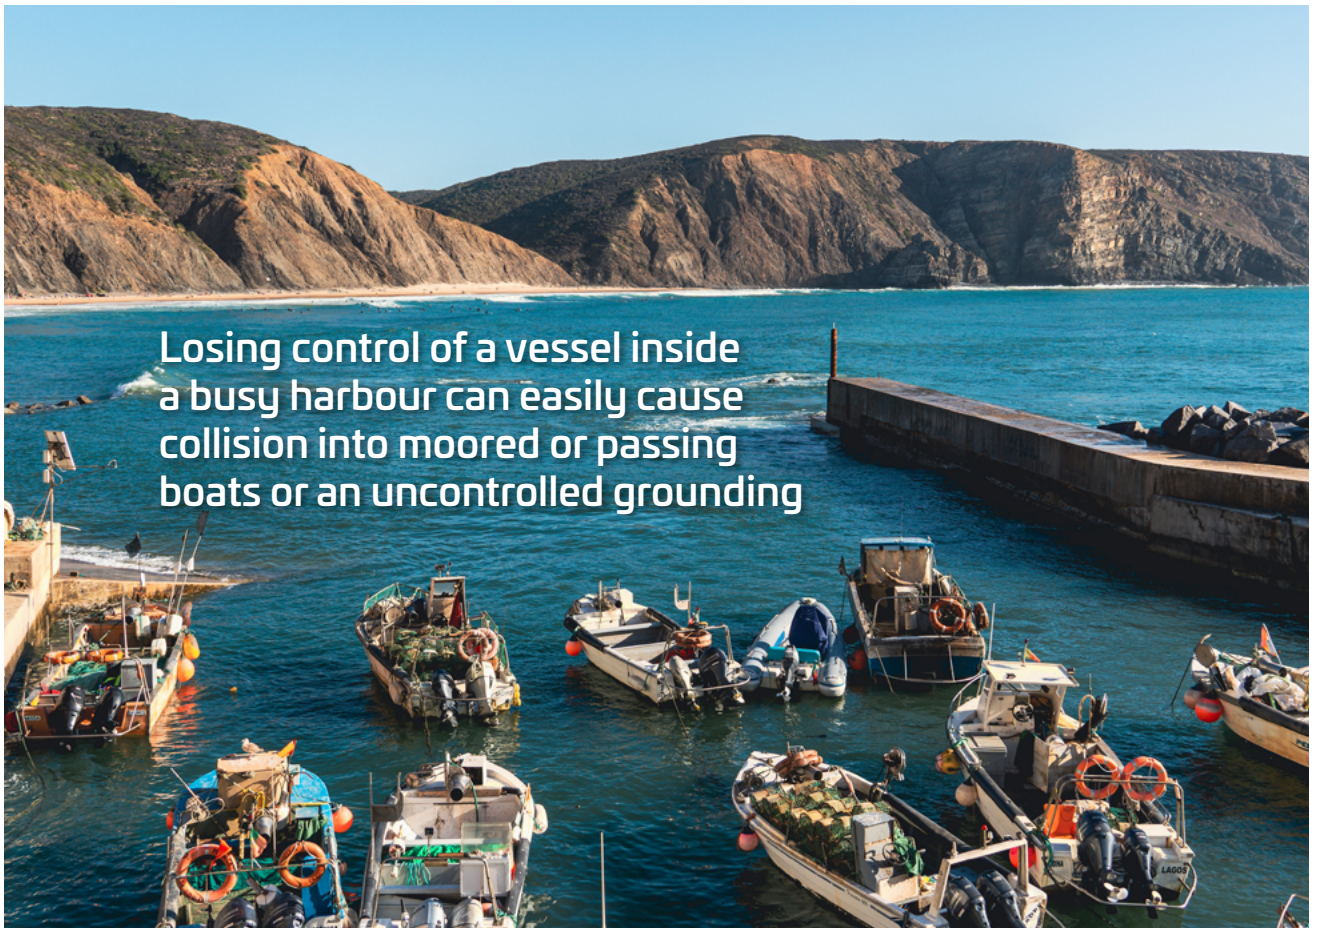
Shortly after a fishing vessel entered the main channel at the harbour entrance, the engine’s revolutions unexpectedly slowed, and the engine temperature rose. A quick investigation revealed that a poorly marked floating line attached to a line of pots had become wrapped around the prop shaft. The line was cut free, but the engine would not restart, and the vessel had to be towed into the harbour by another fishing vessel which was, fortunately, passing close by.

Further investigation proved that the gearbox had been severely damaged and needed to be replaced, costing over £10,000 and two weeks’ lost fishing time. Although the insurance covered the gearbox cost, the loss of income over the two weeks was significant.

Laying pots near a main channel can be attractive because the areas are rarely fished, usually in sheltered water, and are easy to access. However, CHIRP frequently receives reports about vessels becoming snagged on pot lines which have been poorly marked. In this case, the marker was an empty 2-litre plastic milk carton.

Local practices – Check whether your harbour allows pots to be laid inside the harbour. Where it is permissible, lay away from navigational routes or among lines of moorings. Where practicable, ensure the riser is at the end furthest away from the channel, and avoid using a floating line.

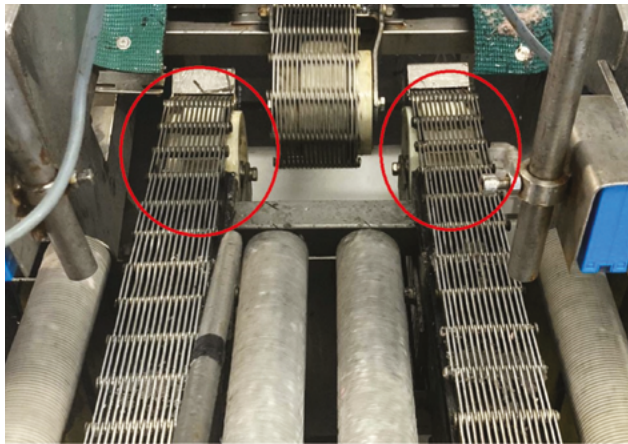
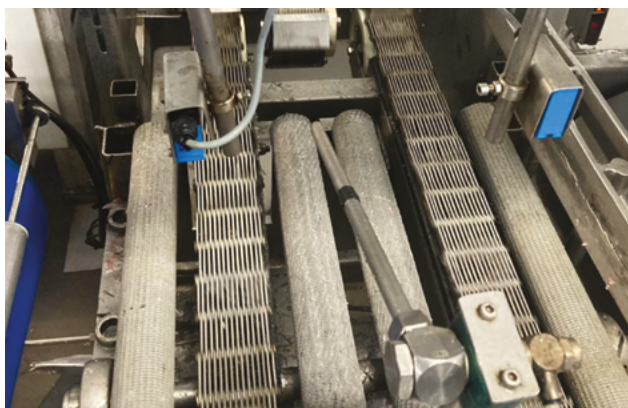
The engineer on a fish processing vessel needed to conduct maintenance on a conveyor belt used for moving fish boxes. During a crew break, the engineer activated the emergency stop so that the conveyor belt would not be reactivated while they worked on it. They did not inform the crew of their maintenance intentions.

When processing restarted after the break, a fish box was placed on the conveyor, breaking the 'magic eye' beam, which restarted the conveyor. However, the engineer was still maintaining the chain and their fingers became trapped when it restarted. They lost a fingertip before they could retract their hands.

The engineer thought activating the emergency stop would prevent the system from operating, so they didn't correctly isolate the system. CHIRP contacted the company and received very positive feedback on how they would ensure that this type of incident would be prevented from happening again. This hazard had been identified in the risk assessment for this work. Still, it did not include Lock Out, Tag on, Tag off (LOTOTO) procedures which were only available for work on electrical systems and not on equipment with moving parts. The company have made changes to include this safety procedure for all equipment with moving parts.

Design – It should have been impossible for the conveyor to restart until the emergency stop button was reset. Emergency cut-off systems are not an acceptable alternative to the established pre-work isolation routines.

The company have made changes to include this safety procedure for all equipment with moving parts.

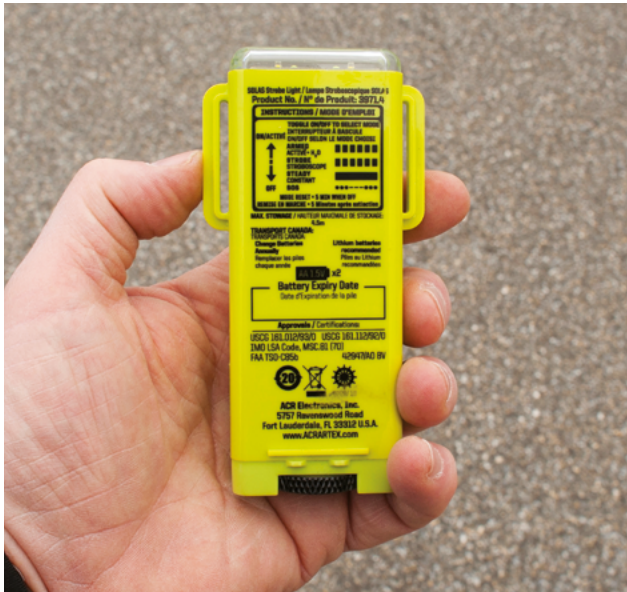
A typical personal locator beacon (PLB)

When fishing single-handed, CHIRP advises that a ladder is rigged to aid self-rescue or a floating messenger line attached to a lifebuoy streamed from the stern and next to the ladder. Fishers are also strongly encouraged to wear a waterproof hand-held VHF radio or (even better) a Personal Locator Beacon (PLB), which can alert the emergency services if you fall in.

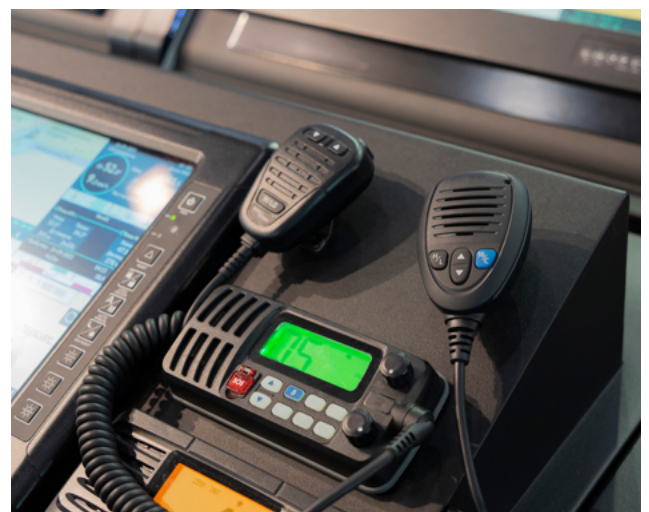
Shortly after a RO-RO ship left its berth, it collided with an inbound fishing vessel. The fishing vessel sank, but all 7 of the crew were safely recovered. In this port, vessels needed to request permission to enter or leave so that vessel movements could be deconflicted by the port's traffic services to avoid potential collisions, although this rule was often ignored by smaller vessels. In this case, the fishing vessel did not have a working radio, so there was no communication between the vessel and the port, nor could it hear that the RO-RO vessel calling after it had left its berth.

The causes of this incident were present a long time before it happened. By allowing smaller vessels to ignore the requirement to radio for permission to enter or leave, deficiencies in the ports monitoring or detection systems went unnoticed. Potentially, the reduced emphasis on radio communication from small vessels made it less likely that fishing vessels would carry a spare radio, and possibly meant that the failure of the primary radio went unnoticed. In any case, the port did not detect the inbound vessel and granted the RO-RO permission to leave its berth.

The activities involved in entering or leaving a harbour likely distracted the bridge teams on both from their primary task of keeping a good lookout to detect the risk of collision (Collision Regulations rule 5). In any event, even when risk of collision was determined, neither vessel took the correct action to avoid collision (rules 8 and 17).

Local Practices – In this port, smaller vessels commonly ignored the requirement to request permission to enter or leave. The port authority should enforce the requirement to report because it hampers the port's ability to operate a safe harbour. Are you aware of your reporting requirements when arriving or departing a port?

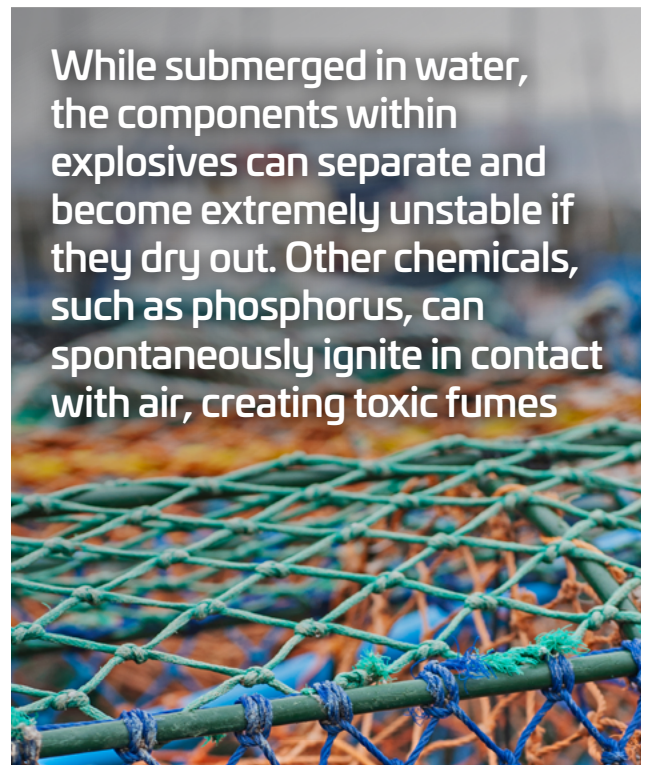
A fishing vessel entered the harbour to land its catch. It also landed some rusty metal objects that had become tangled in the 'cod end'. A member of the harbour staff realised that these were items of historic ordnance and could contain explosive residue. The emergency services were called, and a bomb disposal team attended and took away the items, which were subsequently proven to be unexploded ordnance. Had the items entered a waste recycling plant, they would have posed a significant hazard to both people and equipment.

While submerged in water, the components within explosives can separate and become extremely unstable if they dry out. Other chemicals, such as phosphorus, can spontaneously ignite in contact with air, creating toxic fumes

In this instance, the ship's crew were unaware they had unexploded explosives on board. But if you are in doubt, do not touch it or try to throw it back over the side. Keep the crew as far away as possible, increase your vessel's watertight integrity by closing all weather-tight and water-tight accesses and contact your regional emergency services and follow their directions. Reduce your speed and steer a course that minimises boat movement. More guidance has been published by the UK's Maritime and Coastguard Agency in MGN 323 (https://assets.publishing.service.gov.uk/government/uploads/system/uploads/attachment_data/file/440107/323.pdf)
