## Plotting the course to safe waters

**Adam Parnell**  
Director (Maritime)

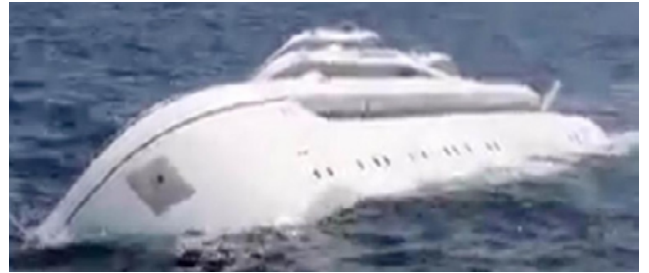
At first light, the vessel got underway and set off to another dive site – this time with a list of 5-6 degrees. As it approached the main shipping lane at 10 knots, the vessel heeled over to starboard and over the next hour the list progressively worsened until it capsized onto its side in less than 30 seconds. One of the vessel's life rafts was released but did not inflate as the painter was not secured to the vessel. It was later manually inflated but could not be righted. The 2<sup>nd</sup> life raft was released and inflated, and the vessel's tender boat, despite being slightly damaged, was used to tender passengers and crew to the life raft. Flares were released, and other nearby dive vessels came to assist. The dive team on board carried out dangerous and courageous rescues within the vessel to free trapped passengers and crew.

According to our reporters, escape from the vessel was hampered by missing handles on one of the emergency escape hatches, and missing handrails on the stairs between decks made it extremely difficult to get out of the vessel. The lack of securely fastened furniture, including unsecured beds, also created a hazardous environment with floating debris obstructing escape routes. None of the passengers received a safety briefing upon boarding the vessel.

Despite the passengers raising concerns on several occasions, it is troubling that the crew neither recognised nor reacted to the obvious warning signs

Significant structural changes invariably affect stability, and inclining tests must be conducted to update the vessel's stability curve data. Despite the passengers raising concerns on several occasions, it is troubling that the crew neither recognised nor reacted to the obvious warning signs. At best, this indicates a lack of training and at worst, the company put commercial interest above crew and passenger safety by continuing the voyage. Although the vessel had significant safety design defects e.g., lack of handrails on the steps between decks, the crew also demonstrated a complacent attitude to safety: items were not correctly secured for sea, nor were basic safety items such as the life raft painter correctly fitted. These, and the lack of a safety briefing for the guests, all point to a poor safety culture compounded by inadequate crew training and competency.

**Design** – Poor design choices when installing the additional decks significantly affected the vessel's stability. Scrutiny of the stability requirements should have occurred before the refit; and after the work had been completed, it should have undergone an Inclining test overseen by the Class society and Flag.

member joining (or on) a vessel that has had substantial structural change, ask to see evidence that stability tests and sea trials were correctly carried out.

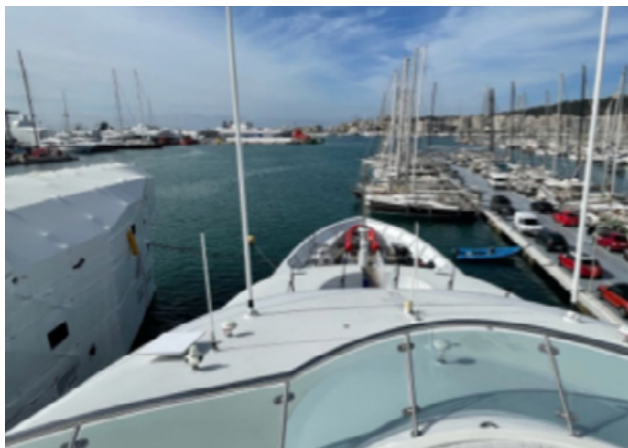
During the departure, the starboard stabiliser fin snagged a ground line belonging to one of the smaller sailing vessels. This incidental contact caused a slight movement among the adjacent yachts, resulting in a slow collision between the yacht's hull and the vessel whose ground line was entangled.

Upon realising the situation, the master held the vessel steady in an awkward position while the entangled ground line was safely removed. The shipyard was promptly contacted, and they confirmed that no evident damage was observed except for the snagged line. The stabiliser was also assessed and proved to be operational with no damage.

Our Advisory Board members discussed whether additional mitigation measures might have further assisted the master and crew during the departure. These included asking the port to temporarily relocate some of the other small boats to provide more clearance or the use of mooring lines to warp the vessel until it is clear of potential hazards.

It is best practice to discuss problematic departures the port authorities, and an illustrated departure plan is very helpful in such situations. These plans must consider the vessel's specific requirements and consider potential hazards like the presence of ground lines. Escalating the issue to the port's management well in advance can ensure adequate attention and resources are allocated to address your (un)berthing concerns effectively.

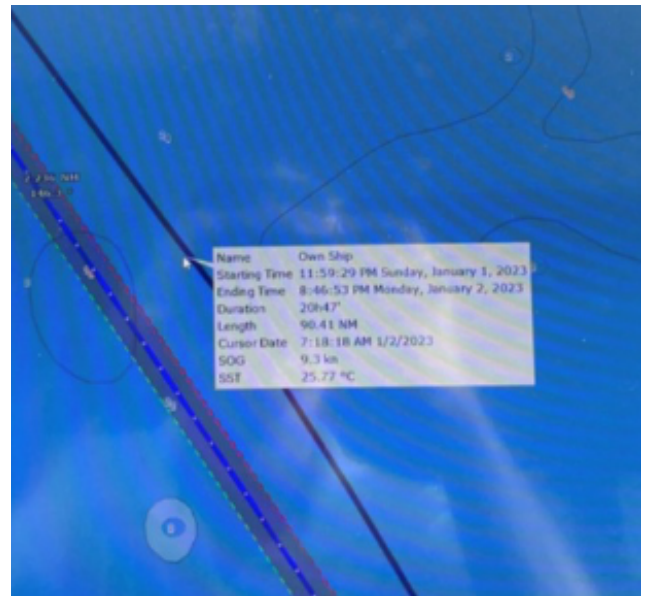
Screenshots of ECDIS (Electronic Chart Display and Information System) show that the planned track – shown as a dotted line – went over the top of a 1.9m shoal depth even though the vessel's draft was 2.3m. The vessel's course – shown as a solid line – was starboard of the

planned track but still grounded because of a combination of shallow water, speed and squat. This resulted in the vessel dry-docking for several weeks for significant repairs.

Subsequent correspondence with the reporter revealed that to satisfy the owner or guests' requests to visit certain locations, the vessel often navigated to areas 'by eye,' i.e., visually detecting shallow areas because even large-scale charts lacked sufficient sounding data.

CHIRP discussed with the relevant hydrographic office (HO) the issues experienced concerning navigating in the area related to the report. Crucially, a compliant ECDIS system must be used, and the charts must be updated to the latest edition and corrections. It was noted that an official ECDIS system

The HO placed great weight on using the sailing directions for the area as a pre-requisite before planning the passage. They contain valuable navigational information, including the nature of the seabed and the likelihood of shifting sandbanks, which in this case were prone to shifting. The vessel's speed must be set according to the under-keel clearance to avoid significant squat. Most fine-lined super yachts will trim by the stern when experiencing squat effect, and damage to the propellers and rudder can be expected if the vessel touches the seabed.
