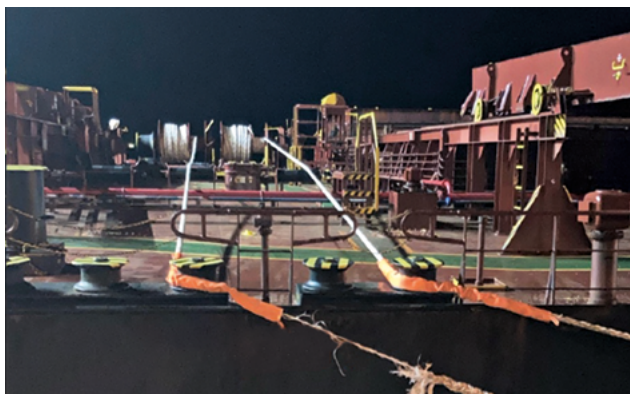
Whilst the vessel was alongside at our terminal, long-period low amplitude swell waves (groundswell) caused a large bulk carrier to yaw and roll. This motion caused the edge of the roller fairlead to saw through one of the forward spring lines. Fortunately, this was detected by the crew before it was cut all the way through, and they were able to replace the line before it parted.

The design of the mounting block on which the pairs of roller fairleads are mounted requires review. The 90-degree edges act as a blade on surging ropes. Naval architects are reminded that the edges of these should be considered during the design phase of a new vessel. By eliminating such hazards at this stage can significantly decrease the chances of lines abrading or parting during the vessel's lifetime. [OCIMF's Mooring Equipment Guidelines \(MEG4\)](https://www.ocimf.org/publications/books/mooring-equipment-guidelines-meg4) (<https://www.ocimf.org/publications/books/mooring-equipment-guidelines-meg4>) provide further guidance on the design and construction of the mooring system.

Vessel owners remain responsible for maintenance in most cases, and they should ensure that such hidden hazards are removed as soon as possible, or at the latest, during the vessel's next maintenance period.

Design – Naval architects should avoid designing sharp edges over which lines are likely to be run. Crews: does your vessel have this issue? If so – report it!

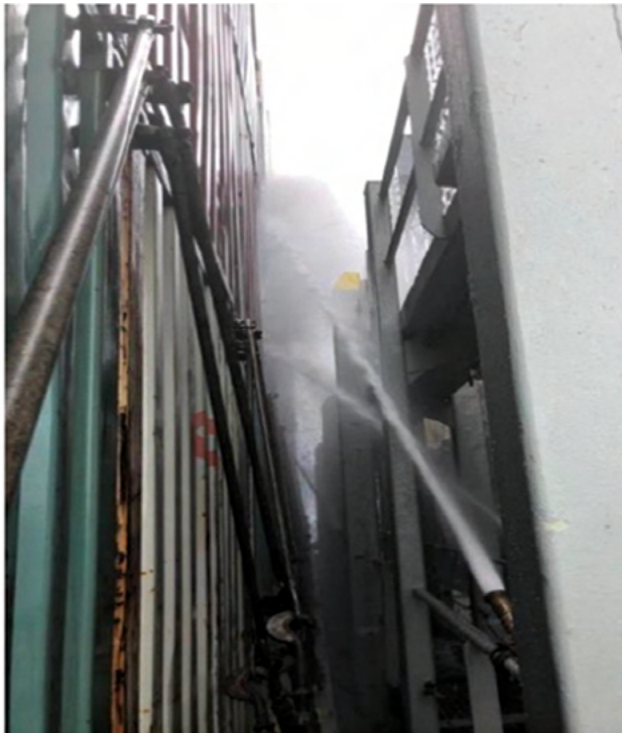
During a voyage, a 20ft container loaded with cargo installed with lithium-ion batteries caught fire. The cargo had been mis-declared as non-DG (dangerous goods). Despite the difficulty and safety risk when gaining access to an above-deck container in a confined space, the crew punctured the container and flooded the burning cargo with water. This action controlled the fire until the vessel got to the next port, where the container was discharged for an investigation by the terminal authorities.

Shippers must strictly comply with all relevant national and international safety, health, and environmental regulations when transporting goods containing LIBs. They must thoroughly evaluate the anticipated transport conditions, including factors like manufacturers and customers involved, and conduct a comprehensive assessment of the risks inherent in the supply chain.

The selection of appropriate containers, and following proper packing procedures, is especially important when shipping LIBs. Use temperature-controlled cargo units or

protective stowage locations if the expected temperatures within a container are likely to exceed 40 degrees Celsius during the voyage.
