Stay Aware – Stay Safe

Welcome to the 5th edition of Superyacht FEEDBACK. It's hard to believe that this is the publication's first anniversary already. With the assistance of our amazing reporters, we've tackled some significant safety issues: how to pre-empt and respond to unsafe requests; the importance of minimising distractions on the bridge or in a tender – especially at night; the challenges posed by lithium-ion batteries; and why even new-builds can suffer with safety issues (and how to spot them).

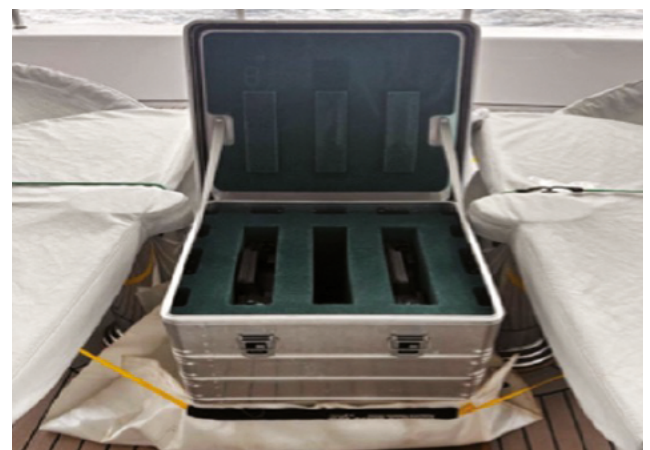
During a routine inspection by the deck crew, one of two Lift E-Foil lithium-ion batteries, stored inside a purpose-built battery storage box, was significantly warmer than the other. The batteries were charged the day before for routine maintenance, and no abnormalities were detected during the charging.

Upon finding the warm battery, a temperature reading was taken of 37°C. The storage box with both batteries inside was moved to the main deck aft to a location visible by CCTV. The box was placed on top of a fire blanket.

Hourly inspections of the battery and readings of the temperature were added to the hourly rounds of the deck crew. By noon the following day, the temperature of the battery had risen to 47°C, and the captain gave the order to dispose of the battery overboard. The battery was disposed of at the recorded position at sea and time. The incident was recorded in the official logbook, and the disposal was recorded in the garbage record book.

The investigation revealed that there was a suspected thermal run-away developing. The cause of this was potentially a faulty cell within the battery.

CHIRP urges all owners and masters carrying LIB on their Super Yachts to understand the manufacturer’s guidelines clearly. Importantly, they must train the crew to be aware of potential harm from LIB, including how to respond to a possible thermal runaway incident.

Company SMS should be reviewed to see if changes are required using the latest industry information on LIBs, including guidance for handling LIBs and emergency preparedness if a battery malfunctions and shows potential for a thermal runaway event.

It is recommended that the life history of the lithium-ion battery should be documented from the factory to their disposal. CHIRP notes that while the industry is still discovering more about LIBs and their life cycle, greater information sharing should be provided on LIBs within the superyacht industry. A standardised logbook within the super yacht sector should be considered.

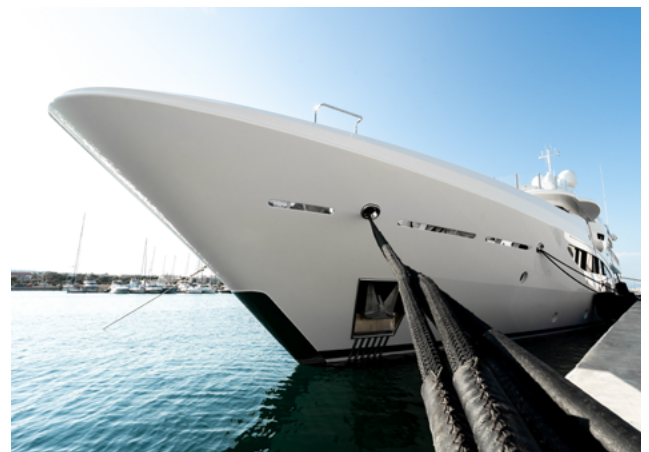
In this incident, a large yacht was anchored in a confined area with other yachts when a sudden squall with strong winds struck. The anchor chain stretched, and the yacht began to drag the anchor, which was confirmed by the radar anchor watch. To respond, the bridge team started the main engines to reposition the yacht.

However, the crew in the water, who were busy securing recreational water equipment like jet skis, must be made aware that the engine was about to start. When the swim platform was raised for manoeuvring, those in the water could not reboard the yacht.

With no means of communication and the strong wind making it difficult to shout warnings, the crew dropped a line into the water to allow the yacht to manoeuvre freely. Those in the water had no choice but to get on the jet skis to stay afloat and were forced to tow inflatables, lines, and other skis away from the yacht, making the situation more complicated.

The propulsion system was engaged without warning, creating a severe safety risk. At this crucial moment, the captain and chief officer were on the bridge while the second officer was on a break. There were no officers available on deck to manage the unfolding situation.

The morning toolbox talk should encompass all planned recreational activities, emphasising communication protocols, weather forecasts, and contingency plans for aborting activities if conditions become unsafe.

A thorough review of the anchor-dragging procedure is necessary for a dragging anchor. Initiating engine operations without informing anyone, especially with passengers and crew in the water without communication, poses a significant danger. Before any yacht manoeuvres, it is crucial to ensure the proper securing or retrieval of water sports equipment to prevent damage to propellers and the motor yacht.

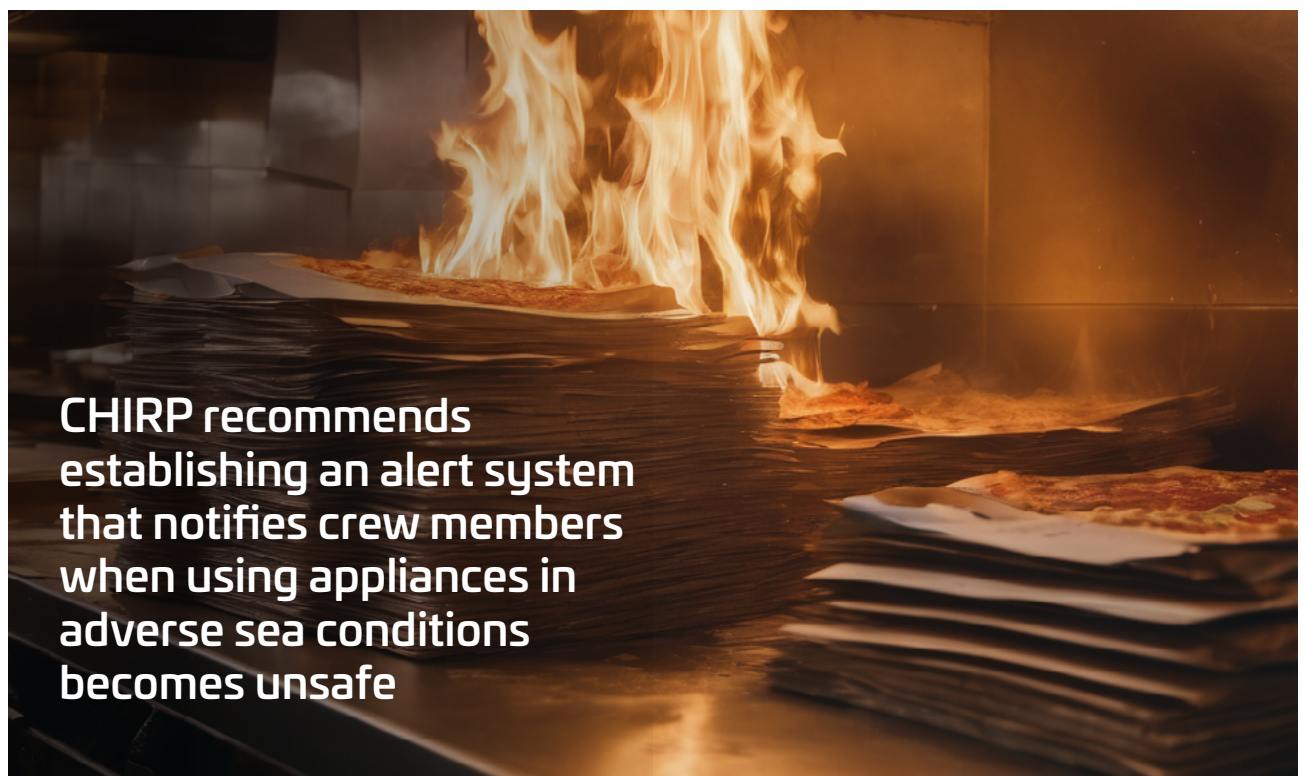
The reporter noted that, in rough weather, unsecured appliances in the accommodation area created a hazardous work environment, potentially endangering the crew, passengers and the vessel. These unsecured appliances included galley freezers, galley ovens, and laundry washing machines. E.g., the galley freezers had locking bars for securing them, but this made them unusable in their secured state, and they weren’t directly attached to the vessel. The galley oven had no securing mechanism and needed a mop to keep it in place, which was unsafe and impractical.

More consideration was needed for designing and securing these appliances during installation, leading to problems when the vessel was at sea.

To fix this issue, the reporter suggested installing purpose-built securing arrangements during the next refit and for all future appliances. Given the vessel’s size and speed, the reporter was concerned that the crew was not adequately protected against the movement of the appliances during rough sea conditions.

CHIRP recommends establishing an alert system that notifies crew members when using appliances in adverse sea conditions becomes unsafe

equipment within working areas. Installing secure locking or latching systems on appliances is crucial to preventing shifts during rough seas. Further, incorporating effective locking mechanisms for cupboard doors and utilising non-slip containers minimises accidents caused by shifting objects in heavy weather.

Repositioning appliances strategically to reduce exposure to rolling movements and using anti-slip materials underneath them offers additional strategies to enhance stability without compromising their functionality during adverse conditions. CHIRP underscores the importance of integrating a heavy weather checklist into the Safety Management System (SMS) and maintaining a register of moveable heavy objects, e.g., forklifts and loose furniture. These tools proactively manage challenges from heavy weather, ensuring a systematic and well-prepared response.
