## Attention to detail

Welcome to Drone FEEDBACK Edition 9.

### Report No1 - DUAS24 – Minor collision with window catch

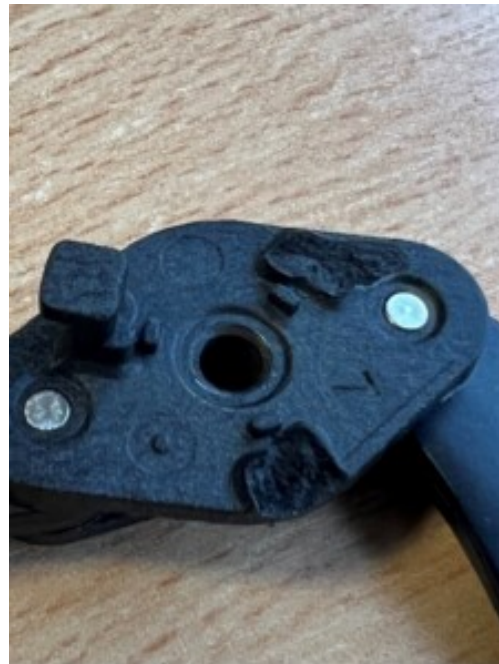
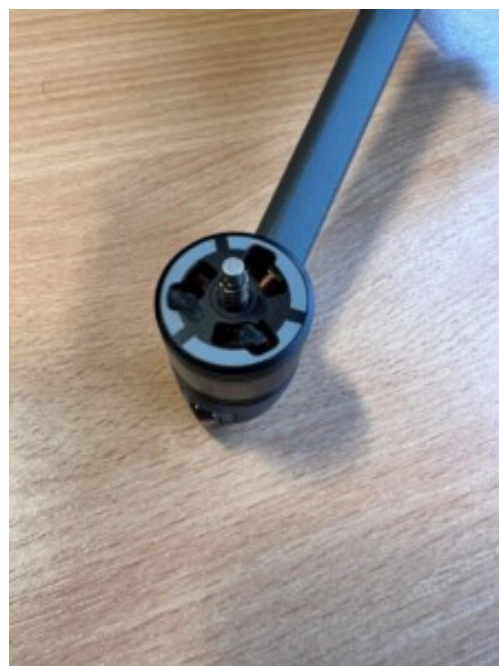
Upon completing a flight, the UAS was landed, and the battery changed. When starting the rotors for a subsequent flight the left rear propellor did not spin up as expected and a grinding sound was heard. The UAS and Controller were switched off and inspection of motor assembly was made assuming motor failure. Motor was resistant to rotation and assumed failed. On removing the propellor it was noted that two of the three flanges that secure the propellor to the propellor hub had failed and entered the motor housing (see pictures) There was no suggestion of this impact or damage

prior to carrying out the previous flight. Total Estimated Flight time on the propellor set is in the region of 27 hours. The failed parts were removed from the motor housing and motor freedom was tested. The propellor was replaced and the UAS restarted. Ground running test completed satisfactory, and short flight test completed satisfactorily and UAS returned to service.

One possible failure mode that was considered after the event was observed is the way that the UAS is unfolded and folded. If Remote Pilots were to continually use the propellor to extend and unfold the arms this could put excessive stress on the propellor hub flanges over a period of time and eventually weaken the structure to the point of failure.

**Below are pictures of the broken propellor flanges and the motor with the two flanges that had broken off stuck in the housing.**

to be identified before it caused an accident. The aircraft in question was a DJI Mavic 3. This is in fact a relatively new model from DJI. The DJI Phantom 4 had several issues with its propellers, and it is disappointing to see a possible recurrence of a propeller weakness on the Mavic 3. Whilst this is not necessarily an operator-related HF issue, it is perhaps a manufacturing related HF issue, in quality control. The reporter's suggestion of checking propellers between each flight would be a sensible mitigation, particularly in a world where if one comes off in flight, the ground risk is substantial. After all, a variety of basic checks is very much something that happens between flights in the crewed aviation world. You should always for example check full and free movement of the controls between flights. The reporter interestingly mentions that folding and unfolding the rotor arms by holding the propellers themselves rather than the arms may have been an underlying cause of stress on the flanges. We think that if this was indeed the way the arms were being unfolded, it may well be a root cause of the flanges being sheared off.

Consider adding an interim hardware check after each take-off and landing or each battery change.

Review of Propellor loading and replacement requirement (currently 100 hours).

Inspection of all other propellor hubs.

*CHIRP recommends that folding and unfolding propeller arms is always done by pulling the arm itself rather than the propeller blades.*

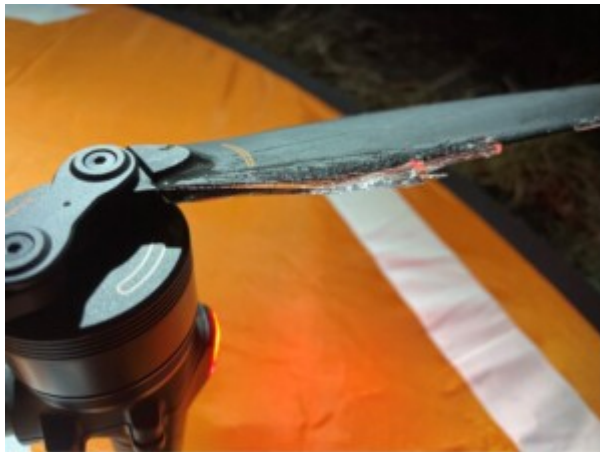
I was on a live deployment. I conducted a short test flight to check for icing on props as the temperature was close to zero. After a short time, I recognised a change to the drone's handling characteristics so landed. On inspection, the drone had icing on propellers (see picture). No further flights were conducted.

A concise report that serves as an excellent example of what to do prior to a deployment, urgent or otherwise, in the winter season. We can only congratulate the pilot for a very sensible approach to safe flying. Looking at the photographs of the propeller, the aircraft would have very quickly lost any available lift if the flight had continued. A point to highlight is that the temperature was "close to zero" without being either zero or minus. It is important to remember that icing can occur at temperatures above zero and, although the nominal freezing point of water is 0°C, water in the atmosphere does not always freeze at that temperature and often exists as a "supercooled" liquid. If the surface temperature of an aircraft structure (such as a propellor) is below zero, then moisture within the atmosphere may turn to ice as an immediate or secondary consequence of contact in such conditions. Ice may form on propellers just as on any aerofoil. It reduces propeller efficiency and may induce severe vibrations.

It was a reminder of the importance of checking local environmental conditions when flying the drone. A thorough risk assessment led me to conduct a test flight and take extra precautions.
