ANNUAL DIGEST

CHIRP

2023

Annual Digest of Reports and Insight Articles 2023-24

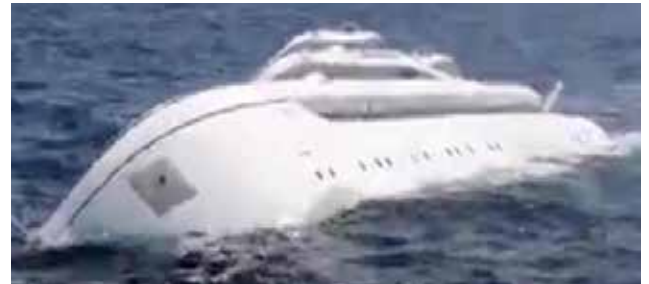
According to our reporters, escape from the vessel was hampered by missing handles on one of the emergency escape hatches, and missing handrails on the stairs between decks made it extremely difficult to get out of the vessel. The lack of securely fastened furniture, including unsecured beds, also created a hazardous environment with floating debris obstructing escape routes. None of the passengers received a safety briefing upon boarding the vessel.

Significant structural changes invariably affect stability, and inclining tests must be conducted to update the vessel's stability curve data. Despite the passengers raising concerns on several occasions, it is troubling that the crew neither recognised nor reacted to the obvious warning signs. At best, this indicates a lack of training and at worst, the company put commercial interest above crew and passenger safety by continuing the voyage. Although the vessel had significant safety design defects e.g., lack of handrails on the steps between decks, the crew also demonstrated a complacent attitude to safety: items were not correctly secured for sea, nor were basic safety items such as the life raft painter correctly fitted. These, and the lack of a safety briefing for the guests, all point to a poor safety culture compounded by inadequate crew training and competency.

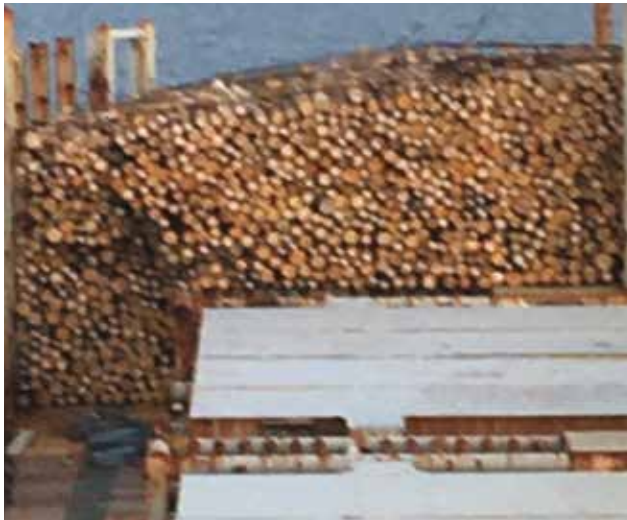
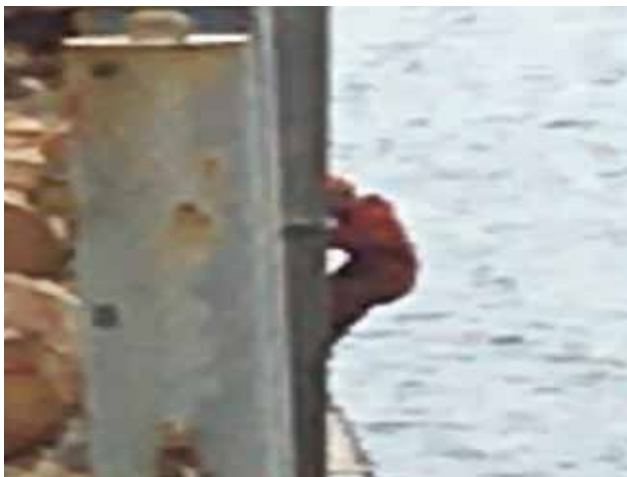
Unsafe access for the crew on a logger

This is a lethal accident waiting to happen.

Vessel owners remain responsible for maintenance in most cases, and they should ensure that such hidden hazards are removed as soon as possible, or at the latest, during the vessel's next maintenance period.

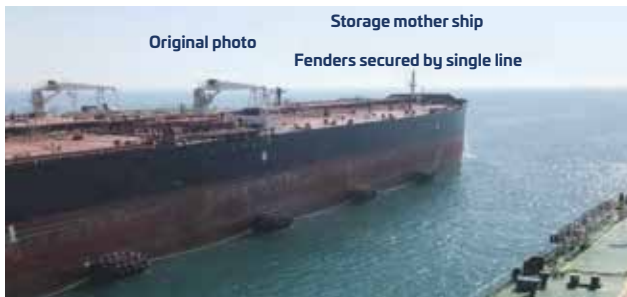
Our reporter sent a photo of a storage ship with incorrectly rigged fenders, noting that a failure of any of the fender's securing lines will lead to a failure of the complete fender protection system.
