Expect the unexpected!

Welcome to Drone FEEDBACK Edition 10.

Report No1 - DUAS29 – Unexpected move post-launch

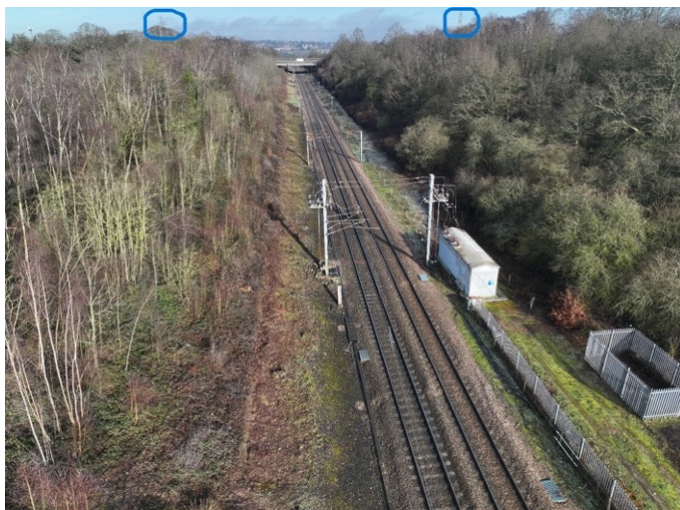
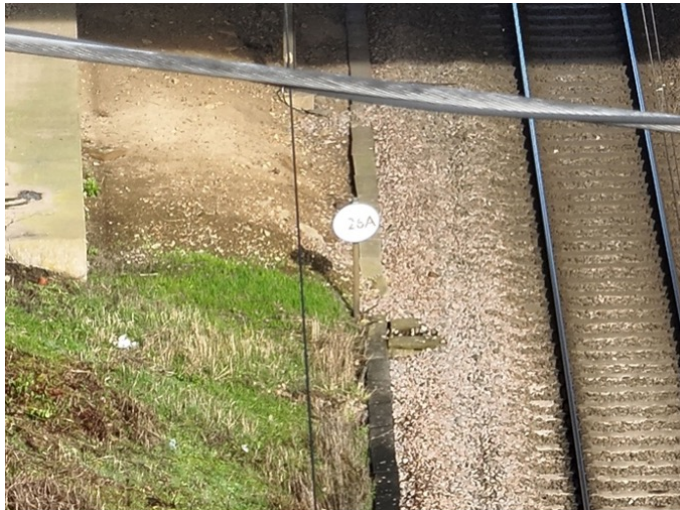
Performing Beyond Visual Line of Sight (BVLOS) flights with visual mitigation (observers positioned out along the flightline who are in touch with each other and the pilot) for the purpose of data capture, we flew through cabling between two pylons a total of 4 times and only noticed they were there when looking at the photographs after the flights. The pylons were obscured from the TOAL site because we were in a cutting. We had previously flown an adjoining section of the same infrastructure in the opposite direction and the pylons at the end point of the two sections were obscured from the TOAL at both ends of each section, even if the aircraft always remained VLOS. The electricity cables were across the infrastructure rather than parallel with it. This meant they were much more difficult to see. The first photo I attach is a general view from aircraft. The pilots were located on the right-hand side, away from the track. There was little visibility of the cables that were across the track and the pylons were obscured from view. The previous flight was flown towards

the road bridge, from the far end. The cables were between 30 and 45m high and crossed over this side of the road bridge. The second photo is an approximately 11X zoomed picture looking under the road bridge.

Lessons learned: When checking for electric cables, it is not sufficient to just look for pylons alone. Electric cables are difficult to see and the site inspection should include the start and end point.

The end point of two flights that meet in the middle but are flown in opposite directions, may inadvertently end up not being subject to on-site visual inspection by the pilot. Pylon cables are difficult to see with the naked eye, particularly if they are at some distance. This report shows how easy it is to mistakenly fly through unseen wires when the pilots are concentrating on the output, rather than the flights. This occurrence is all about the lack of real pre-flight planning. Closer attention to relevant Apps that supply all the information for low-level flying is essential and a focus on the detail as well as ensuring the relevant layers are switched on, would have avoided this situation.
