Leading by example

Adam Parnell
Director (Maritime)

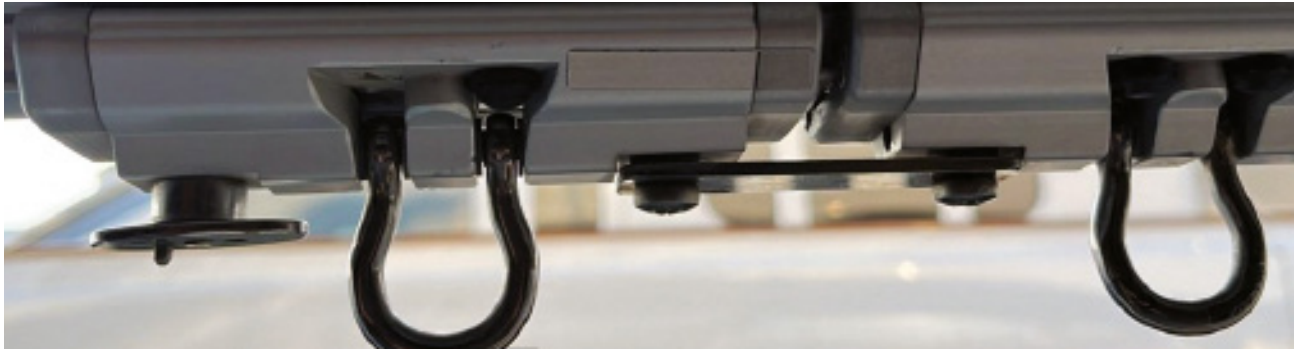
A typical rail arrangement – not the one in the report.

As they traversed the rail track from forward to aft, a gap in the track system caused the safety line to detach from the rail, and the reporter fell into the water as the carabiner slipped off the end of the track.

The carabiner rail to which the line from the harness was attached must be inspected and form part of regular maintenance inspections. The gap in the track system would be apparent to see if it was properly inspected. Inspections of the carabiner rail must form part of regular maintenance checks. In this case, the rail should have been taken out of service until it was repaired.

CHIRP highlights the design of these frequently used safety rails, which require extensive maintenance due to their many moving parts. Retrofitted rail connections may not be as strongly connected to the superstructure as those fitted at the new building stage. CHIRP recommends that the class attend to advise on superstructure connections for retrofitted rails.
