Building a culture of continuous learning

Key Human Factors lessons from recent reports

I Learnt About Human Factors From That

To cap it all...

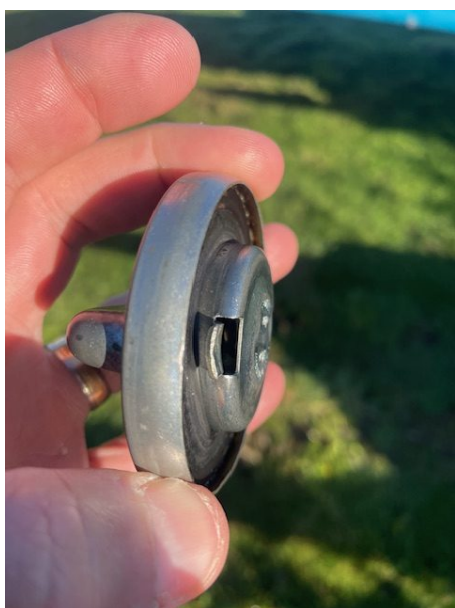
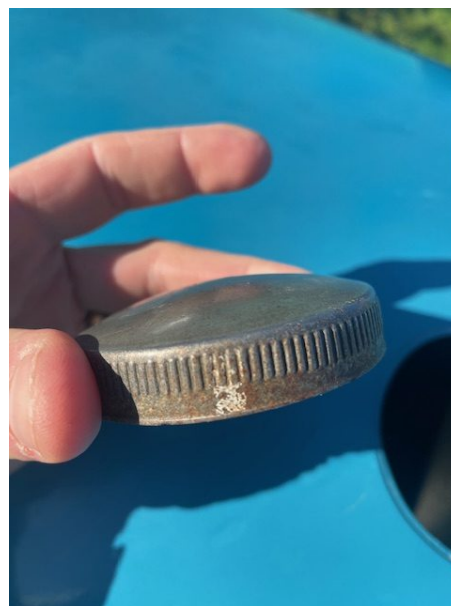
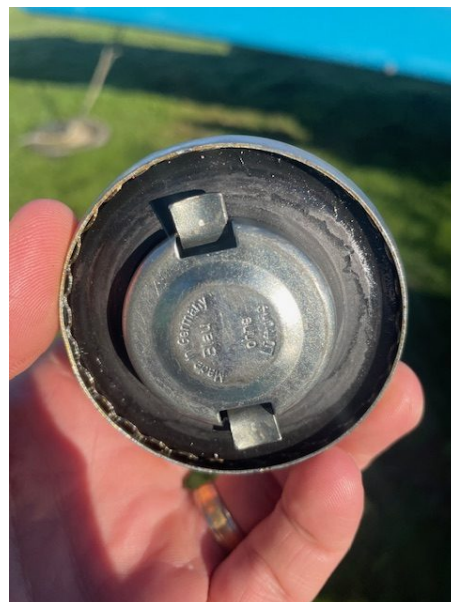
On removal of the engine cowling came the proof: somehow, someone had managed to replace the oil filler cap with the vented fuel filler cap...and placed the (unvented) oil filler cap onto the fuel tank. In plain sight, it was so obvious: the oil filler cap has a symbol of an oil can on it. But it looks, feels and FITS exactly as the fuel tank filler cap does.

Not only did it catch us out, but further investigation – including going back through old photos – suggested it had been like that for over 8 previous hours of flight.

Had this not been picked up, any of our members might have experienced fuel starvation and an undesirable flight outcome, particularly had their flights been slightly longer and more fuel consumed.

First, the importance of conducting pre-flight checks sequentially. We cannot establish how it came to be that the oil filler cap AND the fuel filler cap were both off the aircraft at the same time. Had the fuel levels been checked and the cap replaced BEFORE moving on to check the oil, the first hole of the Swiss cheese wouldn't have existed.

Second, it's useful – albeit very difficult (as an 'unknown unknown') to pre-identify and highlight components that might be subject to confusion or mix-up. I would think it's highly unlikely that two components of an aircraft would be capable of fitting so perfectly in different locations – it is both a questionable design feature as well as a stroke of poor luck that both the oil filler cap and fuel filler cap are of identical dimensions. Then again, perhaps it is more common than we thought? It would be a useful exercise to query whether the same mix-up is possible in other aircraft types.

Third, it's amazing just how much confirmation bias came into the equation here. Even though we were looking directly at the oil filler cap, 5 different pilots failed to notice that it was the wrong cap. It is very easy with the benefit of hindsight to say that 'it has an oil can symbol on it', but it's quite faded, not very noticeable, and easily overlooked when you're focussing more on the underside of the cap to check it's the venting type. How many people lift off the oil filler cap without looking at it also?

Fourth, it would be prudent to improve the marking or labelling of the filler caps. One option in our case might have been to have a fuel filler cap of the same colour as the fuselage, which would then have looked completely incongruous against the oil reservoir had it been put there.

During in-depth hangar maintenance there are a number of reasons where both the oil and fuel caps might be off at the same time if both systems are being worked on for some reason, but careful storage and labelling of disassembled parts is one way of preventing mix-ups. There's little reason for both to be off during routine line-maintenance or replenishment tasks, but it's easy to see how it might happen if people are trying to be organised in preparing the aircraft for top-ups. The idea of differing the colour of the 2 caps is a good one because that means that the caps are not being physically altered but can easily be differentiated from

each other – yellow for oil caps is a fairly common colour, and that would stand out if placed on the fuel filler pipe. Another option, if feasible, is to have one or both caps attached to their respective filler pipes by a suitable chain or lanyard of some description so that they can't be moved away from their intended location. Many such caps are secured this way, so perhaps there's scope for looking at doing that on at least one of the caps if appropriate, or fixing/replacing an existing chain if there's one intended to be there that's broken or missing.
