Welcome to Drone FEEDBACK Edition 12.

Report No1 - DUAS xx21 – Loss of control following geofence breach

Report No2 - DUAS xx22 – Ageing batteries and what to look out for

Report No3 - DUAS 0032 – NOTAMs and whether they get read

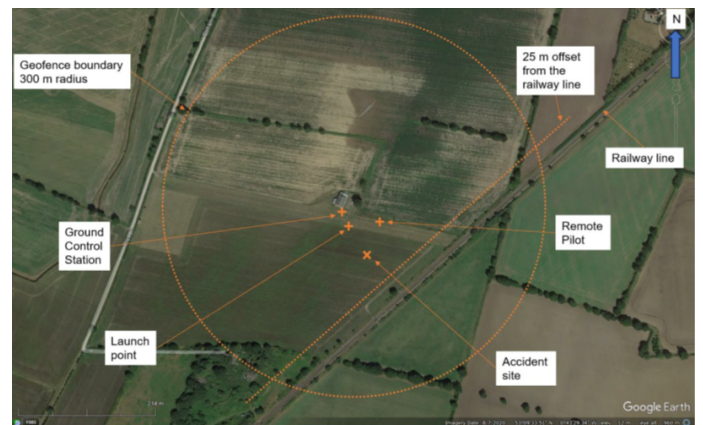
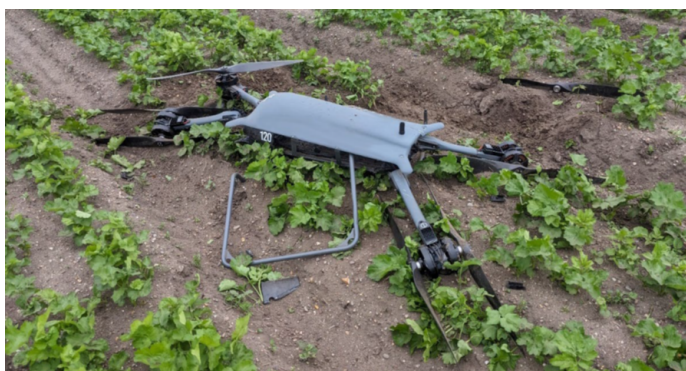
The Remote Pilot (RP) was undertaking a skills currency flight using a Malloy Aeronautics T150 unmanned aircraft and was assisted by a Ground Control Station (GCS) operator. The RP and GCS operator were in two-way communication via radio. The RP was flying circuits in Stabilised flight mode (stab mode) at a training ground. It is a remote site on farmland used by the organisation he was contracted to fly with, as an R&D and training pilot. The geofence for the flight was 40m high by 300m radius with the centre on the take-off point (see picture). The dimensions of the geofence were not considered by the RP and GCS operator prior to the flight but accepted as a standard training envelope.

The GCS operator noticed the aircraft was approaching the upper limit of the flight geography zone within the geofence and he informed the RP using terminology not immediately understood by the RP. The RP was aware that the aircraft was turning to the right and climbing quicker than he had expected. Shortly afterwards the aircraft breached the upper limit of the geofence and reverted to an automated Return to Launch (RTL) flight mode. The RTL automation initially commanded the aircraft to climb, which the RP instinctively counteracted by reducing the throttle. The GCS operator informed him that RTL mode was engaged, and the RP changed the flight mode, by

The aircraft diverged from level flight and was seen to follow an erratic flight path unfamiliar to the RP, during which it achieved a maximum pitch of -41° and -60.9° of roll. To regain control the RP increased the throttle to 100%, which caused the aircraft to overcorrect, and it then pitched to 85.3° with 60° of roll before descending rapidly from a height of 37 m. The RP realised he could not regain control and switched to an automated mode (loiter mode) but by this time the aircraft was heading towards the RP's ground position, and he decided to close the throttle, bringing it to the ground. Twelve seconds had passed from the geofence breach before the aircraft struck the ground approximately 50m from the RP's position and within the horizontal boundary of the geofence.

The operator no longer uses the manual mode and has promoted the use of standardised phraseology between the ground control station operator and the remote pilot. Further action has been taken to consider and apply a suitably sized geofence for each operational flight.

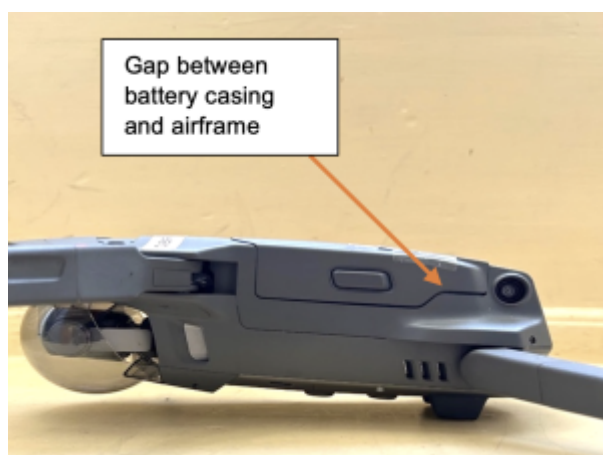
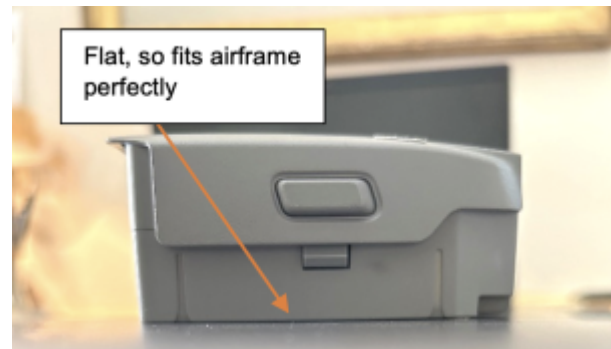
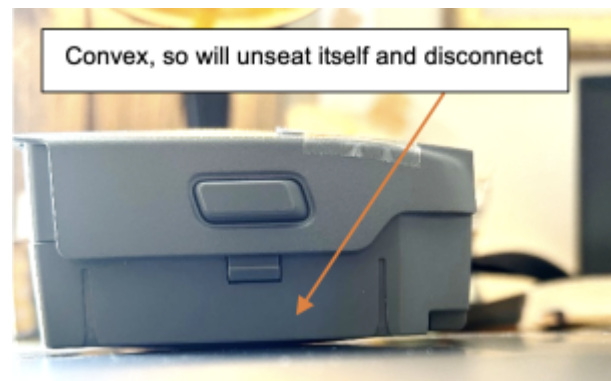
An online search found examples where the same model of battery pack had swelled, and this had compromised the ability of the battery to be securely attached to the UA. An examination of the battery pack after the accident showed that the casing was split, probably as a result of the impact with the ground, but also that there was some evidence of swelling. However, it was not possible to determine whether this swelling was present

prior to the accident. If a battery was swollen and had a curved underside surface, this can impede or prevent secure retention of the battery by the latching mechanism.

Below is a photo of what we think happened. Which from looking down on the drone or at night could be missed if rushed.’

This message to its pilots was accompanied by an instruction to report any battery issues to the appropriate person to arrange replacement. The 3 pictures show: the battery not properly secured, but with button positions that could indicate it was if viewed from above; a normal battery with a flat underside; and a battery with evident swelling.

Please be reminded that with any drone, prior to flight, the battery is checked, and you confirm this with a confidence test. (Push pull) and that you photograph or BWV [Body Worn Video] the completed build. Not only from the top but of any locking part and the side view. This should be completed each time you change a battery. NB – Although the locking buttons on the side of the battery should be protruding to indicate locked, as per the photos below if the battery is not sitting flush then even though the buttons are protruding, the battery is not secure.

For those operators who work extensively at night when lighting of the site could be limited, a 3D printed frame that can be passed over the battery to check its shape is perhaps a useful

way of verifying whether there is any swelling, and this could be introduced into the pre-flight checks sequence.
