# Building a Safe and Inclusive Superyacht Sector

## A 'bitt' of a hazard!

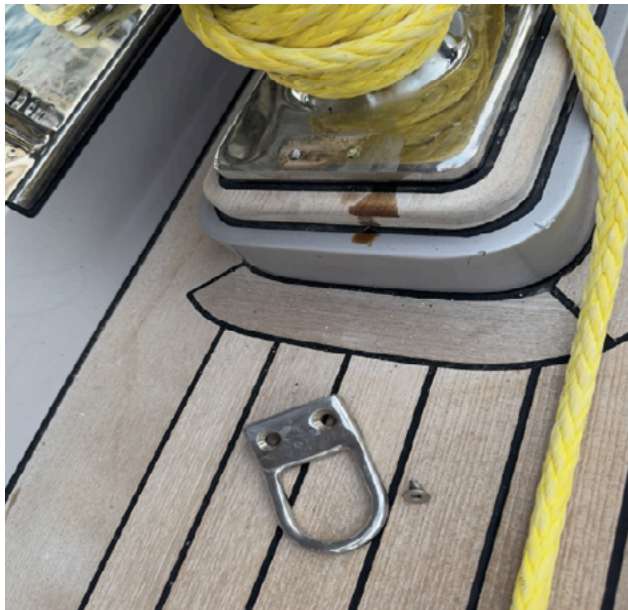
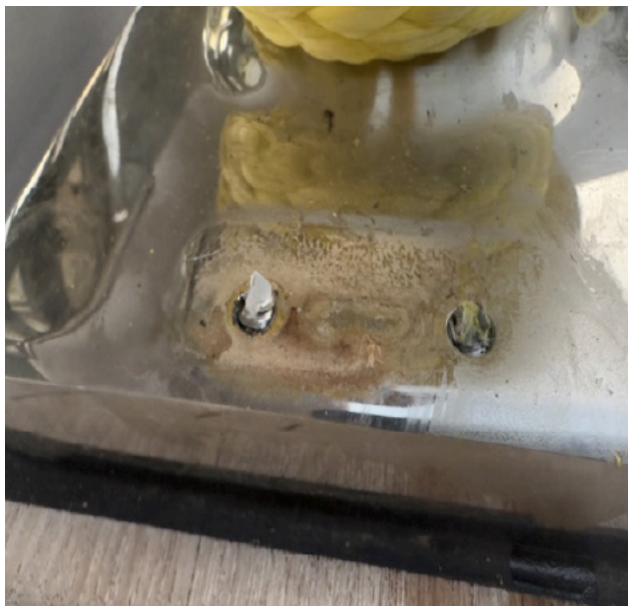
M2293

The mooring bitts pictured below had a D-ring attached to them, which was used as the strong point for connecting a rope stopper. When the weight of the mooring line came onto the stopper, the D-ring's connecting screws sheared off, and the D-ring was fired into the air towards the mooring party. Luckily, no one was injured.

Stoppers – and whatever they are connected to – must be capable of supporting the loads transmitted through the mooring lines. The small-diameter screws connecting this D-ring to the bitts were entirely inadequate for this task. A better arrangement would be to attach the standing end of the stopper around the bitt or a nearby cleat.

**Design** – If your super yacht has a similar design, ask the manufacturers to confirm its safe working load (SWL).

**Local Practices** – Any equipment designed to take a load should be documented in the vessel's SMS and inspected/tested as appropriate.

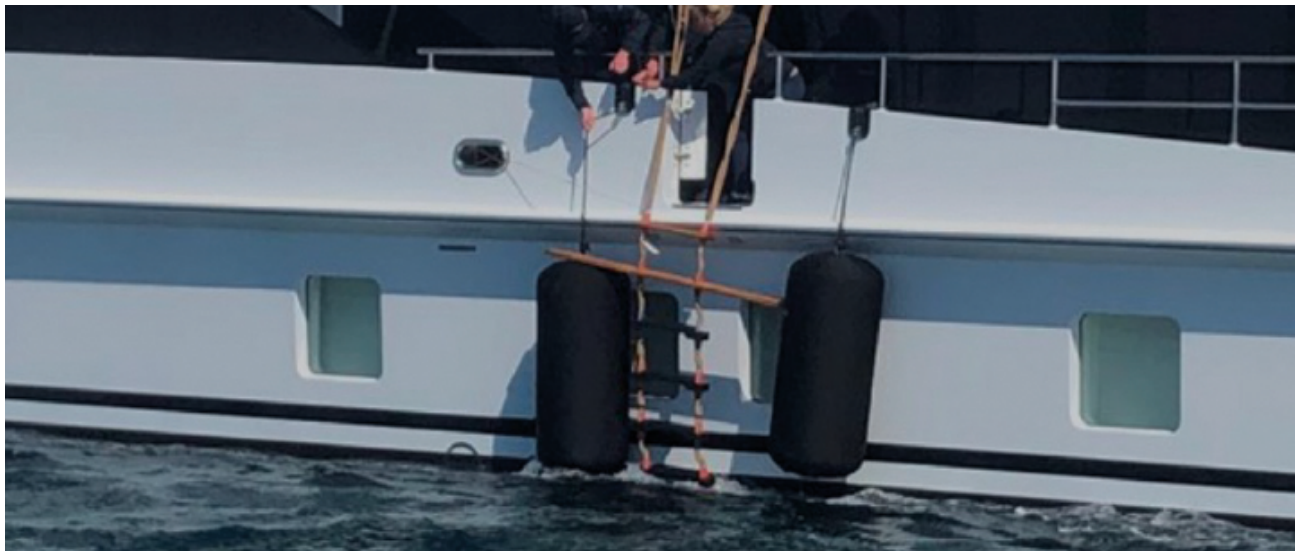
A pilot informed CHIRP that during embarkation onto a super yacht, the pilot ladder rungs were not horizontal, and the ladder was not shackled to the deck. There were no fixed stanchions, and oversized fenders obstructed the ladder. There was no cut-out in the deck-level belting, so the ladder hung away from the ship's side.

The overhanging superstructure makes it impossible to meet SOLAS regulations for boarding arrangements, which require the ladder and spreader bar to rest firmly against the hull. This is a fundamental design flaw. Note that boarding arrangements have to be SOLAS compliant irrespective of whether or not the vessel itself has to be SOLAS compliant.

In consultation with pilots, CHIRP has suggested that the following guidance be provided for all visiting super yachts to ensure compliance with the pilot transfer arrangements (PTA) regulations.

- Specific super yacht pilot ladder guidance will be issued to visiting yachts during their visits.
- Specific super yacht pilot ladder guidance is to be issued to pilots.
- Vessels that do not comply with the requirements must receive a letter stating that they must rectify this before their next call.
- The Harbour Master is to be contacted when booking vessels for their next visit for early engagement to ensure that past issues have been rectified.

**Local practices** – Check that your boarding arrangements comply with the regulations – use the poster referred to above for guidance.

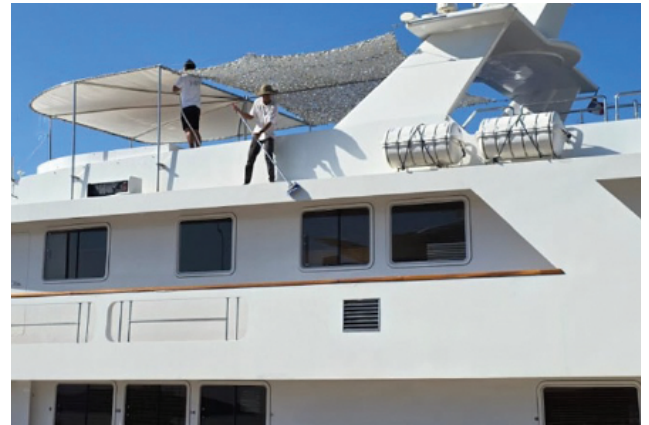
This photograph, taken from a nearby yacht, shows crew members working aloft without visible fall arrest equipment (e.g., harness, safety line) or other PPE.

The regularity of the photos submitted to CHIRP - often several each month - suggests that such behaviour is normalised across the industry. At best, it demonstrates that many vessels do not adequately supervise their crews, and at worst, it suggests that, on some vessels at least, such behaviour is actively condoned to save time. In reality, donning a safety harness is much swifter than dealing with a severe medical emergency following a fall from a height.
