Safety takes time: Do we give ships enough time to stay safe?

CHIRP

Confidential Human Factors Incident Reporting Programme

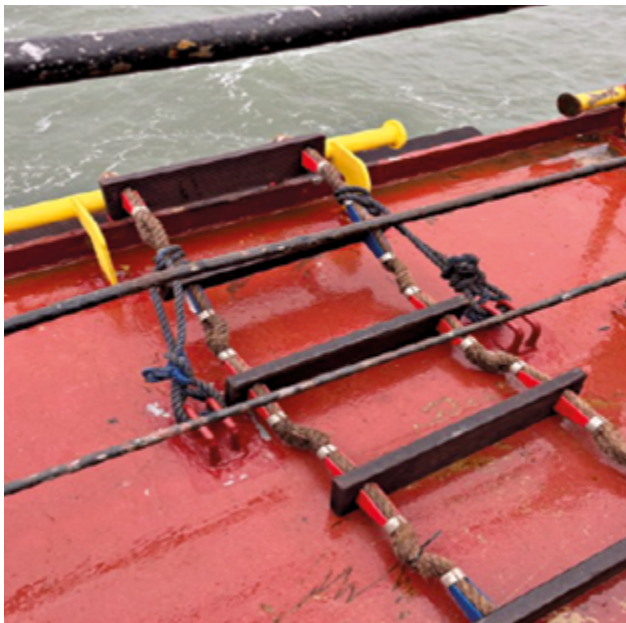
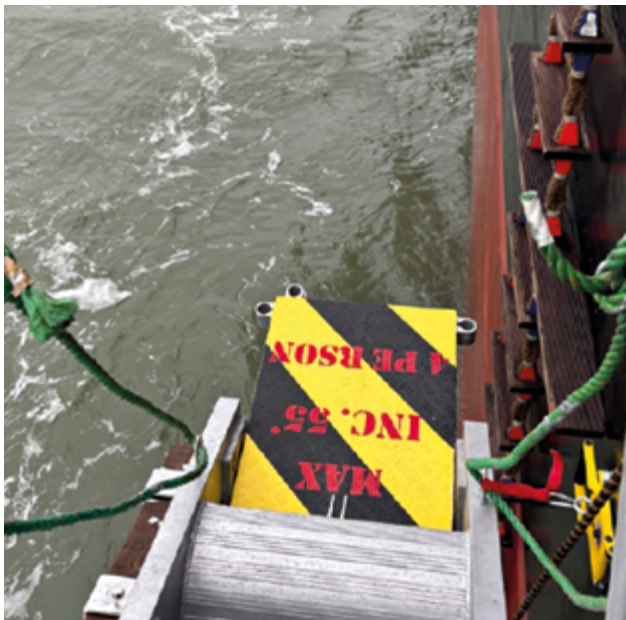
M2354

Non-compliant pilot ladder

Our reporter sent pictures of a pilot ladder that did not meet SOLAS regulations. No handholds were securely fastened to the ship's bulwarks, preventing the pilot from stepping safely and comfortably from the top of the ladder onto the ship's deck. The accommodation ladder platform did not have stanchions, and the ropework and securing hitches were substandard. The pilot ladder was not correctly secured at deck level.

This was reported to the master when the pilot boarded the vessel. The master was informed about the proper securing of the combination rig and has given assurances that corrective action will be taken. Port state authorities were alerted to this incident.

The quickest way to motivate the industry to address this common issue properly is to refuse to board. This also ensures pilots' safety. Do not take chances – there is no such thing as a 'safe' non-compliant ladder.

CHIRP calls on Flag States to mandate that ladder rigging be supervised by a ship's officer and that this activity be included within the Permit to Work system because of the potential risk to life.

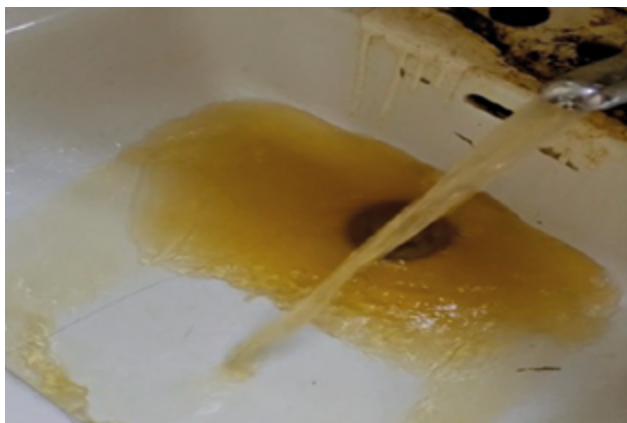
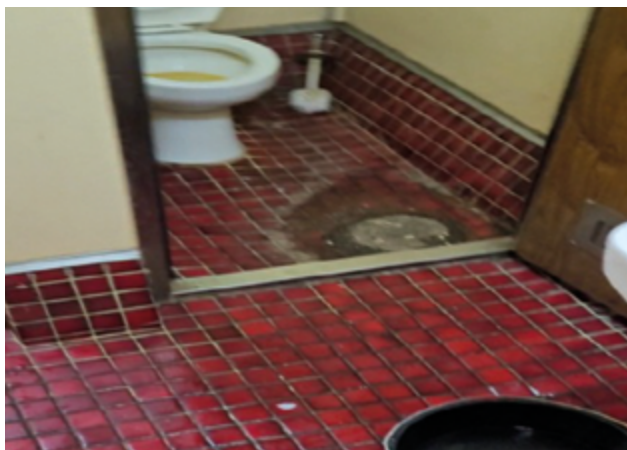
M2317

Unacceptable living conditions

During a recent deployment, a temporarily embarked armed security guard reported that the ship's material condition and living conditions were deplorable. The potable drinking water system was inoperative, and the crew relied on outdated bottled water. The water used for showering, brushing teeth, and laundering clothes was rusty. There was no air conditioning, and the toilet system was broken. Additionally, the living quarters were unhygienic, and the crew experienced numerous bed bug bites all over their bodies.

Food was also unsatisfactory: meals were monotonous, with limited meat or fish options. Fruit was rarely available and tasted of rust.

The armed guard is to be praised for raising this report because the crew were too afraid of reprisals to do so themselves. This raises worrying questions about the company's safety culture. Many seafarers are unaware of their rights, set out in the [Maritime Labour Convention](#), regulation 3.1 (page 43). The vessel in this report is breaching many of these legal requirements. CHIRP contacted the vessel's Flag State, which has a legal obligation to ensure that the vessel addresses these shortcomings immediately.

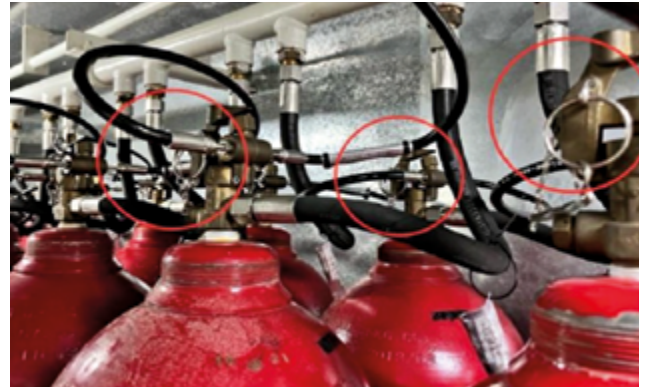
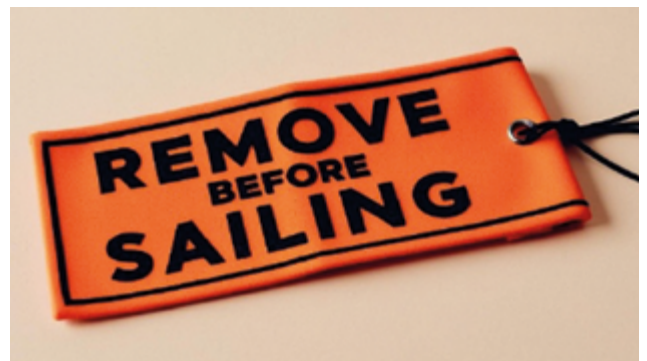
M2311

Near miss: poor configuration of CO₂ firefighting system

Following a period of maintenance, a pre-sailing inspection revealed that the safety pins which prevented the CO₂ firefighting system from operating were still in place. A contractor had inserted the safety pins to prevent accidental discharge while maintaining the system but had not removed them once the work was completed.

Had these remained in place, the system could not have been used in the event of an engine room fire.

The design of the pins is a contributing factor: they are a similar colour to other nearby items and CHIRP suggests that if they had been painted, or had a label like the 'Remove before Flying' tags used in the aviation industry, it would have been much easier to identify that the pins had not been removed.

There is always a pressure to get vessels out of dock and back to operational service as quickly as possible. However, similar to report M2319 (Fire on large motor yacht), this pressure resulted in several important steps being missed. Whenever equipment is handed over to or from a contractor, it is best practice that a suitably qualified crewmember and the contractor jointly inspect the equipment so that both agree on its material condition and out-of-service status and operational readiness configuration at the start and end of a job.

Communications – 'Remove before sailing' tags are useful to help crew and contractors identify the state of the system.
