## A selection of HF occurrences

Welcome to Drone FEEDBACK Edition 13.

### Report No1 - DUAS xx23 – Software Coding?

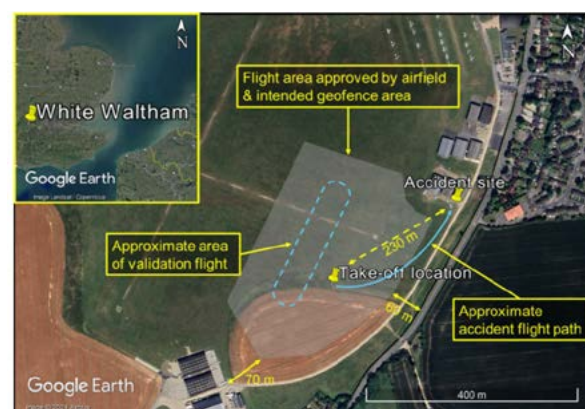
After being powered on, the UA was unable to acquire a GNSS signal, preventing a geofence, which mirrored the white area shown in Figure 1, from being applied. The RP decided to proceed with the flight on the basis that several means to activate the Flight Termination System (FTS) were available in case of an emergency. The team launched the UA and completed a short flight which validated the stabilised, alt hold and loiter flight modes. The UA was then repositioned. The RP launched the UA and, when he selected the auto mode, the UA climbed and veered left.

The RP was reported to have shouted "kill, kill, kill" and attempted to activate the FTS from his controller, which was not successful. The RP then used the backup controller to activate the FTS, which was successful. The RP and CUO then lost sight of the UA as it descended to the ground, with the CUO and CO both hearing 'an impact with what they assumed to be one of the unoccupied GA aircraft parked outside a nearby hangar'.

Figure 1 White Waltham Airfield and designated UA area

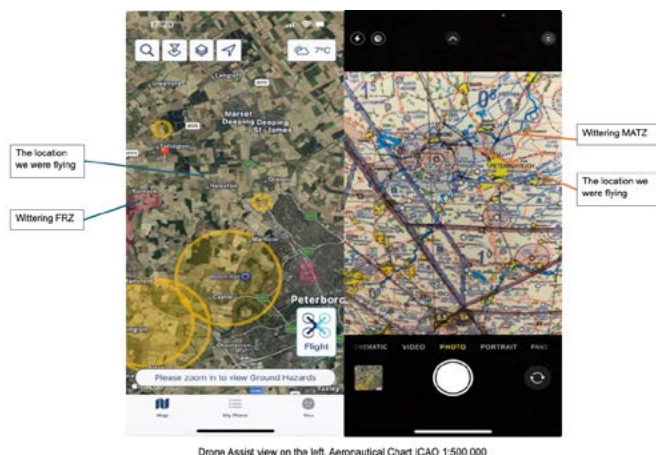
Whilst planning a mission over linear assets, Drone Assist was used to ensure the flight went near but not through the Wittering FRZ. However, the FRZ that is marked is much smaller than the MATZ, which is not marked. We flew through the MATZ without realising or co-ordinating with Wittering. Have we made a (Human) error?

Drone Assist view on the left, Aeronautical Chart ICAO 1:500,000

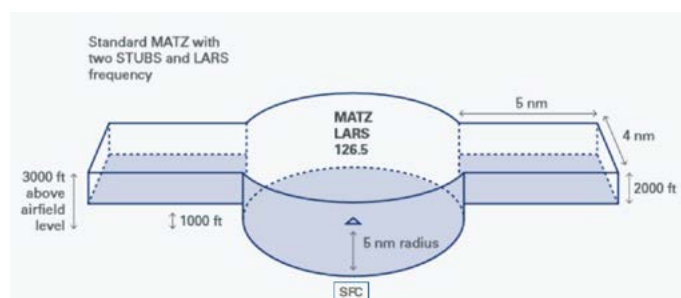
- Looking at the diagram below it is to be noted that the 5nm radius cylindrical part of the MATZ starts at surface level and goes up to 3,000ft. The stubs of the MATZ start at 1,000ft and go up to 3,000ft. So, depending on exactly where the reporter's flight took place, they may not in fact have flown through the MATZ itself, if their flight was within the standard Drone height limit of 400ft. and was in one of the stub areas.

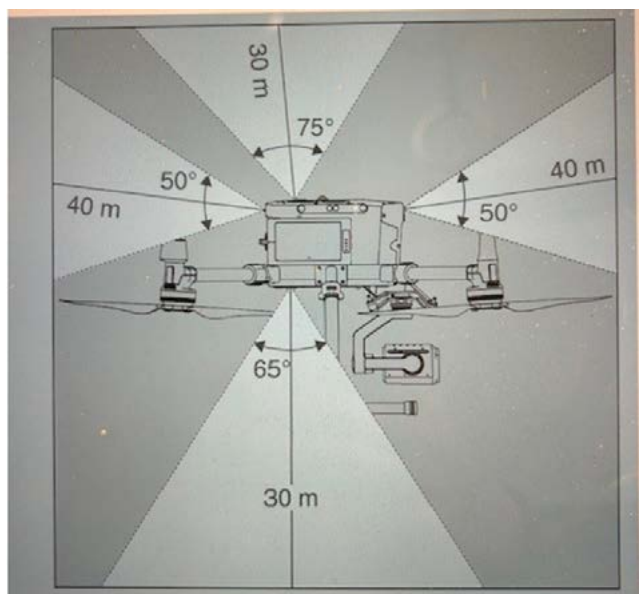
- We believe the root cause of this occurrence was the downward looking obstacle sensors being switched on. We understand that some versions of the DJI M300 automatically switches them on below 5m and automatically switches them off above 5m. If the aircraft was hovering only 1m above water, the problem was created by a combination of the barometric pressure-based altitude reading saying one thing and the Infrared Sensing System altitude reading saying something different. Water has very low reflectivity and in addition, if there is any wave movement, what is reflected gives a false readout.
- The DJI M300 User's manual makes it very clear that the downward looking vision system will not function properly when over water.

DJI M 300 RTK User Manual, Vision Systems detection range
