## Drugs, Design and Dry-docks!

## Fire on a large motor yacht at the end of dry-dock

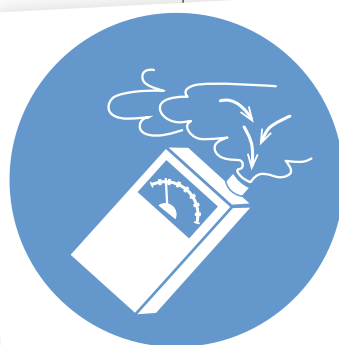
Use gas detector

CHIRP urges vessel operators and regulators to ensure all enclosed spaces are appropriately identified, marked, and documented, with gas detection equipment readily available and crews trained in its correct use. Ignoring this issue puts lives at risk, and action must be taken to close this safety gap.
