Built to Break?

Design decisions shape safety outcomes at sea

M2494

Unacceptable design for pilot boarding and crew attendance

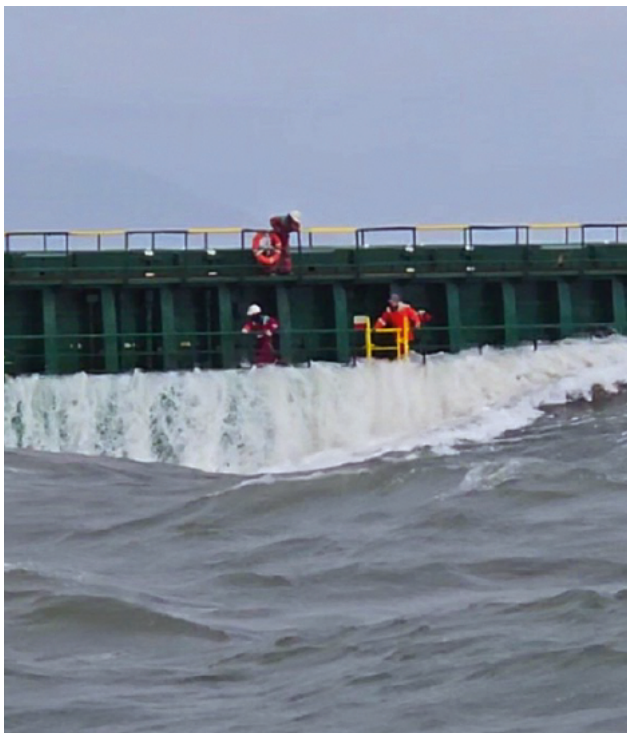
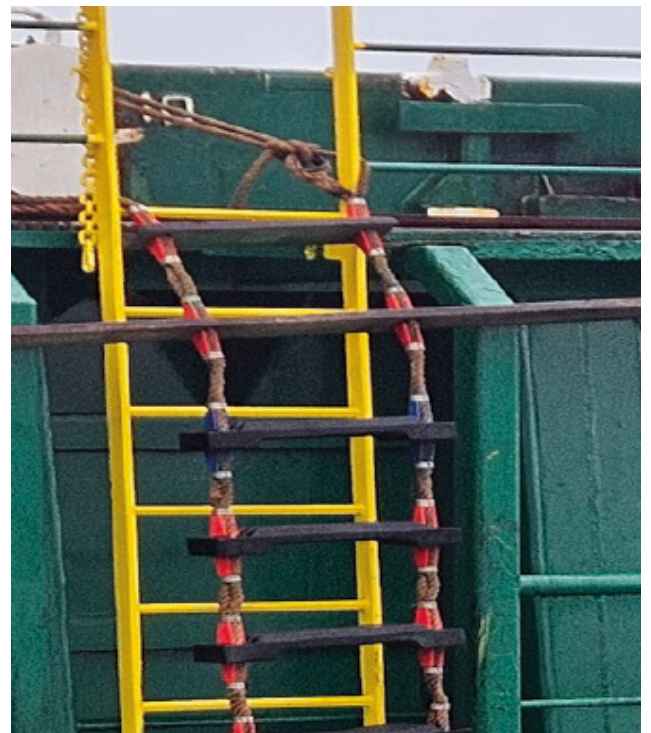
First Attempt – Boarding aborted – The crew was observed standing on the hatch cover above a fixed yellow metal ladder (see attached image), appearing to expect the pilot to board via this structure. No pilot ladder was rigged.

Two crew members were again stationed at the top of the fixed vertical metal steps. This arrangement is non-compliant and places both pilots and crew at unnecessary risk.

The crew attempted to open a gate amidships as an alternative boarding position, but the vessel was shipping seas on deck and clearly unsafe (see image above).

Third Attempt – Boarding completed – Conditions had eased, and the pilot was able to transfer via the lower deck. However, several safety issues were observed with the rigged pilot ladder (see image above):

The ladder was not resting against the ship's hull.

It was secured to the handrail, not to strong points on deck.

There was an obstruction at the top – the ladder rope did not sit flush with the deck, creating a tripping and entanglement hazard.

If the lower deck is the only viable transfer point, this must be clearly stated in the vessel's pilot card and agreed in advance. It is not helpful to inform the pilot when they are on the bridge about the transfer arrangement. This raises the question: do ports have heavy weather boarding procedures in place, with weather and sea state limits established? Only those conditions that fall within the criteria should be allowed for pilot boarding to take place.
