GENERAL MARITIME

Edition MFB 80
Summer 2025

Built to break?

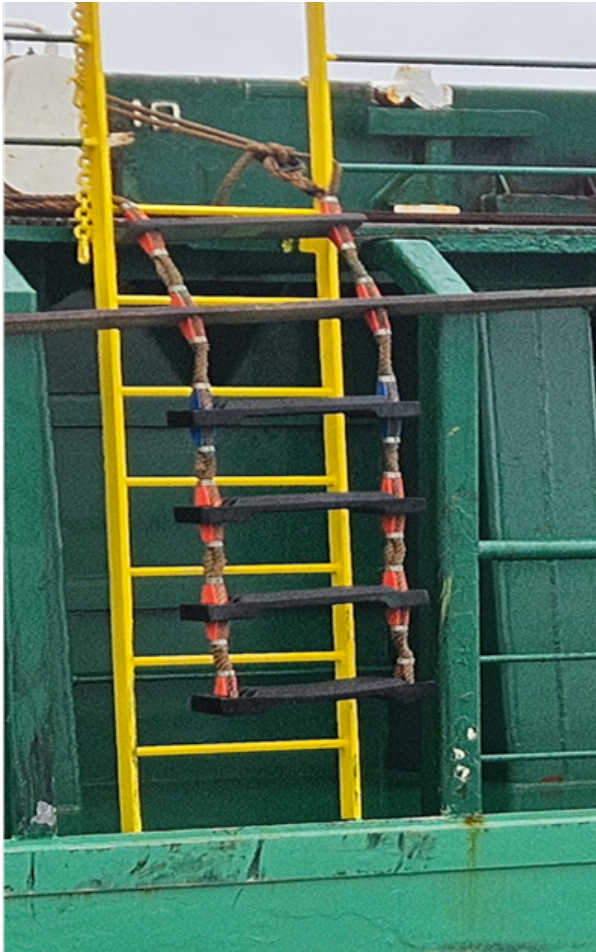
First Attempt – Boarding aborted – The crew was observed standing on the hatch cover above a fixed yellow metal ladder (see attached image), appearing to expect the pilot to board via this structure. No pilot ladder was rigged. The pilotage act was aborted due to the absence of a compliant ladder. The Master was informed, and a second attempt was planned for the following morning.

directed to board near the accommodation area at the vessel's stern, at the lower deck level. However, this area was repeatedly overtopped by swell, making it unsafe for transfer. Two crew members were again stationed at the top of the fixed vertical metal steps. This arrangement is non-compliant and places both pilots and crew at unnecessary risk. The crew attempted to open a gate amidships as an alternative boarding position, but the vessel was shipping seas on deck and clearly unsafe (see image above).

However, several safety issues were observed with the rigged pilot ladder: the ladder was not resting against the ship's hull, it was secured to the handrail, not to strong points on deck, and

there was an obstruction at the top – the ladder rope did not sit flush with the deck, creating a tripping and entanglement hazard."

Although the third attempt succeeded in calmer weather, the pilot ladder rigged was still unsafe, with poor securing, gaps between the ladder and hull, and obstructions at the top. This raises serious concerns. Improvised boarding methods, however well-intentioned, expose pilots and crew to unacceptable risk. SOLAS and IMO regulations are not optional; they are the minimum standard.

If the lower deck is the only viable transfer point, this must be clearly stated in the vessel's pilot card and agreed in advance. It is not helpful to inform the pilot when they are on the bridge about the transfer arrangement. This raises the question: do ports have heavy weather boarding procedures in place, with weather and sea state limits established? Only those conditions that fall within the criteria should be allowed for pilot boarding to take place.
