Short Notice Temporary Danger Areas “TDA’s”

Welcome to Drone FEEDBACK Edition 15.

Report No4 - DUAS XX30 – AAIB Bulletin: 10/2025 PW Orca AAIB-30757

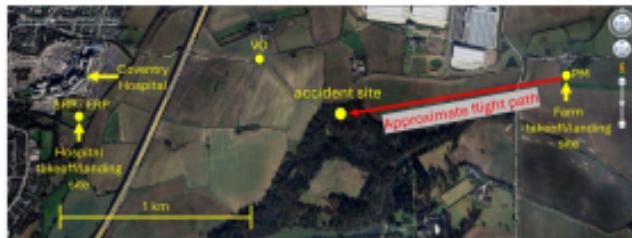
Figure 1
Relative position of takeoff, landing and accident sites
© 2025 Google, Image © 2025 Airbus

Several flights were being flown a total distance of about 1.5nm between a farm and a field adjacent to Coventry Hospital (Figure 1). These were being performed in preparation for a BVLOS VM demonstration flight.

The flight crew consisted of a Remote Pilot (RP), Safety Remote Pilot (SRP), Pad Manager (PM), Visual Observer (VO)¹ and an Emergency Response Team (ERP). The PM was located at the farm site and had a handheld controller that allowed the aircraft to take off and land. The SRP was at the hospital landing site and had a remote controller that provided the ability to take manual flight control of the aircraft, arm and disarm it and also terminate flight in the event of an emergency (refer to the aircraft information section for further detail). The RP was at the operator's facility some miles away and was using a PC-based ground control station to control the aircraft, with the VO located about midway between the two sites and the ERP collocated with the SRP (Figure 1).

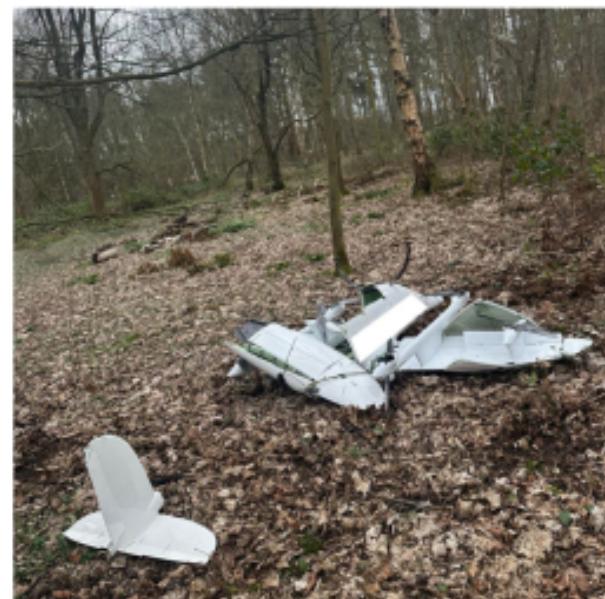
Figure 2
Aircraft wreckage

The aircraft was observed to follow the planned flight profile but as it approached approximately the halfway point the aircraft's motors suddenly stopped. The aircraft initially maintained altitude but subsequently stalled, before descending quickly and striking the ground within a wooded area (Figure 2). No persons were injured and there was no damage to property; the aircraft was damaged beyond repair.

The aircraft struck the ground in a wooded area (Figure 2) which was accessible to the public. Approximately 250m from the accident site was an outdoor activity centre.

When the aircraft took off from the hospital site during the fifth flight, the SRP controller's arm/disarm switch was in the arm position. In accordance with the operator's procedures it should then have been set to the disarm position when the aircraft landed and set back to the arm position prior to take-off. However, the recorded data showed that as the aircraft approached the hospital landing site, and communication with the SRP controller was established, the controller was recorded as being in the disarm position. The SRP reported that he had not moved this switch during the flight. It is therefore most likely that the selection was synchronised correctly with the RP after the aircraft had landed at the farm, but a loss of synchronisation with the RP then occurred, with the selection remaining in the disarm position when the aircraft took off.

The checklist used by the RP and SRP did not include a formal verification (check and challenge) of the arm/disarm switch selection. This increased the possibility that a loss of synchronisation between the two remote pilots was not detected and this risk may have been further increased by conducting several flights in relatively quick succession.

- During pre-flight checks, verifying the settings on each controller are compatible and aligned, is critical to successfully completing flights of this nature.
- If using a controller with toggle switches that can easily be knocked, the settings check should be performed just before taking control.
- There should be a clear verbal check and challenge protocol between the pilots, when handing over control.
- As BVLOS (VM) flights become more frequent, passing control from one pilot and controller to another, positioned further along a linear route, means that the potential for the type of Human Factors error discussed in this report, could become more likely.

- Training for every aspect of controller handover needs to follow a detailed protocol and be practised regularly.
- OEM training on its own may be insufficient and should be supplemented with Operator centric training, based on relevant experience.
- The OEM might want to consider additional non regression testing of the UAS software, to improve the quality of its products. The fact that the parachute could be disarmed at the same time as power was removed from the motors, is a false coding logic that should have been found during quality control.
