CHIRP

An independent and confidential reporting system for the Maritime industry

2025-26

Annual Digest of Reports and Insight Articles 2025-26

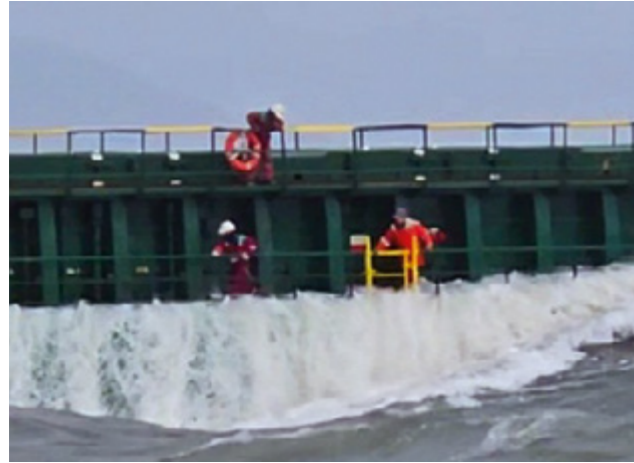
The ladder was not resting against the ship's hull.

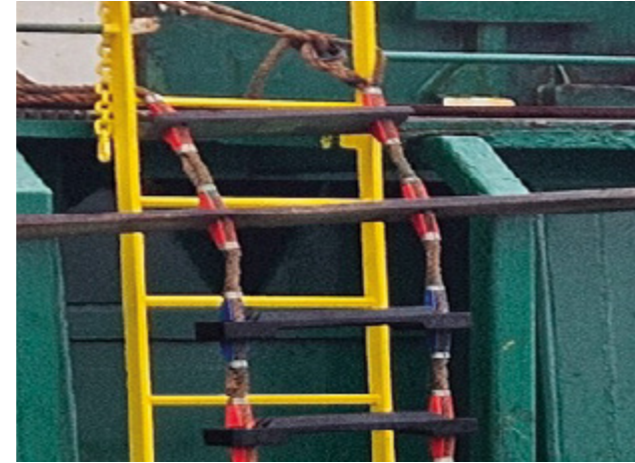
It was secured to the handrail, not to strong points on deck. There was an obstruction at the top – the ladder rope did not sit flush with the deck, creating a tripping and entanglement hazard.

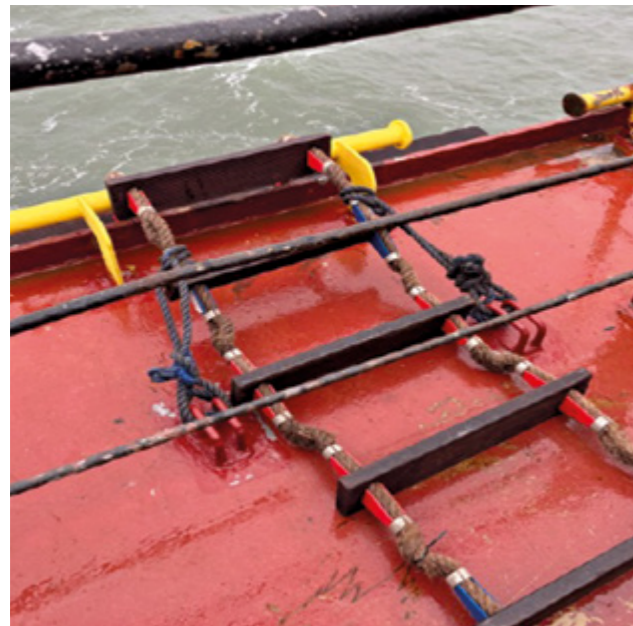
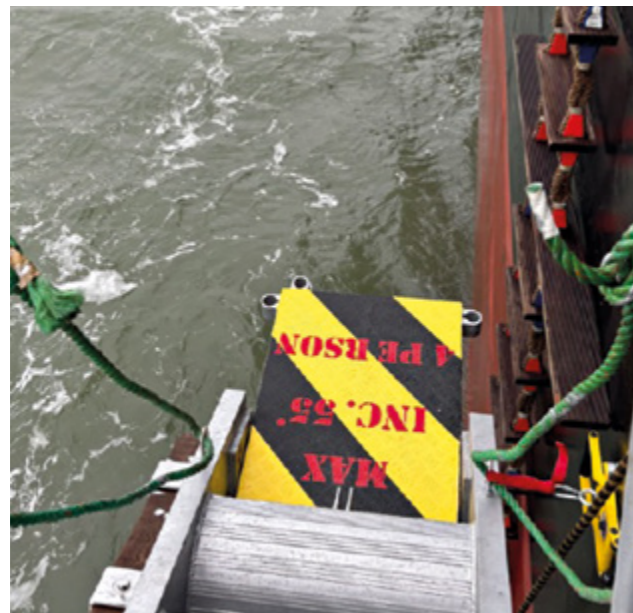
M2354

Non-compliant pilot ladder

This was reported to the master when the pilot boarded the vessel. The master was informed about the proper securing of the combination rig and has given assurances that corrective action will be taken. Port state authorities were alerted to this incident.

The quickest way to motivate the industry to address this common issue properly is to refuse to board. This also ensures pilots' safety. Do not take chances – there is no such thing as a 'safe' non-compliant ladder.
