Automated flight programmes need extra planning

Welcome to Drone FEEDBACK Edition 16.

Report No1 - DUAS 0039 – Pilot Error causes DJI Mini 5 to crash into fine tree branches

Report No4 - DUAS 00XX – AAIB Bulletin: 2/2026 Velos V3 AAIB-30745

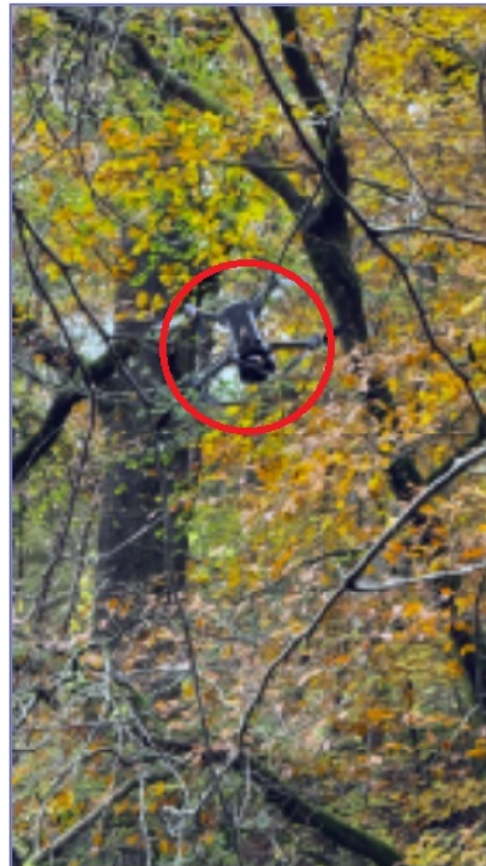
- While conducting the low-level pass, the drone entered an area with multiple fine overhanging branches.
- The pilot briefly focused on the screen to maintain positioning.
- Although most branches were avoided, one fine branch was not detected by the drone's obstacle avoidance system.
- The drone became entangled in the branches above deep water.
- Due to the height, river conditions, and risk to safety, recovery was not possible. The aircraft was deemed unrecoverable and is considered a total loss.

- Weak GPS signal in the gorge.
- Fine branches not detected by obstacle avoidance sensors.
- Pilot over-reliance on obstacle avoidance capability in a high-risk environment.
- Low-altitude proximity to natural obstructions.

The drone is indicated by the red circle in the above image

- When flying in this sort of scenario, it is wise to have tested the Drone proximity detection capabilities beforehand. In doing so you will refresh your sense of the limitations of the aircraft's obstacle avoidance capabilities.

- Although they have evolved substantially, proximity detection systems do have a limit, and very thin branches or wires with a grey background can catch pilots out. In the winter with no leaves on them, they are difficult enough to see with the naked eye. It will of course partly depend on the background.

- Visual Line of Sight (VLOS) should be treated as the primary method for deconfliction. Obstacle Avoidance sensors should serve as a backup method. We wonder whether framing the shot became too much of a focus of attention.

- There is no substitute for a pre-flight site assessment of the route to be flown before deciding to take off. In this instance it is not clear that an assessment was done, which if it had been, may have helped with depth and distance perception and avoiding branches.

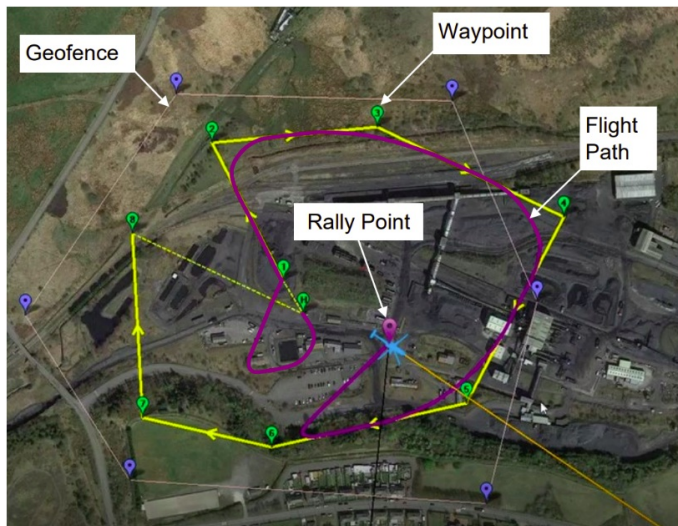
Figure 1 Mission flight overview

The mission for the flight was planned with eight waypoints, overlaid with a geofence that intersected between waypoints 4 and 5. The aim of the mission was to test the UA's response to breaching the geofence and was the first flight with a new ADS-B Mode S transponder fitted. The UA took off and flew to waypoints 1 and 2. Between waypoints 2 and 3, there were two radio failsafe errors, which cleared automatically, and the flight continued. The UA proceeded to waypoints 3, 4 and 5, breaching the geofence (Figure 1).

Multiple data channels between the CU and the aircraft were affected at the same time, which exceeded the normal control parameters commanded by the CU. This resulted in the aircraft being unable to sustain flight. Testing showed that if a loss of connectivity between the radio modem and the flight computer occurred, the last known values would have been held until connectivity was restored. As changes of input value occurred, and the effects were not consistent across all channels, it is likely that the aircraft's systems experienced a level of interference rather than a full loss of connectivity. The aircraft had not suffered from system communication issues prior to the installation and use of the transponder. In the absence of being able to test the aircraft post-accident, it is likely that this was the source of interference.

The UA was subject to interference, which resulted in erroneous inputs to multiple system channels. This left the aircraft unable to sustain flight. It is likely that the interference originated from the UA’s transponder, although the source could not be definitively identified. The Operator’s OA was issued without an assessment of the transponder, missing the opportunity to identify that the transponder’s technical specifications exceeded that required prior to flight.

- The remaining aircraft to be used in the trial will be re-fitted with a different transponder at 20 W output, capable of using either using the 978 or 1090 MHz bands.
- The command-and-control link hardware has been changed to provide a transponder/communications combination with proven capability tested by the equipment manufacturer. Prior to updated regulation and guidance becoming available for use of EC devices on 978 MHz, which is intended to be the standard for UAS, the regulator will continue to advise individual users of EC devices on UAS on a case-by-case basis. Use of 978 MHz is used for EC elsewhere in the world, and its adoption in the UK will increase choice of EC equipment available to operators.

- Using UK Specific Operations Risk Assessment (UK SORA) framework for Specific Category operations, which has a separate Section for EC devices that will assist in providing an additional check point for transponder assessment.
- Updated wording will be incorporated into Section 4.14 of the OA template for 978 MHz devices, including technical compliance specifications.
