DUAS26

Report Title Broken propellor flanges

Initial Report

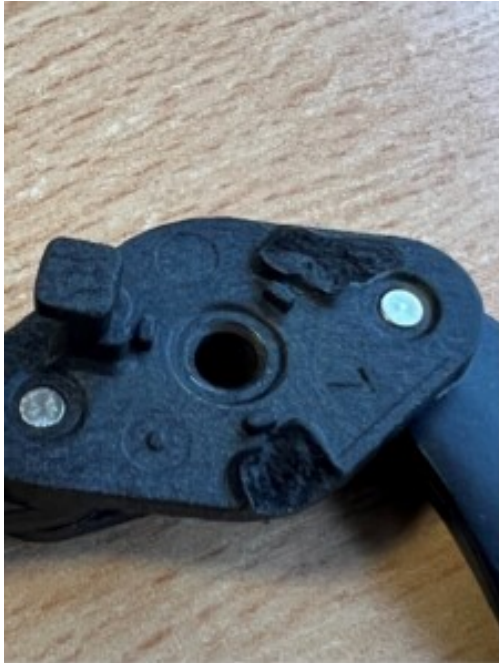
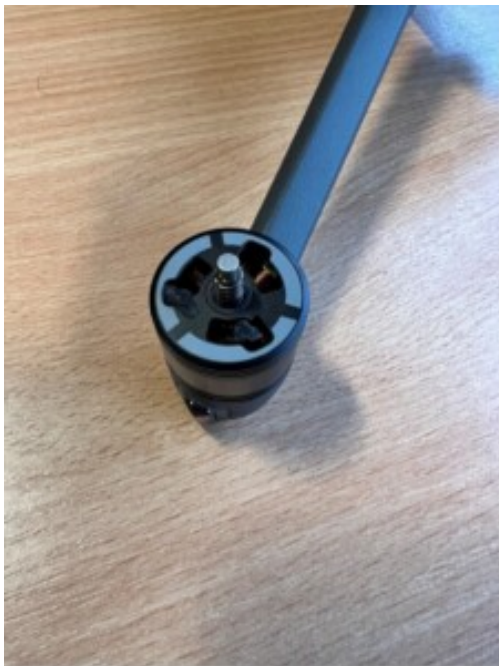
One possible failure mode that was considered after the event was observed is the way that the UAS is unfolded and folded. If Remote Pilots were to continually use the propellor to extend and unfold the arms this could put excessive stress on the propellor hub flanges over a period of time

and eventually weaken the structure to the point of failure.

Below are pictures of the broken propellor flanges and the motor with the two flanges that had broken off stuck in the housing.

This is an excellent example of Human Factors with a positive outcome. The fact that a check was undertaken between flights enabled the issue with one of the propellers to be identified before it caused an accident. The aircraft in question was a DJI Mavic 3. This is in fact a relatively new model from DJI. The DJI Phantom 4 had several issues with its propellers, and it is disappointing to see a possible recurrence of a propellor weakness on the Mavic 3. Whilst this is not necessarily an operator-related HF issue, it is perhaps a manufacturing related HF issue, in quality control. The reporter's suggestion of checking propellers between each flight would be a sensible mitigation, particularly in a world where if one comes off in flight, the ground risk is substantial. After all, a variety of basic checks is very much something that happens between flights in the crewed aviation world. You should always for example check full and free movement of the controls between flights. The reporter interestingly mentions that folding and unfolding the rotor arms by holding the propellers themselves rather than the arms may have been an underlying cause of stress on the flanges. We think that if this was indeed the way the arms were being unfolded, it may well be a root cause of the flanges being sheared off.

Consider adding an interim hardware check after each take-off and landing or each battery change.

Review of Propellor loading and replacement requirement (currently 100 hours).

Inspection of all other propellor hubs.

CHIRP recommends that folding and unfolding propeller arms is always done by pulling the arm itself rather than the propellor blades.
