DUAS28

Report Title Propellor icing

Initial Report

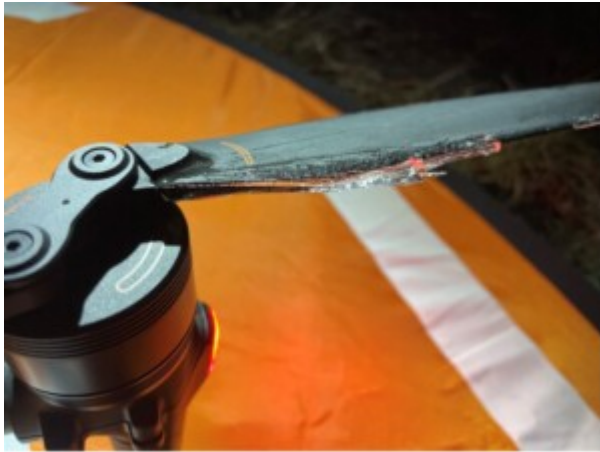
I was on a live deployment. I conducted a short test flight to check for icing on props as the temperature was close to zero. After a short time, I recognised a change to the drone's handling characteristics so landed. On inspection, the drone had icing on propellers (see picture). No further flights were conducted.

A concise report that serves as an excellent example of what to do prior to a deployment, urgent or otherwise, in the winter season. We can only congratulate the pilot for a very sensible approach to safe flying. Looking at the photographs of the propeller, the aircraft would have very quickly lost any available lift if the flight had continued. A point to highlight is that the temperature was "close to zero" without being either zero or minus. It is important to remember that icing can occur at temperatures above zero and, although the nominal freezing point of water is 0°C, water in the atmosphere does not always freeze at that temperature and often exists as a "supercooled" liquid. If the surface temperature of an aircraft structure (such as a propellor) is below zero, then moisture

within the atmosphere may turn to ice as an immediate or secondary consequence of contact in such conditions. Ice may form on propellers just as on any aerofoil. It reduces propeller efficiency and may induce severe vibrations.

It was a reminder of the importance of checking local environmental conditions when flying the drone. A thorough risk assessment led me to conduct a test flight and take extra precautions.
