DUAS30

Report Title Flew through electricity cables

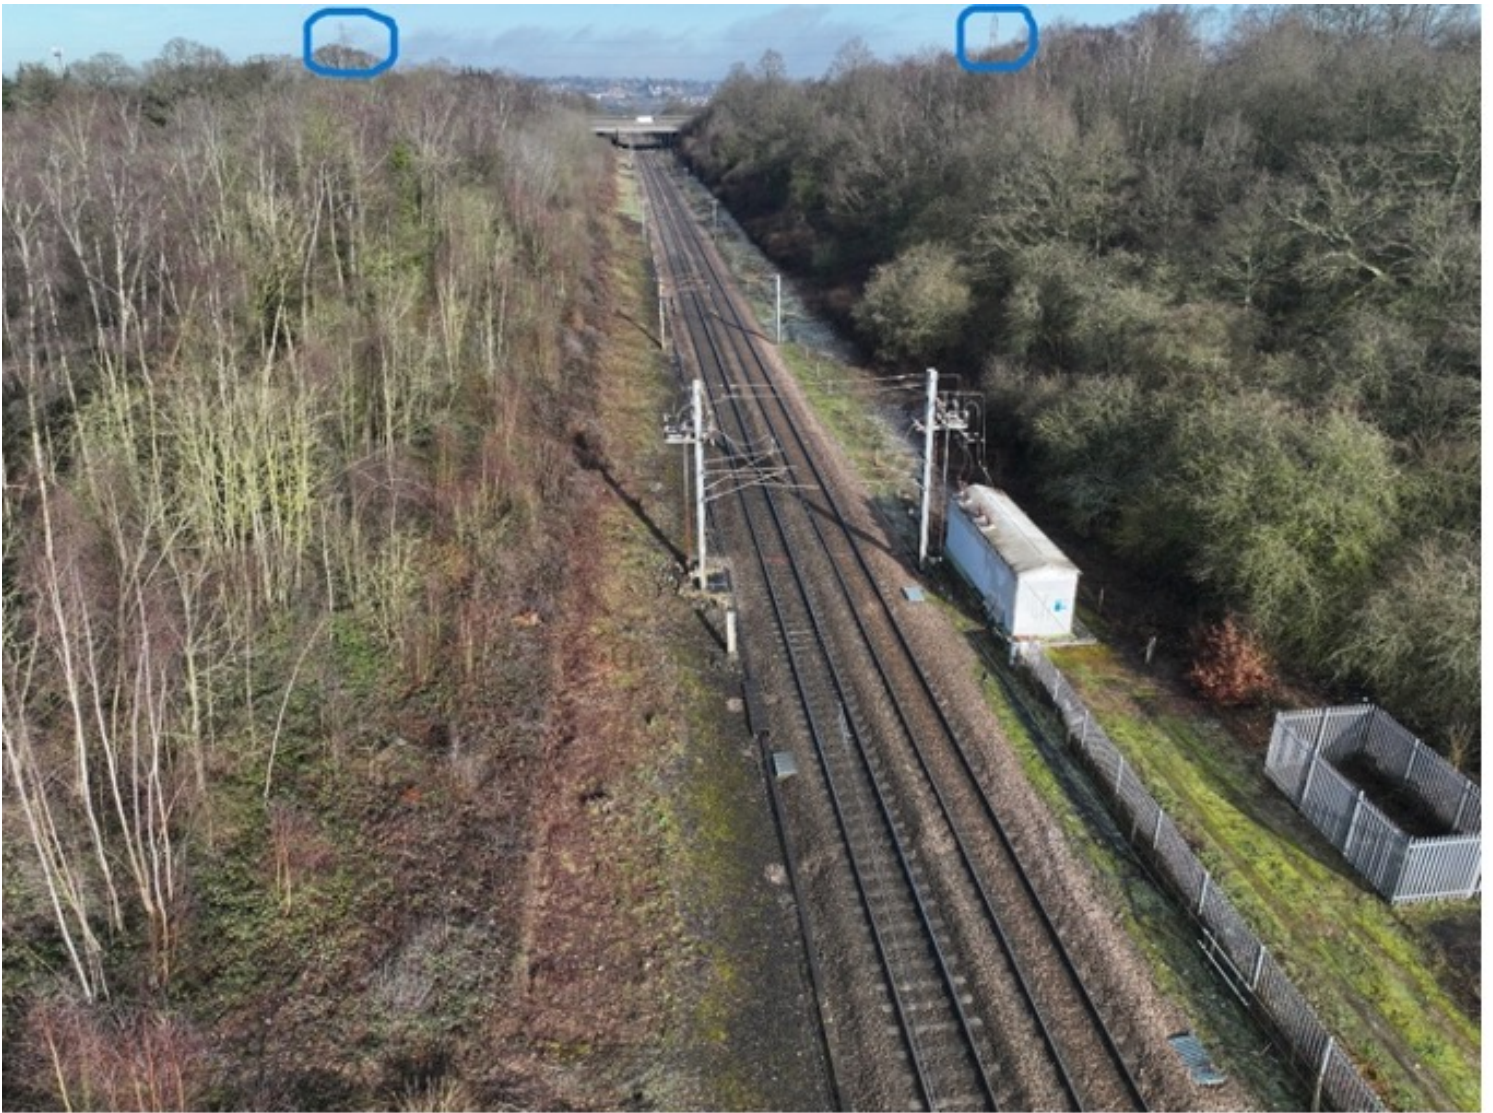
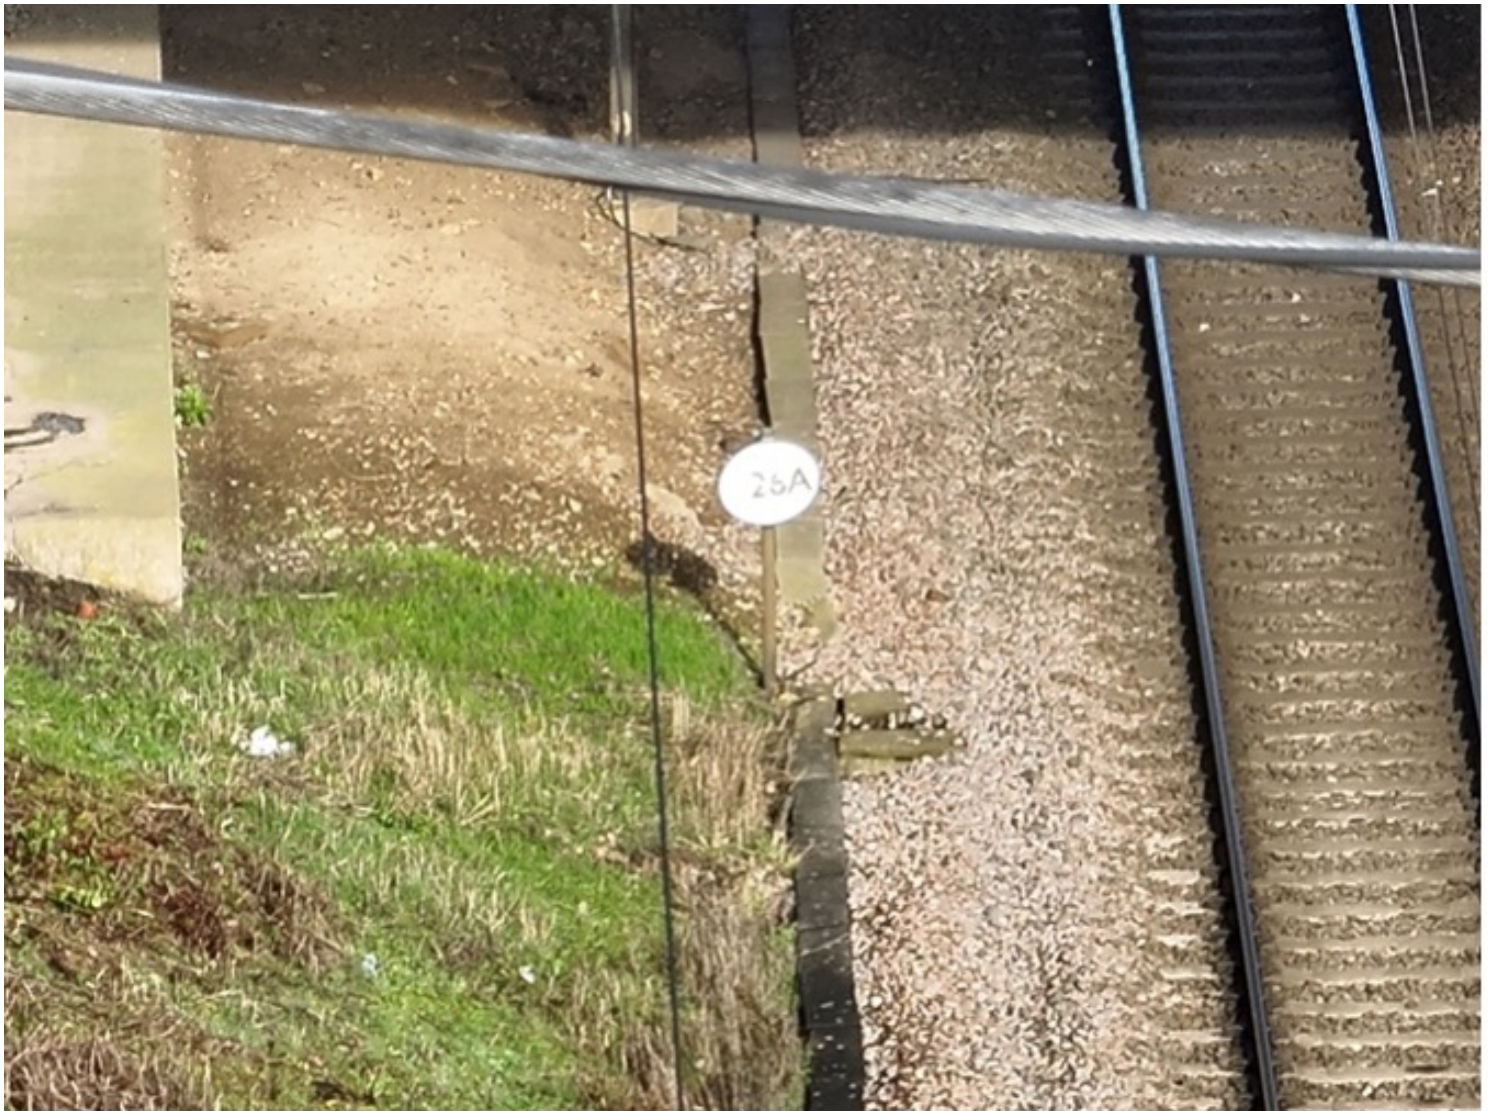
Performing Beyond Visual Line of Sight (BVLOS) flights with visual mitigation (observers positioned out along the flightline who are in touch with each other and the pilot) for the purpose of data capture, we flew through cabling between two pylons a total of 4 times and only noticed they were there when looking at the photographs after the flights. The pylons were obscured from the TOAL site because we were in a cutting. We had previously flown an adjoining section of the same infrastructure in the opposite direction and the pylons at the end point of the two sections were obscured from the TOAL at both ends of each section, even if the aircraft always remained VLOS. The electricity cables were across the infrastructure rather than parallel with it. This meant they were much more difficult to see. The first photo I attach is a general view from aircraft. The pilots were located on the right-hand side, away from the track. There was little visibility of the cables that were across the track and the pylons were obscured from view. The previous flight was flown towards the road bridge, from the far end. The cables were between 30 and 45m high and crossed over this side of the road bridge. The second photo is an approximately 11X zoomed picture looking under the road bridge.

The end point of two flights that meet in the middle but are flown in opposite directions, may inadvertently end up not being subject to on-site visual inspection by the pilot. Pylon cables are difficult to see with the naked eye, particularly if they are at some distance. This report shows how easy it is to mistakenly fly through unseen wires when the pilots are concentrating on the output,

Lessons learned: When checking for electric cables, it is not sufficient to just look for pylons alone. Electric cables are difficult to see and the site inspection should include the start and end point.

rather than the flights. This occurrence is all about the lack of real pre-flight planning. Closer attention to relevant Apps that supply all the information for low-level flying is essential and a focus on the detail as well as ensuring the relevant layers are switched on, would have avoided this situation.
