DUASXX10

Report Title Probable Battery Disconnection

Source: AAIB Bulletin: 6/2023 DJI Mavic 2 Enterprise [AAIB-28582](#)

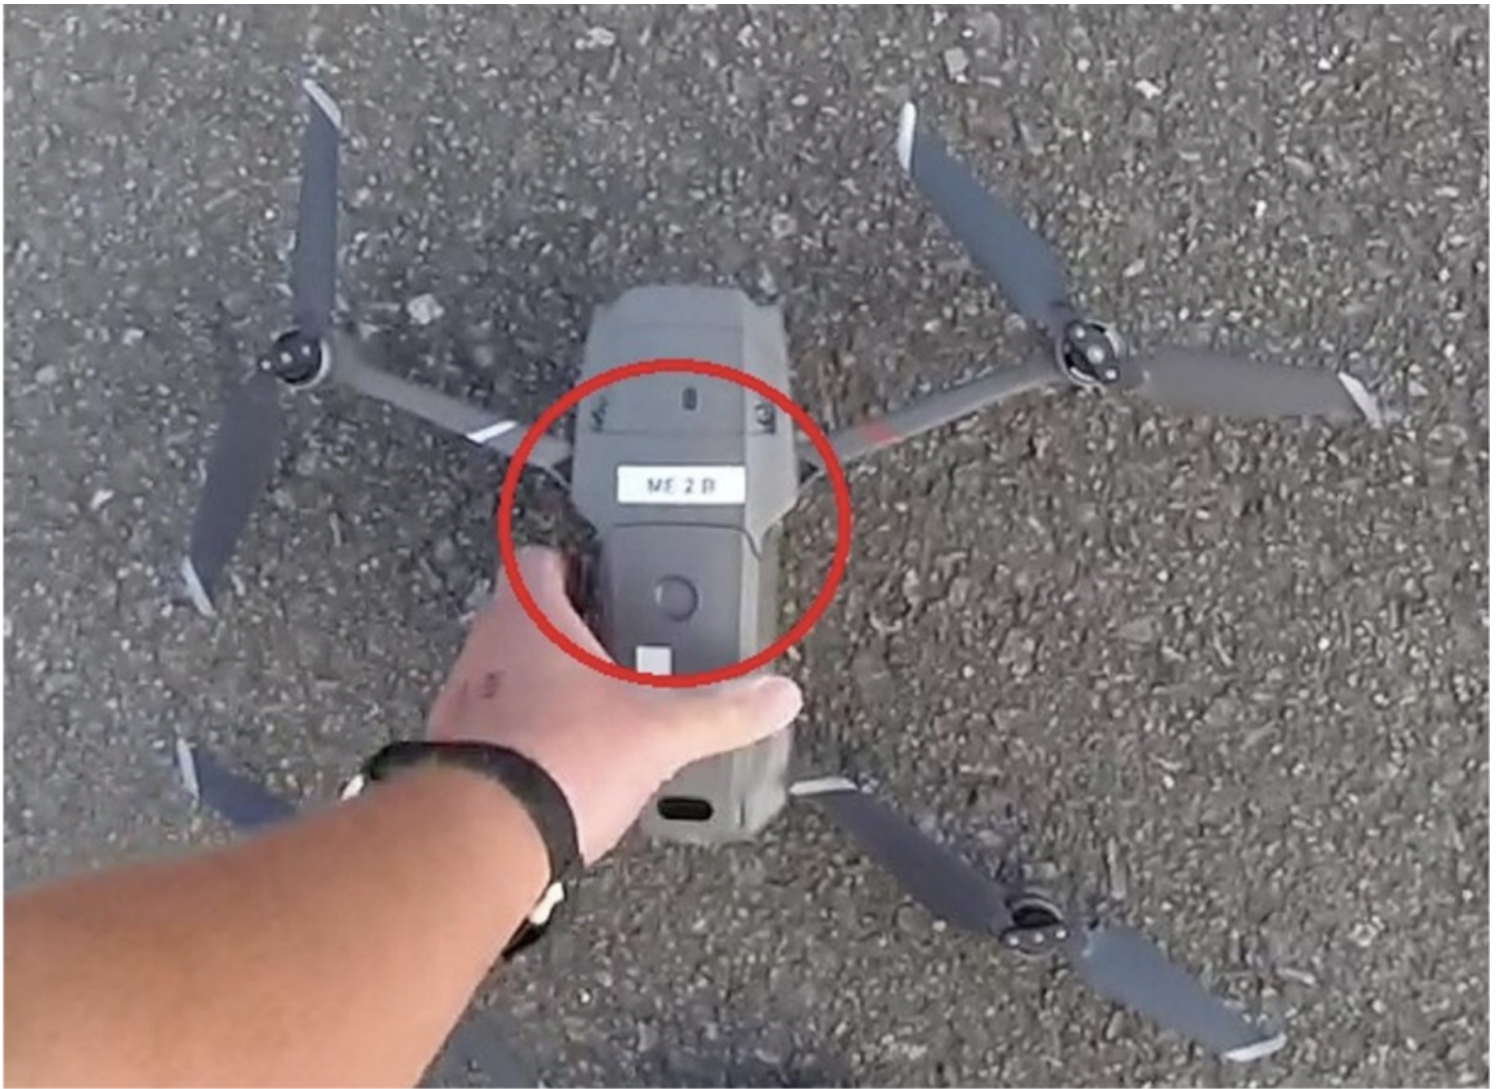
The UAS was being used in an police operation over an abandoned building near a public car park and train station. During hover over the building, the aircraft's motors stopped and the aircraft fell vertically with no prior warning to the remote pilot. The aircraft struck the roof of the building and the battery separated.

Recorded data indicated that the battery probably disconnected in flight. This could have been caused by the battery not having been fully latched prior to take-off, or the latching mechanism or battery being worn from repeated use, resulting in an in-flight disconnection. The operator has taken safety action to remind their pilots of the importance of pre-flight checks and checking airframe and battery condition at their base.

The recorded data indicates that the most likely cause was a loss of battery power to the aircraft which instantly cut off the motors and the link to the controller. The battery state of charge was 77% at the time and there had been no warnings related to the battery. Both the operator and the aircraft manufacturer concluded that the most likely cause was the battery becoming disconnected. The damage to the battery was consistent with it having separated when the aircraft struck the roof of the building, and this detachment was more likely if it was already loose. The operator believed that the pre-flight checks were probably rushed and that the body worn camera image showed the battery not fully engaged (see photo). The aircraft manufacturer could not confirm whether it was fully engaged, but it is possible that it was not. It is also possible that the battery was engaged at that time, but that the latching mechanism or battery were slightly worn from use which led to an in-flight disconnection. There was no indication that the battery was swollen or had exceeded the temperature limit. There are no sensors on the battery locking mechanism to detect and warn the pilot that a battery is not fully latched. For this type of UAS it is important that it is flown in a manner to reduce the risk to uninvolved third parties if it were to fall vertically, and in this case the aircraft was being flown over a large, abandoned building which reduced that risk.

The operator has shared the learning from this accident with all its UAS pilots and reminded them of their responsibility to turn on their body worn camera before they carry out the UAS pre-flight checks so that the checks are captured, and of their responsibility to take time on the UAS checks that are completed at a local air base to ensure the aircraft is fit for use. They also planned to reinforce the briefing of observers, and to carry out routine checks of the batteries.
