# DUASXX11

**Report Title** Rapid Loss of Power

## Initial Report

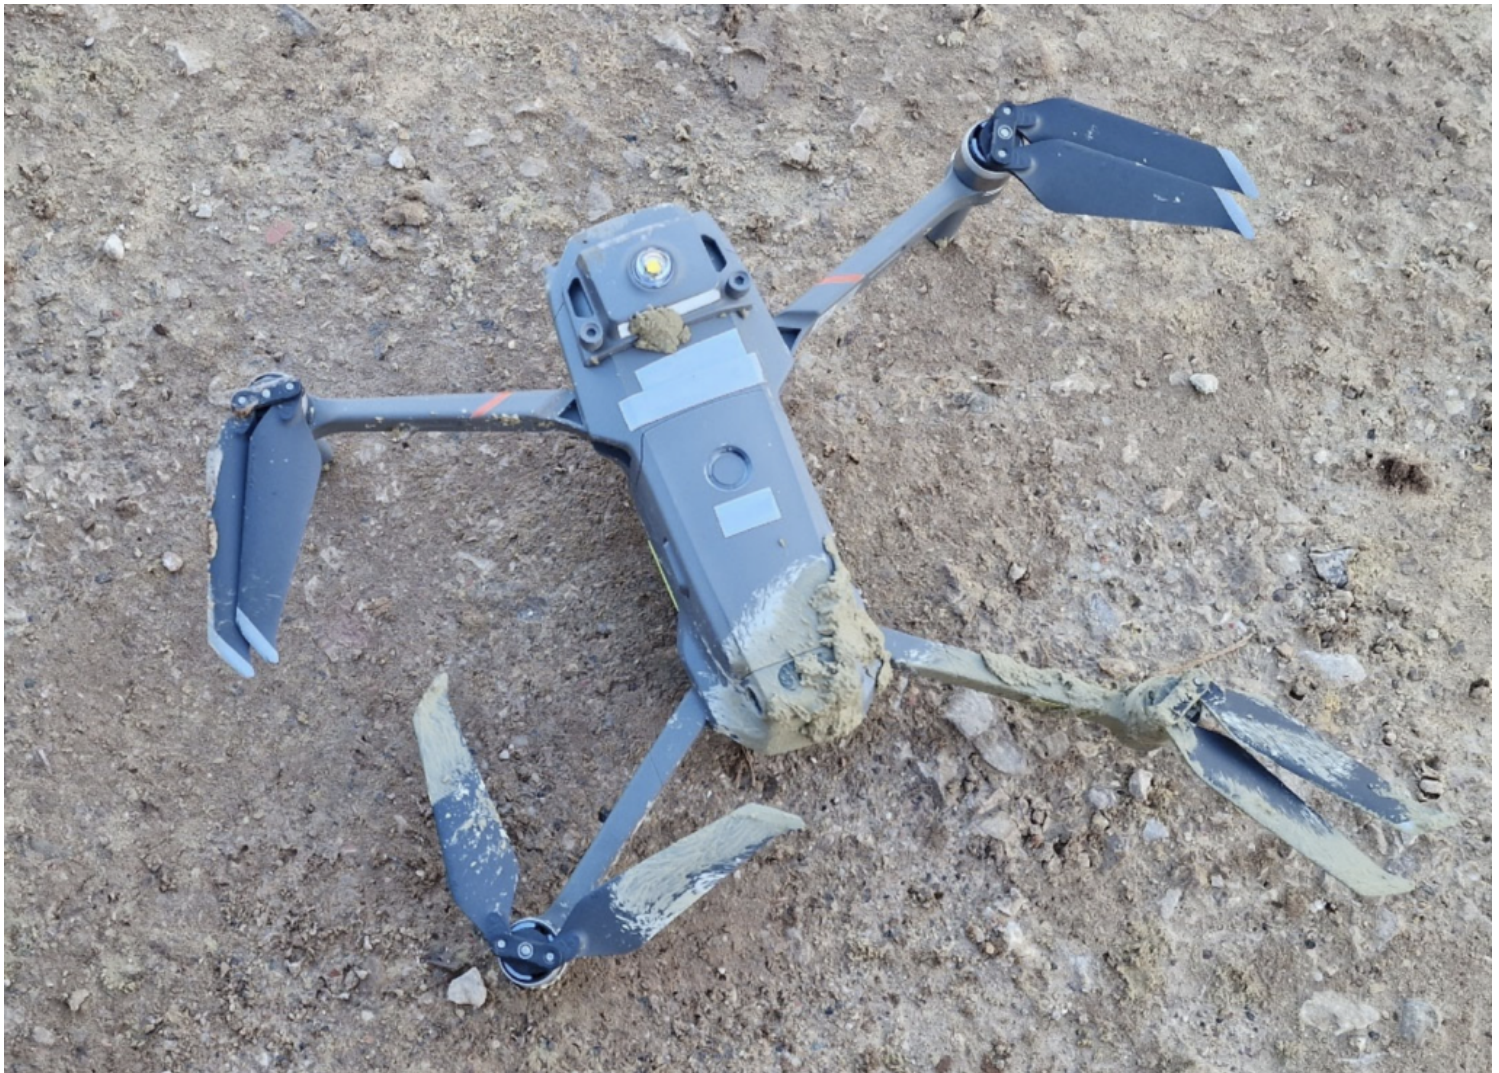
During an aerial survey flight, the UAS detected a rapid loss of battery power and initiated an immediate automatic landing. Whilst descending, its flight behaviour became erratic, control was lost to the remote pilot, and the UA struck an uninvolved person before hitting the ground. The photograph shows the UA after falling to the ground.

It was not possible to determine a cause for the loss of battery power or the flight behaviour. There may have been an opportunity during flight control checks to consider unexpected battery discharge rate as a reason to abort the flight.

The UAS measured a high loss of battery power in a short space of time, leading to an uncontrolled landing where the distance between the UA and uninvolved people and structures was compromised. This sequence of events resulted in the UA striking an uninvolved person. It was not possible to determine a cause of the UA's detecting a loss of battery power or its flight behaviour. Whilst the displayed level of power remaining was sufficient for the planned flight, there may have been an opportunity during flight control checks for the pilot to consider the abnormal battery discharge rate was likely to continue, and to abort the flight.

Warnings during pre-flight control checks should always be heeded. Not everything is explained in the user manual of these type of aircraft, so a warning that comes up on the controller, which is

then countered by other indications, deserves a landing followed by careful consideration. The software sometimes includes in-built triggers that are not fully explained, perhaps because they were part of an update instigated after the manual was published.

Operators are now being encouraged by the Regulator to use any of the publicly available Apps that track a Drone's maintenance status. This includes the status of the battery and is granular enough to track performance of each battery cell. We highly recommend all pilots pre-flight check the performance of their aircraft's batteries on previous flights as a way of detecting any potential weakness in battery performance that may impact their planned flight. It is human nature to forge on if the pilot is under time pressure and thinks they can achieve the task with a reasonable margin of "fuel". It is easy under such circumstances to ignore a warning indication, but it is a mistake to do so!
