DUASXXX6

Report Title F4 Scale Phantom crash

Initial Report

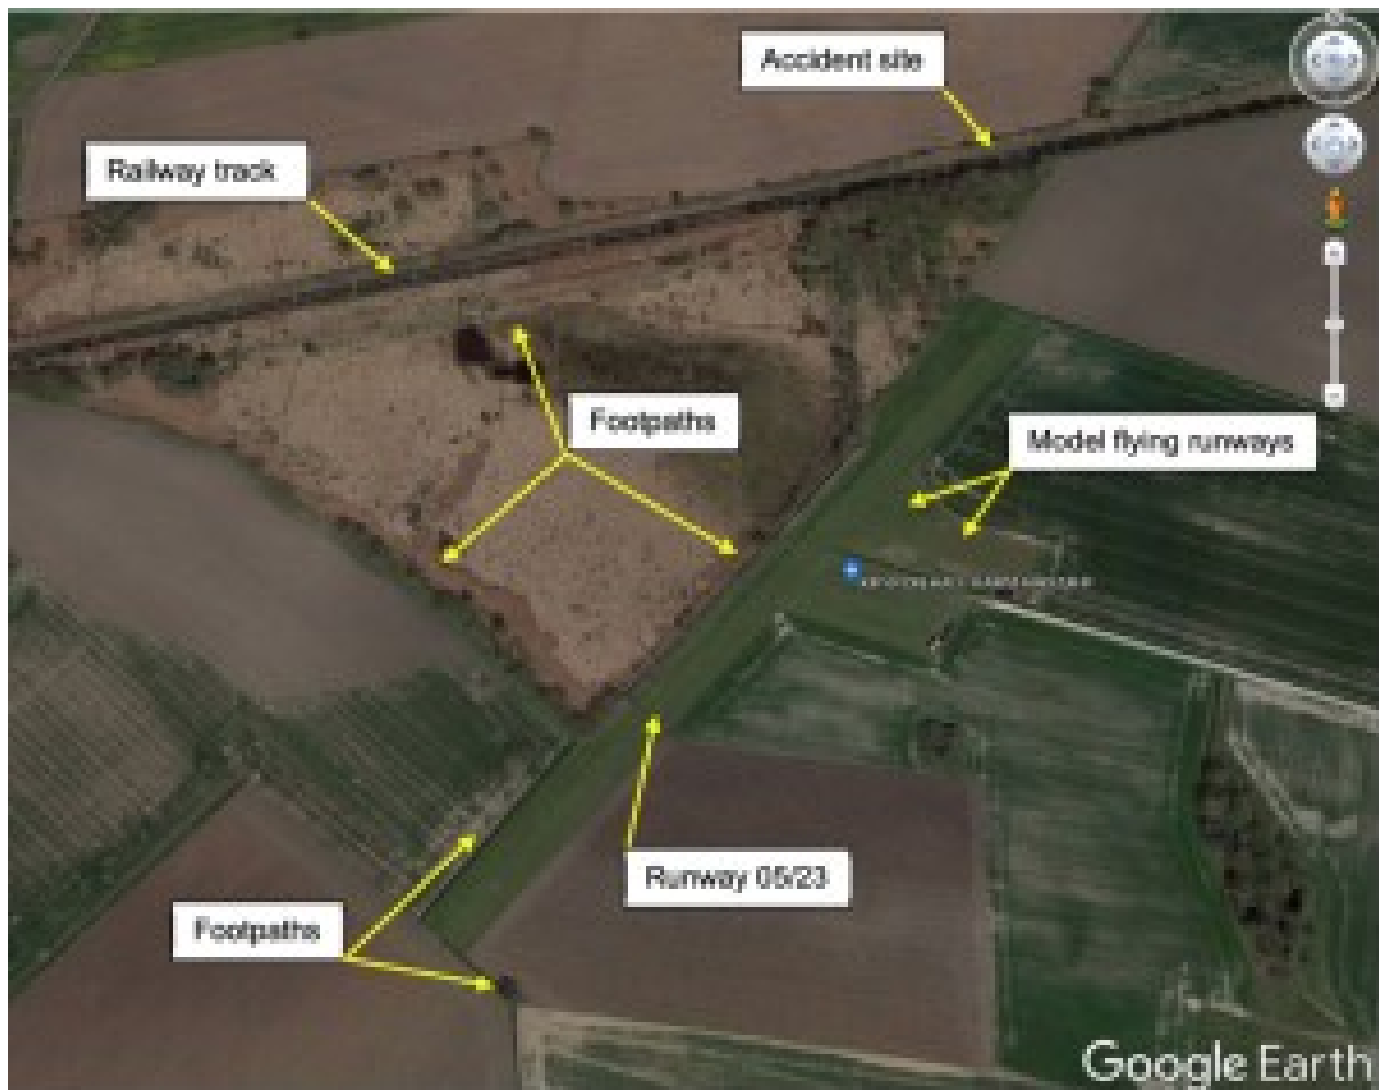
From [AAIB Bulletin10/2022](#) (AAIB-27831). A turbine powered model aircraft suffered a loss of control during its maiden test flight. It continued to fly beyond visual line of sight before crashing on a railway track and was subsequently run over by a passing train. Safety actions taken as a result of this accident include publication of enhanced guidance for members by the British Model Flying Association (BMFA). The model flying club also amended its procedures relating to flying turbine powered models.

The F4 Scale Phantom is a 1:10 scale flying model of the McDonnell Douglas F4 Phantom jet aircraft. It has a takeoff mass of 6.4 kg and is powered by a turbine engine using kerosene. The recently-built model aircraft was undergoing its first test flight. Pre-flight preparation had included an independent check of the control surface sense and deflections, as well as range checks between the transmitter (on the controller) and the receiver (on the aircraft), from multiple angles. A normal takeoff was performed to a height of approximately 200 ft agl, for a flight that predominantly comprised of left hand 'race-track circuits.' During the flight the pilot noted that the aileron response was "sluggish", but he considered it sufficient for safe flight. He subsequently noted that up elevator was required to maintain level flight and progressively applied 'up' trim. During a 180° downwind turn, the aircraft suddenly veered to the right putting it on a north-west heading. Despite the pilot applying corrective aileron inputs, the aircraft did not respond and control was lost. It subsequently stalled, entered a spin and disappeared out of visual line of sight below a tree line. The model aircraft was later found to have come to rest on a railway track adjacent to the airfield, close to a pedestrian crossing, and was subsequently run over by a passing train. The wreckage was recovered by the pilot and other club members. There were no injuries or damage to property. The model aircraft was destroyed. The pilot considered that he had let the airspeed drop too low while concentrating on applying corrective elevator trim. Airfield information: the model flying club is based at Kenyon Hall Farm Airstrip (Figure 1), which is an unlicensed airfield with a grass Runway 05/23 for full size aircraft. There are two runways for model flying, a 75 m strip adjacent and parallel to 05/23 and a 110 m strip, which runs in an east-west direction. A railway track passes to the north of the site. There are several public footpaths which run along the north-west boundary of the airfield, and in the area between the airfield and railway track.

Following the accident, collaboration was undertaken between the BMFA and Network Rail's Air Operations team. This resulted in the provision of tailored guidance for unmanned and model aircraft operators which will be incorporated in the BMFA's member's handbook. It included the provision of a 24-hour emergency contact telephone number for reporting railway safety threats, including the presence of people or objects on or near railway tracks. The BMFA also published an article about this accident, and operation in proximity to railways in general, in the July 2022 edition of its member magazine 'BMFA news'. In addition, the BMFA has updated its incident/accident reporting portal to specifically guide members to telephone Network Rail immediately if an aircraft has come down on Network Rail property, in addition to the requirement to inform the AAIB. After the accident the club amended its procedures to require any turbine powered model to be approved by the club committee before it can be flown at the site, so that its suitability can be assessed. Following this investigation, the club added a section to its procedures relating to retrieval of models that land outside the airfield boundary, which directly references the Network Rail 24-hour emergency telephone number.

For information, the Network Rail telephone number to call in an emergency is: **0345 711 4141**. We recommend that pilots flying anywhere near rail lines ensure they have a note of this number close at hand.
