DUASXXX8

Report Title RPAS ran out of power

From [AAIB Bulletin 1/2023 \(AAIB-28421\)](#).

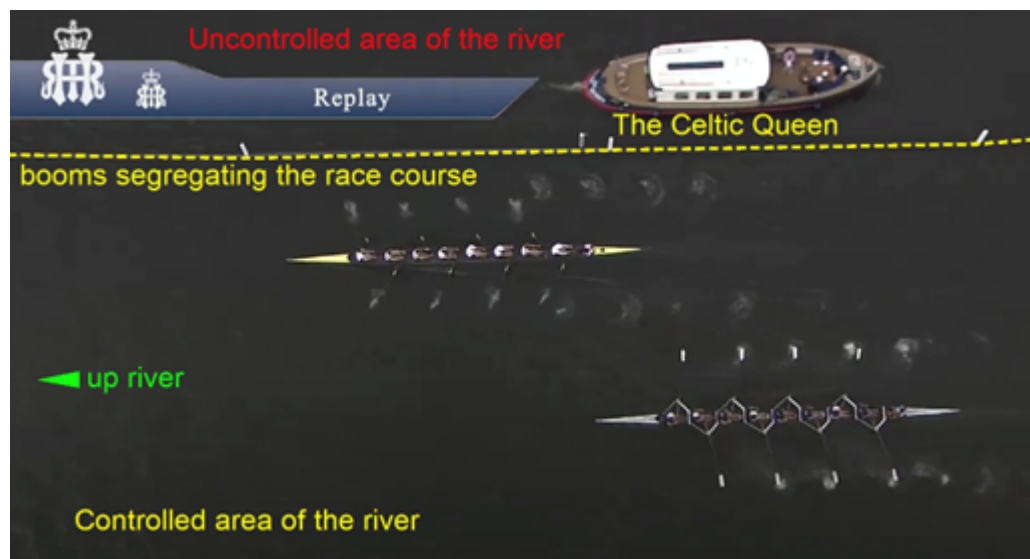
Image from the aircraft, with the Celtic Queen travelling down-river

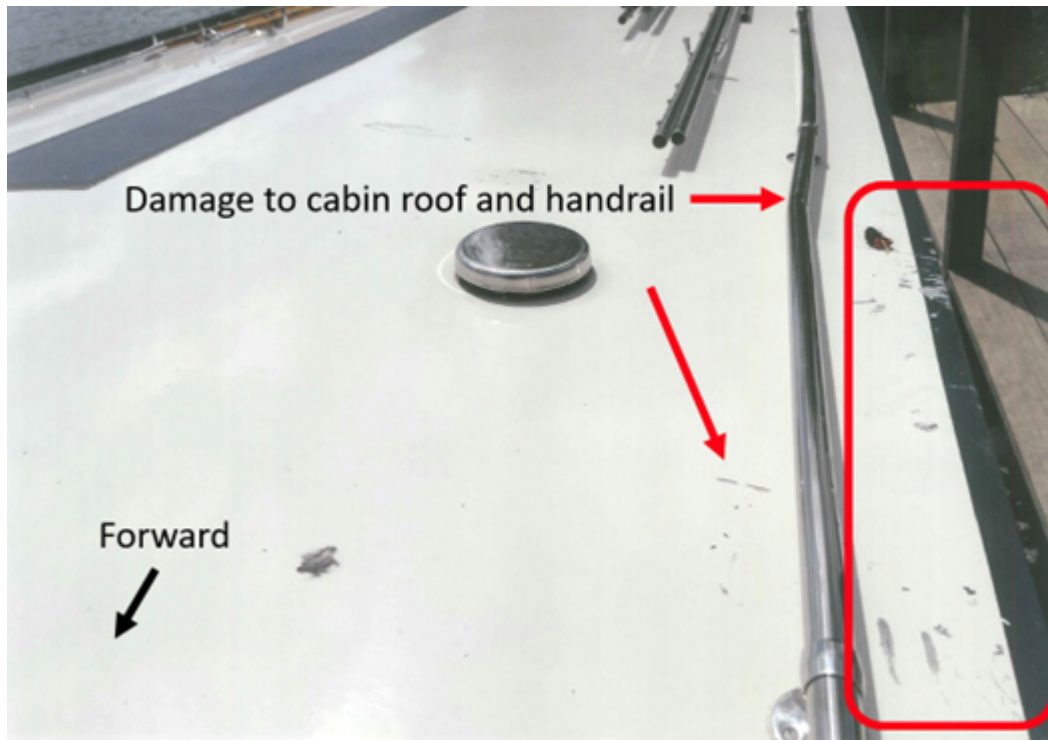
Shortly after the low voltage warning had occurred in flight, the battery reached a critical voltage level at which point controlled flight was lost and the aircraft then descended in near free-fall. The aircraft's kinetic energy when it collided with the boat was estimated to have been about 13,700 Joules. The CASA research paper indicates that fatal injuries would have occurred if the 28 kg aircraft falling at 30 m/s had struck a person on the boat.

Whilst returning to land following a trigger of the low battery voltage warning, the aircraft's battery voltage depleted to the extent that controlled flight was no longer possible. The aircraft descended, in near free-fall, and impacted an occupied private boat on the river. If the aircraft had struck a person on the boat, it is likely that fatal injuries would have occurred.

The pilot did not replace the aircraft batteries when he had intended to, and a pre-flight check of their voltage before the accident flight was most likely not performed. In addition, the low voltage battery warning had been set to a level below that recommended by the manufacturer. Had the battery warning been set to the manufacturer's recommended setting, the aircraft may have been landed safely under the pilot's control.

Damage to the Cabin roof and left side Handrail

- It's never wise to change voltage limits below manufacturers recommended minimum level. They are normally set at a level that has been tested and other limits may have been set accordingly. It therefore follows that other parameters may be impacted, and the pilot may not know which ones have changed and how they have changed. One example of this would be wind gust limits which are set in part by maximum power output calculations.

- On an aircraft system like the Alta, it might be sensible to fix a sticker to the controller with the voltage limit at which return home is necessary, so it is easier to remember, particularly if there is no audible warning mechanism.
