# M2150

**Report Title** Imminent mooring failure averted by vigilant crew

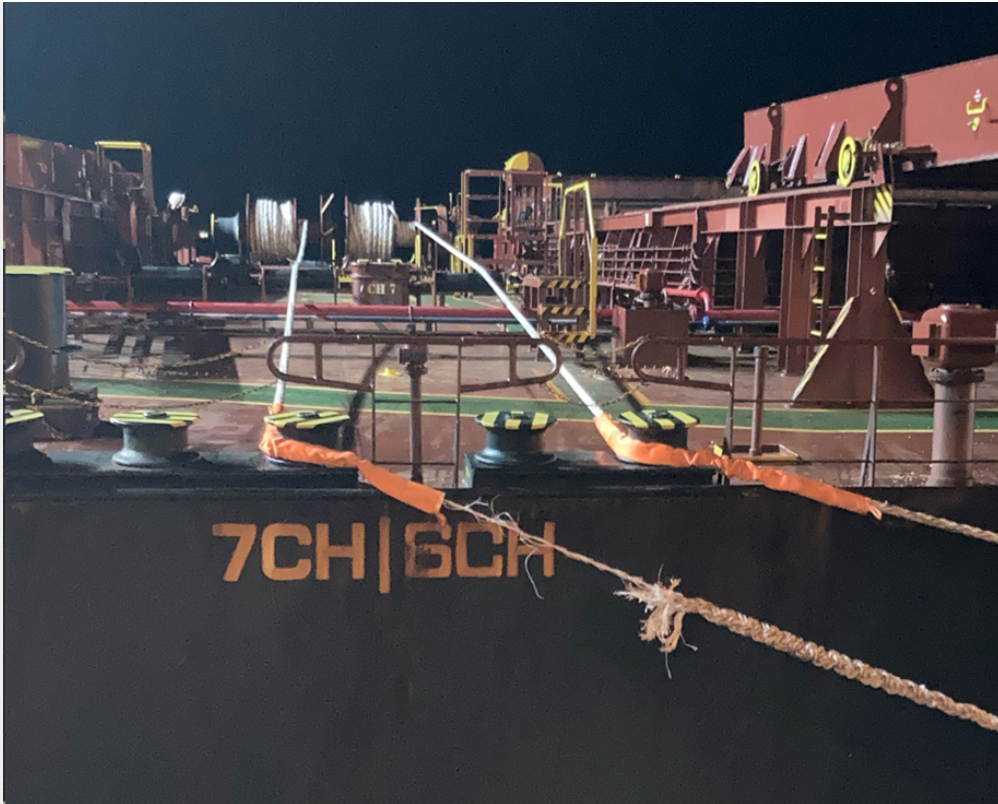
Whilst the vessel was alongside at our terminal, long-period low amplitude swell waves (groundswell) caused a large bulk carrier to yaw and roll. This motion caused the edge of the roller fairlead to saw through one of the forward spring lines. Fortunately, this was detected by the crew before it was cut all the way through, and they were able to replace the line before it parted.

The design of the mounting block on which the pairs of roller fairleads are mounted requires review. The 90-degree edges act as a blade on surging ropes. Naval architects are reminded that the edges of these should be considered during the design phase of a new vessel. By eliminating such hazards at this stage can significantly decrease the chances of lines abrading or parting during the vessel's lifetime. [OCIMF's Mooring Equipment Guidelines \(MEG4\)](#)[1] provide further guidance on the design and construction of the mooring system.

Vessel owners remain responsible for maintenance in most cases, and they should ensure that such hidden hazards are removed as soon as possible, or at the latest, during the vessel's next maintenance period.

**Design-** Naval architects should avoid designing sharp edges over which lines are likely to be run. Crews: does your vessel have this issue? If so – report it!
