# M2164

**Report Title** Lift E-Foil Battery Thermal Run-away

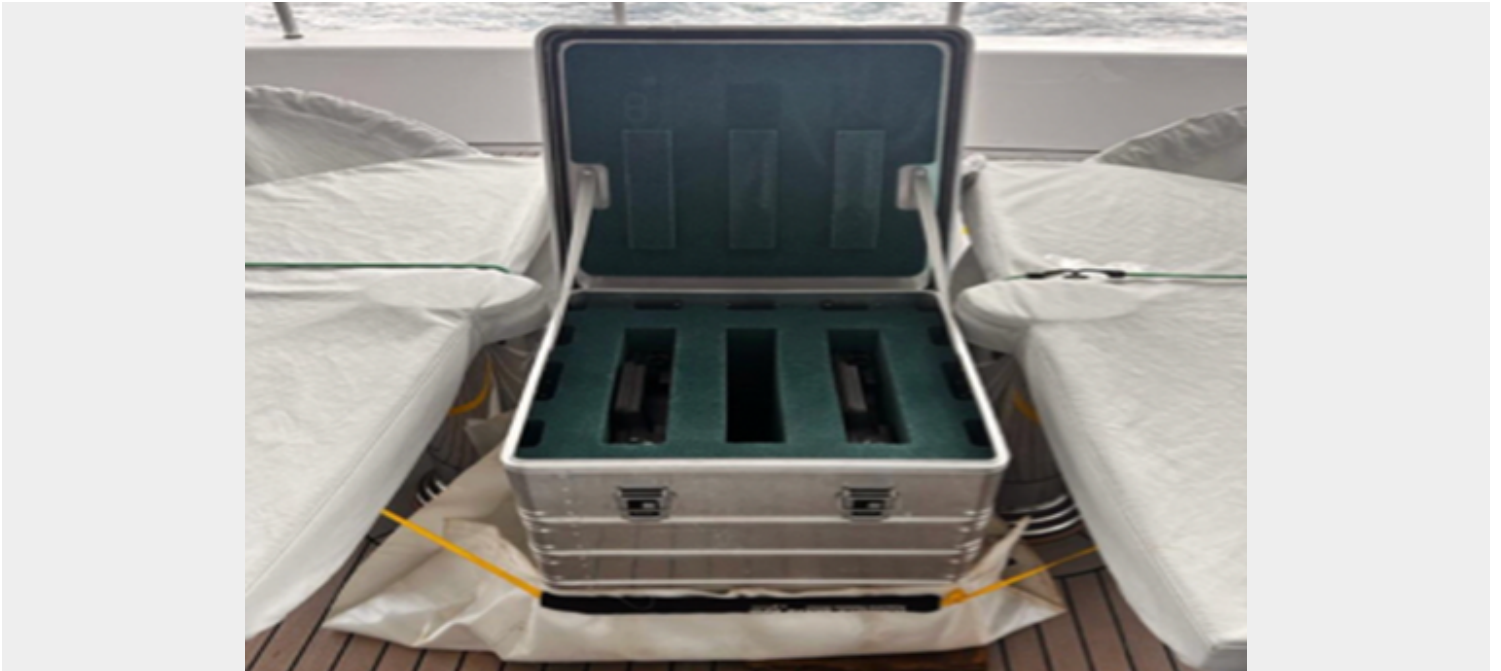
During a routine inspection by the deck crew, one of two Lift E-Foil lithium-ion batteries, stored inside a purpose-built battery storage box, was significantly warmer than the other. The batteries were charged the day before for routine maintenance, and no abnormalities were detected during the charging.

Upon finding the warm battery, a temperature reading was taken of 37°C. The storage box with both batteries inside was moved to the main deck aft to a location visible by CCTV. The box was placed on top of a fire blanket.

Hourly inspections of the battery and readings of the temperature were added to the hourly rounds of the deck crew. By noon the following day, the temperature of the battery had risen to 47°C, and

The investigation revealed that there was a suspected thermal run-away developing. The cause of this was potentially a faulty cell within the battery.
