M2243

Report Title Explosion in the Engine Room

Initial Report

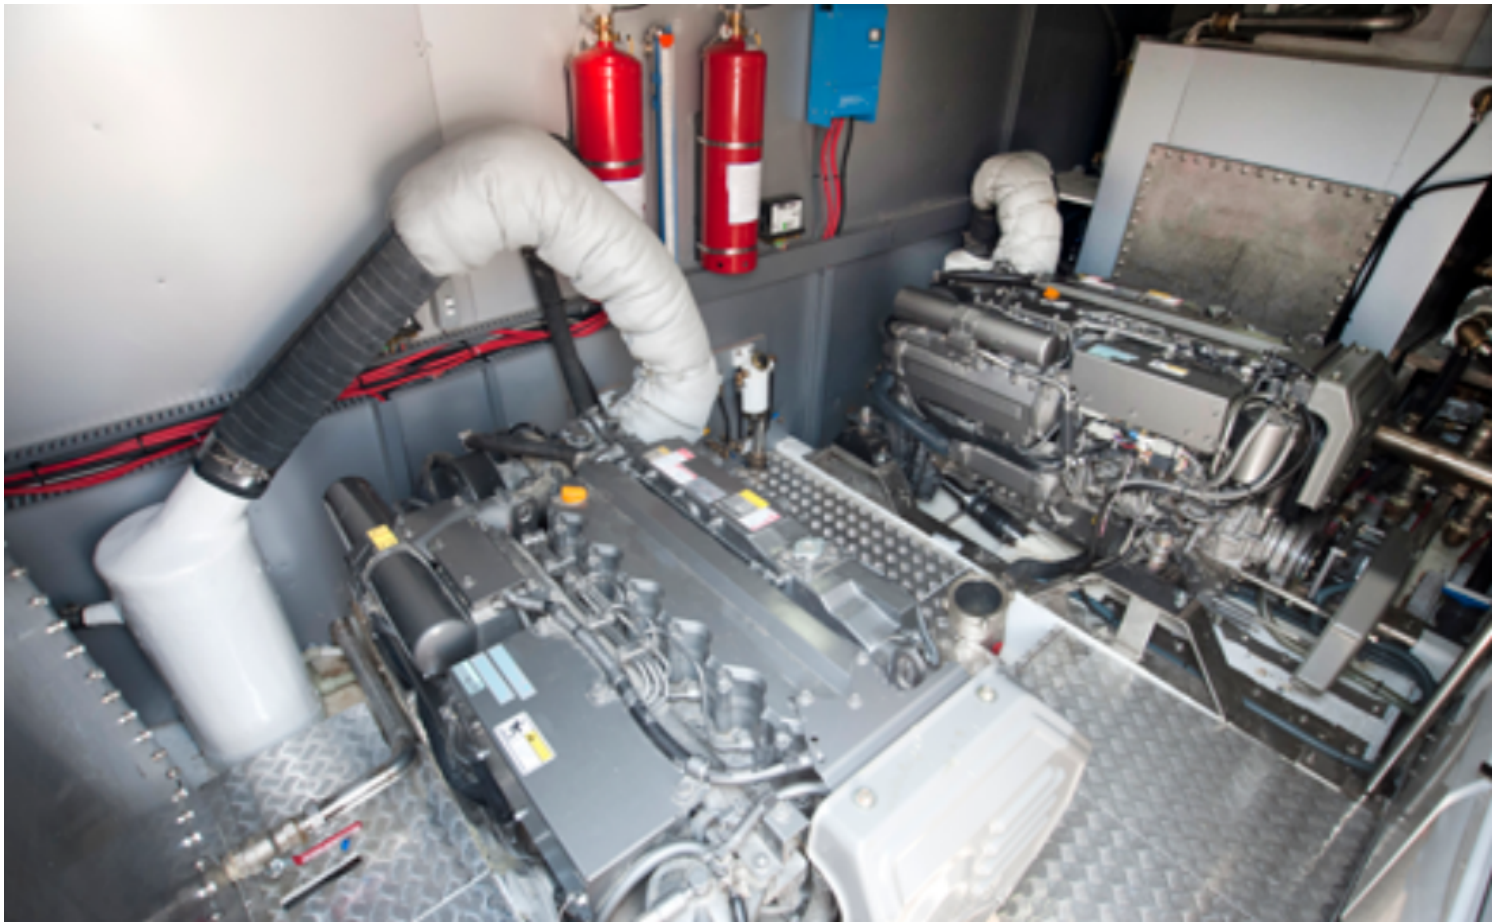
With contacts on, the starboard engine exploded in the engine room, located aft, under the area where the guests were. By checking the CCTV, the master could see only misty air. None of the alarms were activated.

A starting battery explosion is a regular occurrence on some superyachts, where the necessary knowledge of battery maintenance is lacking.

From a technical perspective, CHIRP highlights that the maintenance of the starting batteries requires a good knowledge of them to ensure that they are safe to operate and adequately charged. Venting hydrogen during any charging operation is vital to provide a safe atmosphere. There was a lack of knowledge or a lack of knowledgeable crew to check that the batteries were in good condition and safe to use.

Capability – The vessel did not have adequate inspection and maintenance schedules to ensure the batteries were safe. Does your motor yacht have a maintenance schedule for items of critical importance?

From a crew resource perspective, a risk assessment based on assessing the hazards and threats to the vessel should be carried out to determine the number of crew members to employ to cover maintenance and emergencies safely.
