An independent and confidential reporting system for the Maritime industry

It's good to talk!

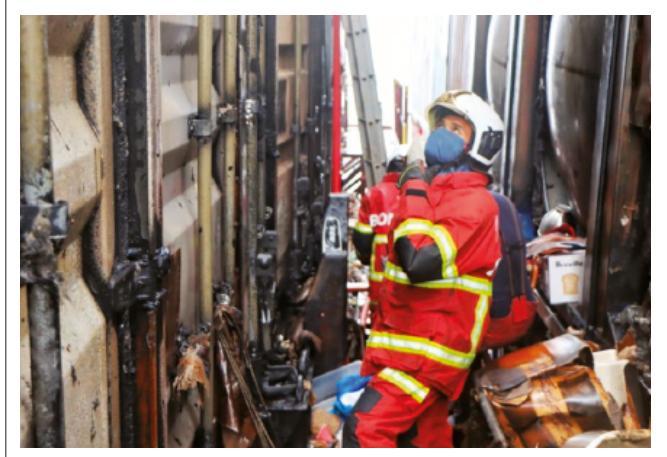
The fire was discovered as the vessel lay anchored off a port. Following the activation of the vessel's fire alarm, assistance from the shore authorities was sought. Fireboats from the maritime authorities were dispatched. Water cannons were employed to engulf the burning deck container stacks. After several hours, the fire was reported to be under control.

The operation involved firefighting in a restricted space and resulted in damage to the containers on fire and to adjacent containers.

Shoreside firefighters assist the crew in tackling the fire.

Understanding the contents of containers is crucial for crew safety and vessel integrity. Mis-declared containers, a common issue, can significantly endanger crew lives. In this case, the containers involved contained resin, which can be transported in various forms, such as bags, drums, containers, or bulk, and may fall under IMDG Class 3 or 4, depending on their state.

CHIRP recommends providing a photograph of the stowed dangerous goods (DG) container before sealing the doors. This allows the crew to understand the cargo behind the doors, enhancing their awareness of the challenges in combating fires involving such cargoes.

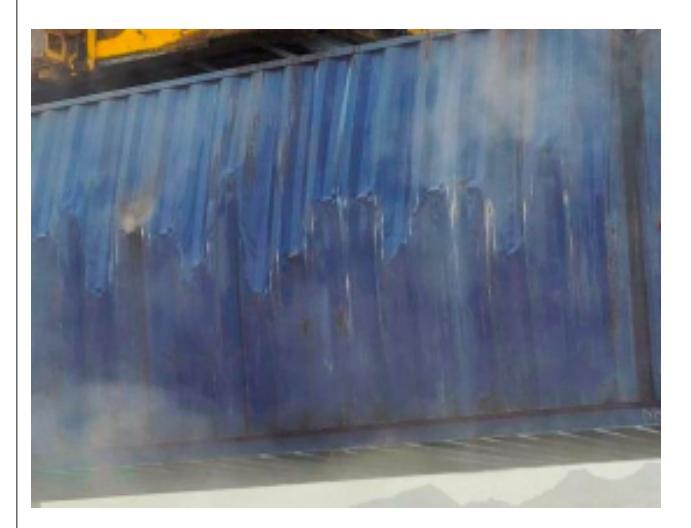
Smoke and a burning smell were detected during port operations. One container stowed in the hold was found emitting smoke, and the side wall of the container was bulging due to the heat and pressure.

"Charcoal, categorised as UN1361 and falling under Class 4.2, presents unique risks due to its tendency to spontaneously ignite if stored improperly. Essentially, when exposed to oxygen, charcoal oxidises, generating heat. To ensure accurate understanding, shippers must precisely label the cargo as carbon/charcoal, as it goes by other names, and its hazardous nature may not be apparent otherwise.

Storing warm or hot charcoal accelerates oxidation, leading to dangerous heat build-up that standard cooling methods may not counteract. This self-heating process can escalate to ignition, posing significant risks. The duration for self-heating varies by charcoal type and weathering and is typically around two weeks before loading into a container.

To address the challenge of charcoal fires, CHIRP advises storing containers on deck for easier access, facilitating swift containment and safe discharge in port, thereby reducing hazards.

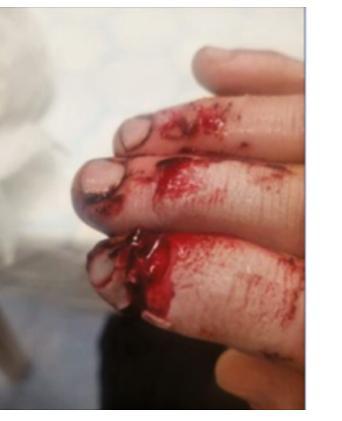
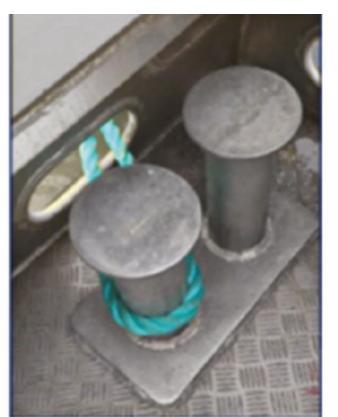
The vessel was headed to the pontoon to moor alongside her regular berth. As the vessel's aft port quarter came alongside the pontoon, the deckhand used the boat hook to pick up the 'in-situ' mooring line and began feeding the spliced eye through the fairlead. They then started placing the line over the bitts; this is where the deckhand's fingers on their right hand became trapped, and serious injuries were sustained to three fingers.

Placing a mooring line over the bitts requires very good situational awareness of the vessel's movement, the position of the mooring line, and the crewmember. The risk of hand entrapment is a well-known hazard, and it can be normalised during routine operations.

Once the eye of the mooring line is through the workboat's fairlead, a sufficient length of the mooring line should be available on the workboat so that the eye can be placed over the bitts without the crew's hand making contact with it. This would prevent any sudden snatching of the line, which could trap the crew's fingers if they were holding the eye of the mooring line.

For heavier lines, a short, stout rope can be fastened to the mooring's eye so that it can be hauled over the bitts without any hand contact with the mooring eye.
