(1) CHIRP

Confidential Human Factors Incident Reporting Programme

Annual Digest of Reports and Insight Articles 2024

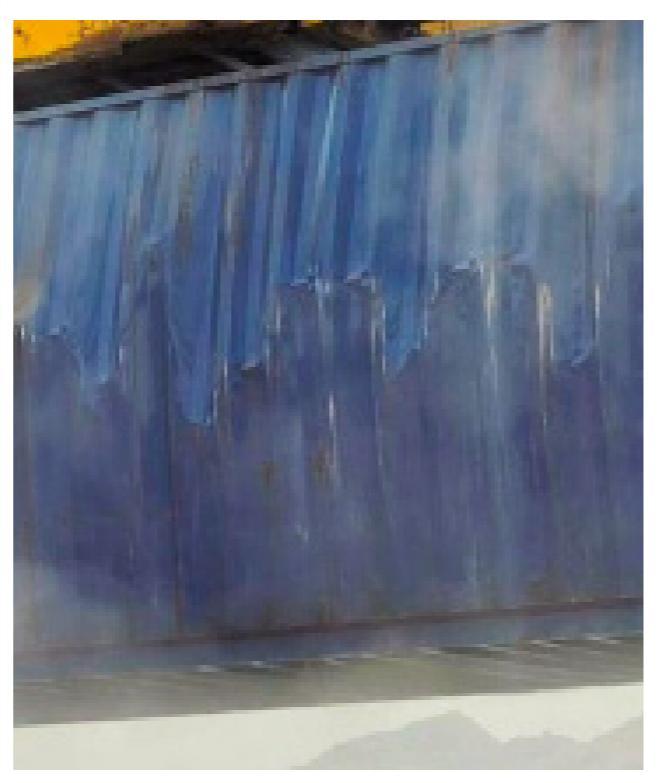
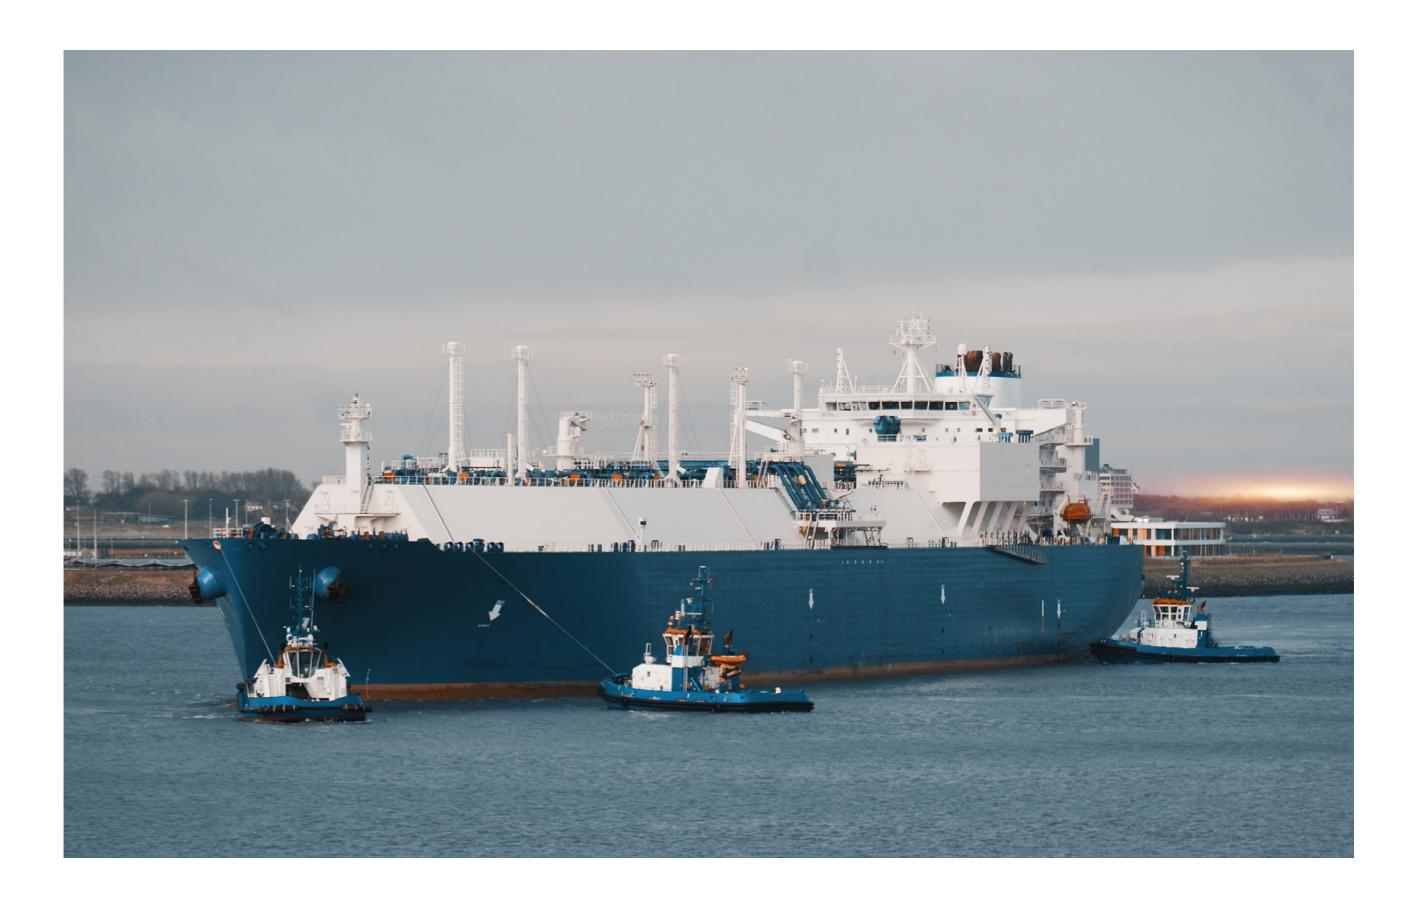
Smoke and a burning smell were detected during port operations. One container stowed in the hold was found emitting smoke, and the side wall of the container was bulging due to the heat and pressure.

The container was discharged promptly and moved to the terminal container yard.

Fortunately, an observant crew member or stevedore saw the signs of fire early before other containers were loaded on top.

"Charcoal, categorised as UN1361 and falling under Class 4.2, presents unique risks due to its tendency to spontaneously ignite if stored improperly. Essentially, when exposed to oxygen, charcoal oxidises, generating heat. To ensure accurate understanding, shippers must precisely label the cargo as carbon/charcoal, as it goes by other names, and its hazardous nature may not be apparent otherwise.

To address the challenge of charcoal fires, CHIRP advises storing containers on deck for easier access, facilitating swift containment and safe discharge in port, thereby reducing hazards.

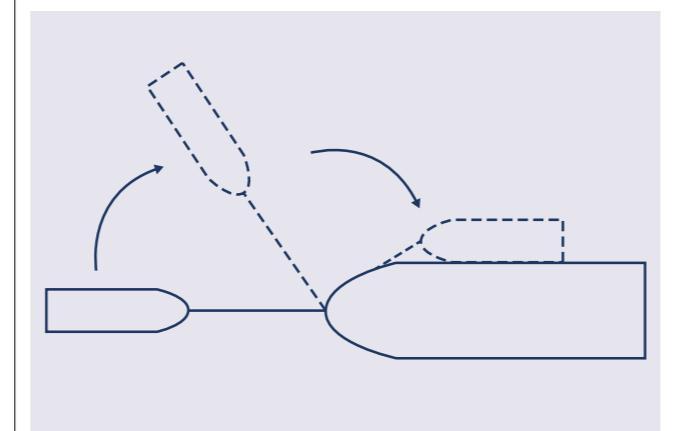
Figure 1: Likely response of a tug to engine failure

As the chief pilot prepared to make a planned alteration of course, both engines of the tug attached to the centre lead forward failed within minutes of each other, and the tug was overtaken and pulled hard against the LNG carrier's bow by the towing line.

A combination of the sea state and the tug's ballast arrangement was found to have caused the sea chest to become starved of cooling water for the generators, which were automatically shut down to preserve the equipment.

Tugs sometimes undertake bow-to-bow (reverse) towing because it keeps their propellors further away from the pressure fields around the towed vessel's bow. This method also ensures that if the tug propulsion fails (as in this incident), it is pulled alongside the towed vessel by its bow, which reduces the risk of capsizing.

The automatic shut-down system protects the equipment from overheating and being damaged or even catching fire. However, many systems do not have a manual override for use in emergencies. Tug vessel operators are advised to investigate how their equipment would react in a similar scenario, whether it would alert the operators before shutting down, and then develop emergency procedures accordingly. A checklist that includes the operating area (open water, sheltered

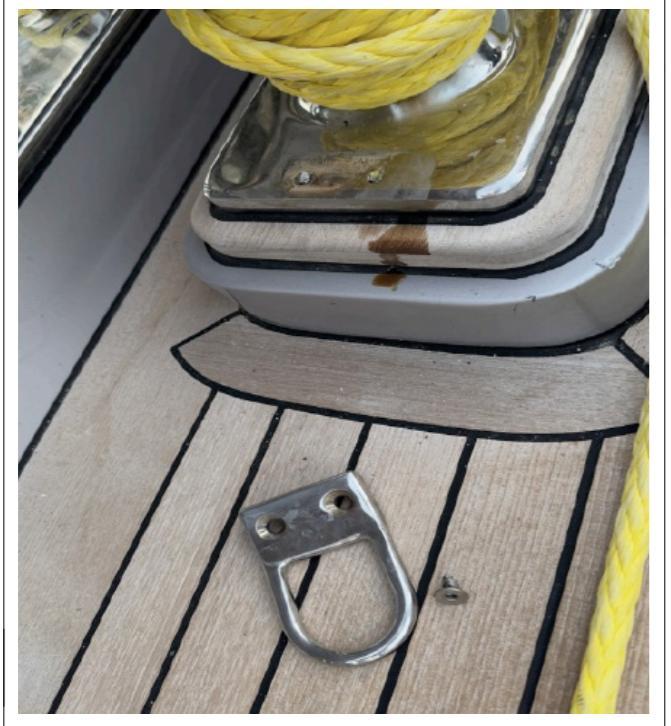
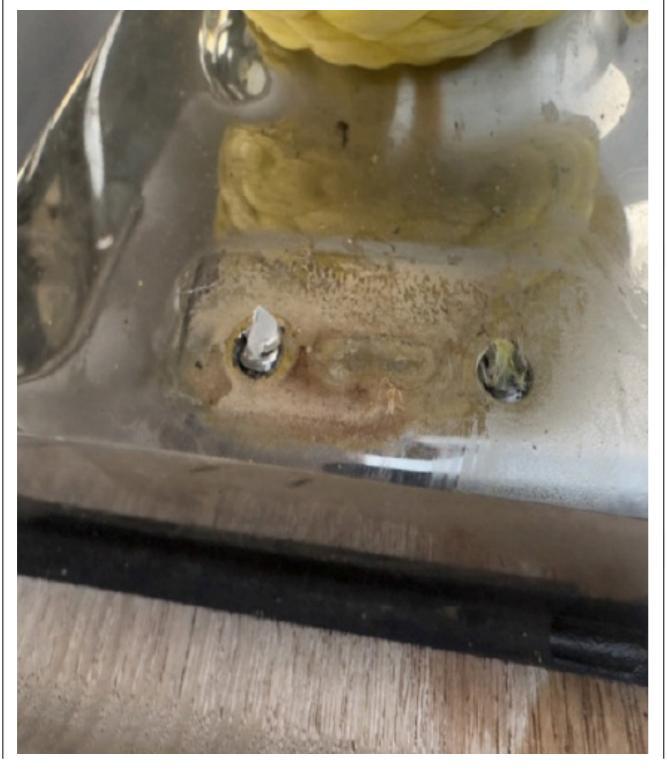
A 'bitt' of a hazard!

The mooring bitts pictured below had a D-ring attached to them, which was used as the strong point for connecting a rope stopper. When the weight of the mooring line came onto the stopper, the D-ring's connecting screws sheared off, and the D-ring was fired into the air towards the mooring party. Luckily, no one was injured.

Stoppers – and whatever they are connected to - must be capable of supporting the loads transmitted through the mooring lines. The small-diameter screws connecting this D-ring to the bitts were entirely inadequate for this task. A better arrangement would be to attach the standing end of the stopper around the bitt or a nearby cleat.

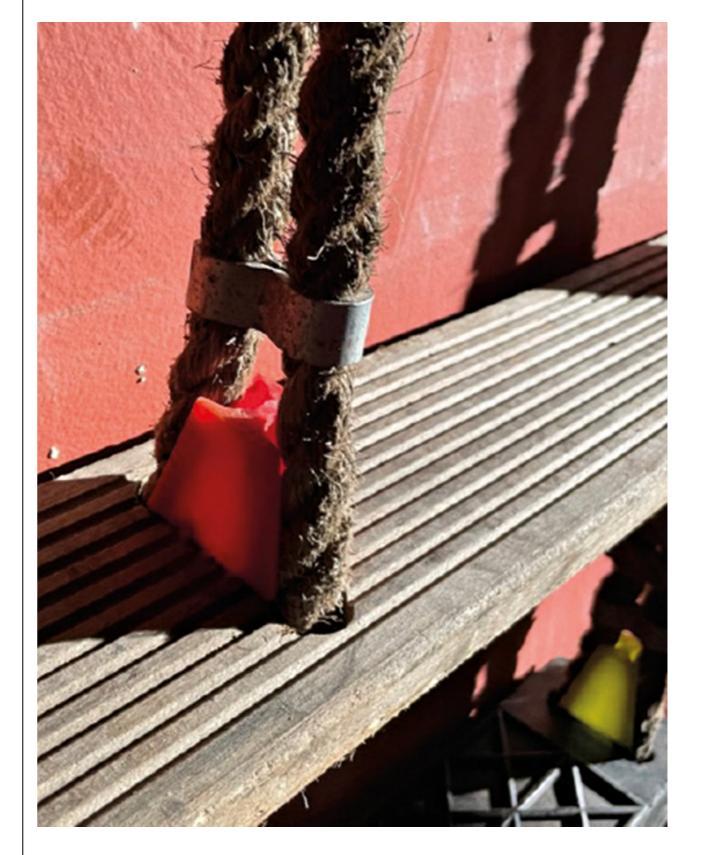
The reporter stated that a pilot ladder had to be condemned as it was unsafe for use. It had very loose steps, which is typical of a certain manufacturer whose ladders seem to have a serious design flaw. The matter has been raised to the port authority.

There is a notable issue with the manufacture and design of pilot ladders, particularly regarding the stability of the steps. A common problem arises with the clamping mechanism used to secure the chocks, if it is not robust enough to ensure that the ladder steps remain horizontal throughout the ladder's working life.

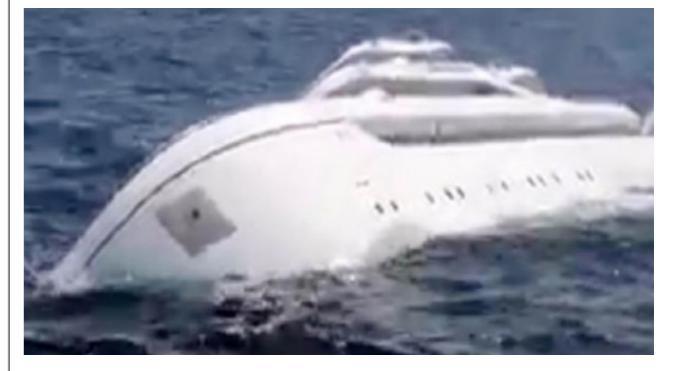
According to our reporters, escape from the vessel was hampered by missing handles on one of the emergency escape hatches, and missing handrails on the stairs between decks made it extremely difficult to get out of the vessel. The lack of securely fastened furniture, including unsecured beds, also created a hazardous environment with floating debris obstructing escape routes. None of the passengers received a safety briefing upon boarding the vessel.

Significant structural changes invariably affect stability, and inclining tests must be conducted to update the vessel's stability curve data. Despite the passengers raising concerns on several occasions, it is troubling that the crew neither recognised nor reacted to the obvious warning signs. At best, this indicates a lack of training and at worst, the company put commercial interest above crew and passenger safety by continuing the voyage. Although the vessel had significant safety design defects e.g., lack of handrails on the steps between decks, the crew also demonstrated a complacent attitude to safety: items were not correctly secured for sea, nor were basic safety items such as the life raft painter correctly fitted. These, and the lack of a safety briefing for the guests, all point to a poor safety culture compounded by inadequate crew training and competency,

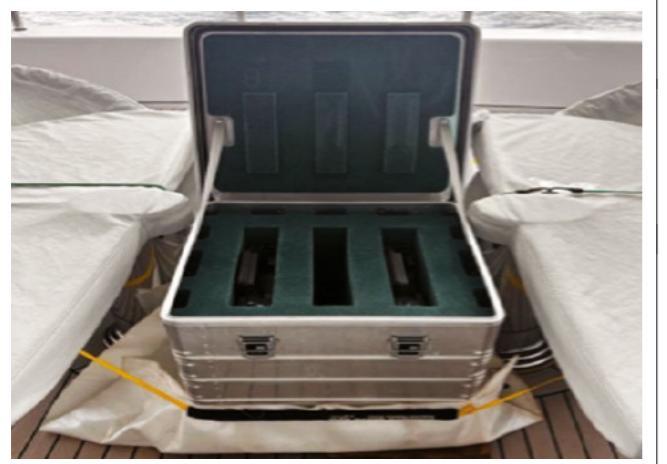
The investigation revealed that there was a suspected thermal run-away developing. The cause of this was potentially a faulty cell within the battery.

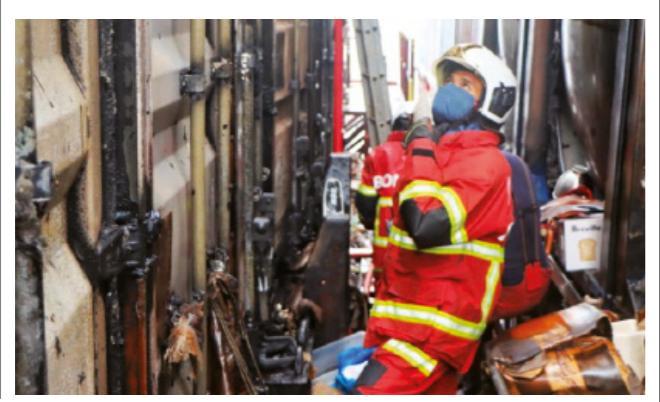
Shoreside firefighters assist the crew in tackling the fire.

CHIRP recommends providing a photograph of the stowed dangerous goods (DG) container before sealing the doors. This allows the crew to understand the cargo behind the doors, enhancing their awareness of the challenges in combating fires involving such cargoes.
