FC5253

Report Title Incorrect hold entry due to chart confusion

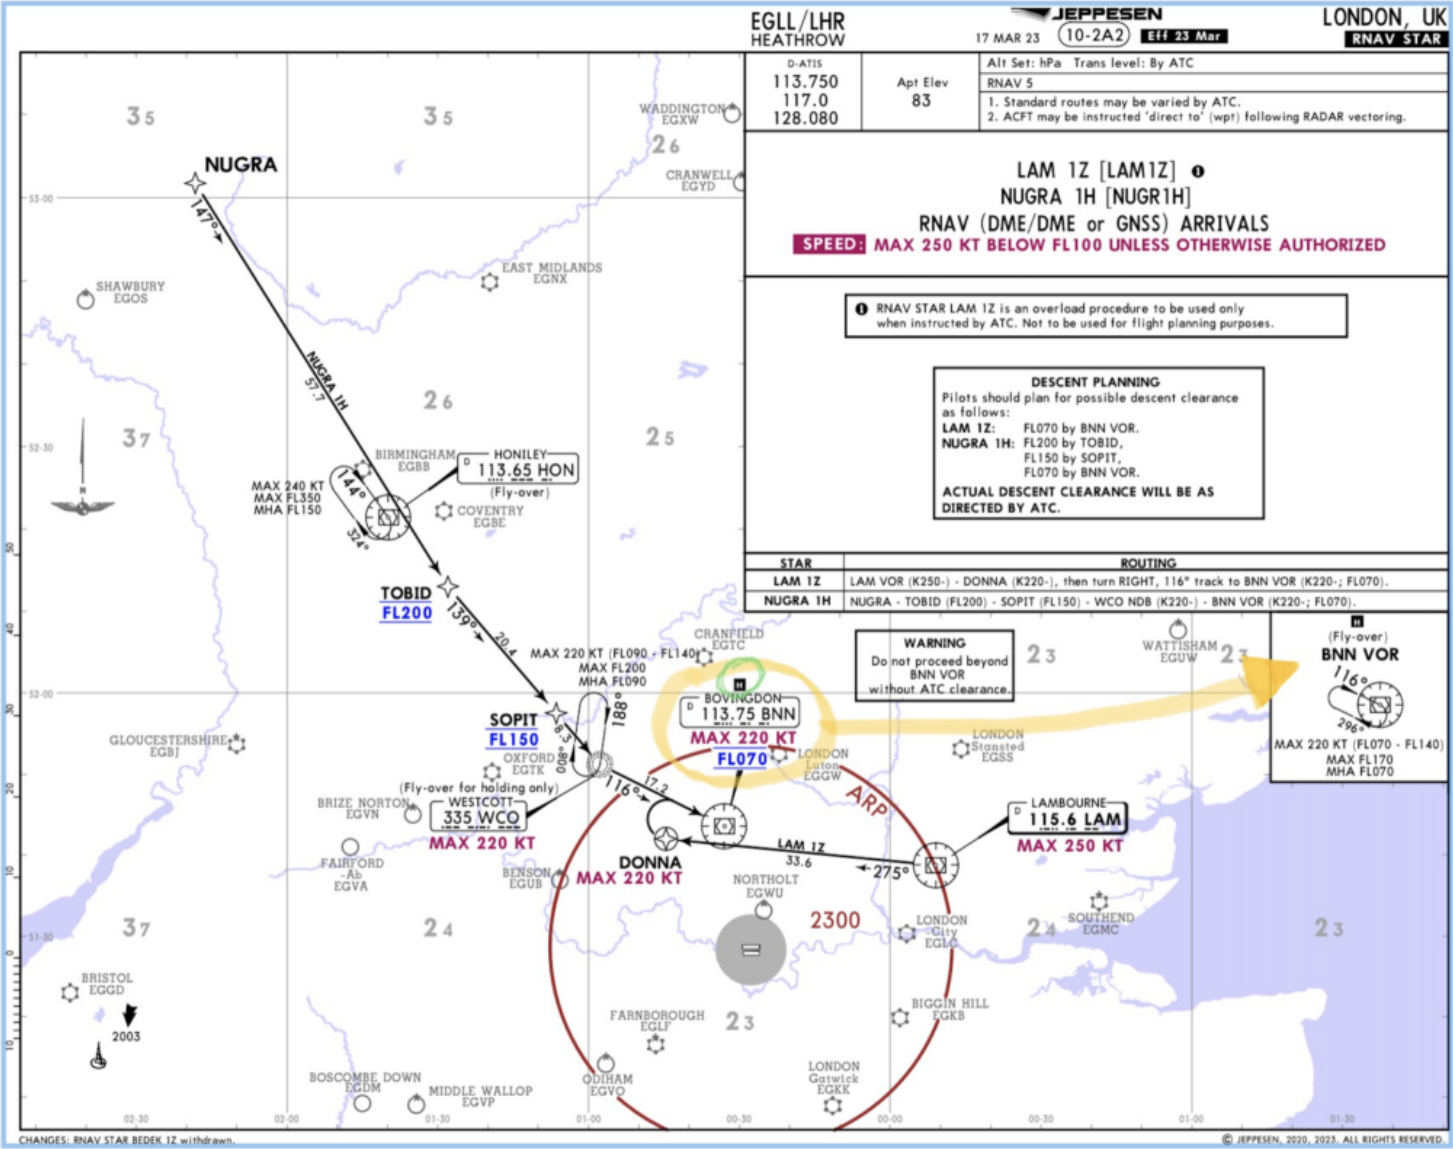
When we got on the ground, I realized something had gone wrong and opted to call the EGWU Tower to get clarification on the holding. After a few minutes of discussion, I realized my mistake; the Jeppesen Chart had a bubble note indicating published hold for BNN but it was not printed close to point of the hold. Because of the way our charts are displayed in the cockpit you must find the bubble note in a different portion of the screen (slew the view to a different portion of the chart) and it was missed. I asked my co-captain if he had ever seen these notes before on other charts and he had not. Unfortunately, I knew about this subtle change but missed it because of the increasing workload. In the end this was good reminder that if you are unsure of a clearance not to accept it until you are positive you know the instructions. The airspace was very busy but asking for a vector hold would have prevented this incorrect hold entry.

Ordinarily, crews inbound to Northolt do not hold at BNN and are given a vector for the approach so being asked to hold would have been unexpected. Furthermore, the Jeppesen charts for the procedure do indeed have the published hold pattern someway offset from the BNN location on the chart and so there is some sympathy for the crew (see screenshot with highlight arrow). However, as part of their arrival brief, the crew should have made sure they knew what any potential hold procedure would be as they approached BNN and, if not clear what to do when instructed to hold, they should have asked the controller for more information or requested radar vectors. Equally, although controllers were justified in assuming that the pilots would understand what was required when they were issued an instruction and did not query it, the controller could have asked whether the crew knew what was expected of them given that this was not a normal routing. Ultimately, the approach plate gives a warning '*Do not proceed beyond BNN VOR without ATC clearance*' and so the crew ought to have conducted a self-briefing about what contingencies might result once they arrived at BNN in case they were not cleared to proceed beyond.
